Current Site Photographs, Iron King Mine – Humboldt Smelter Superfund Site

*Iron King Mine – Humboldt Smelter Superfund Site
Dewey-Humboldt, Yavapai County, Arizona*

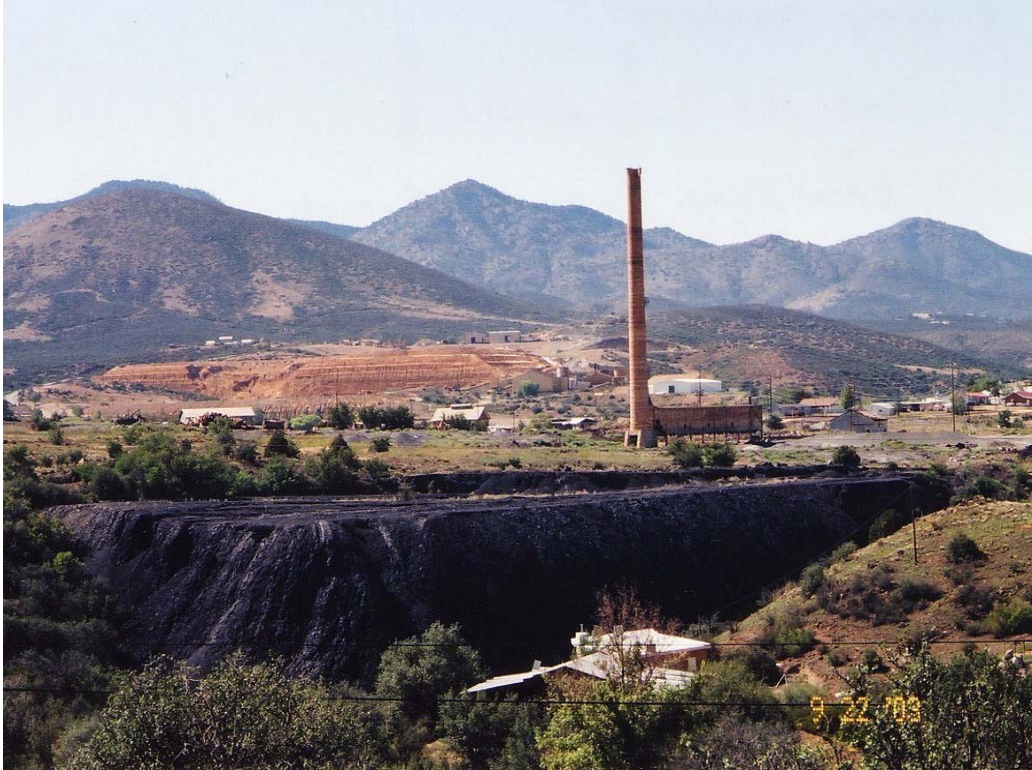
Photograph 1: Site Overview. Former Humboldt Smelter property in the foreground and former Iron King Mine property in the background at Viewpoint (VP) 1 (see Figure A-1)

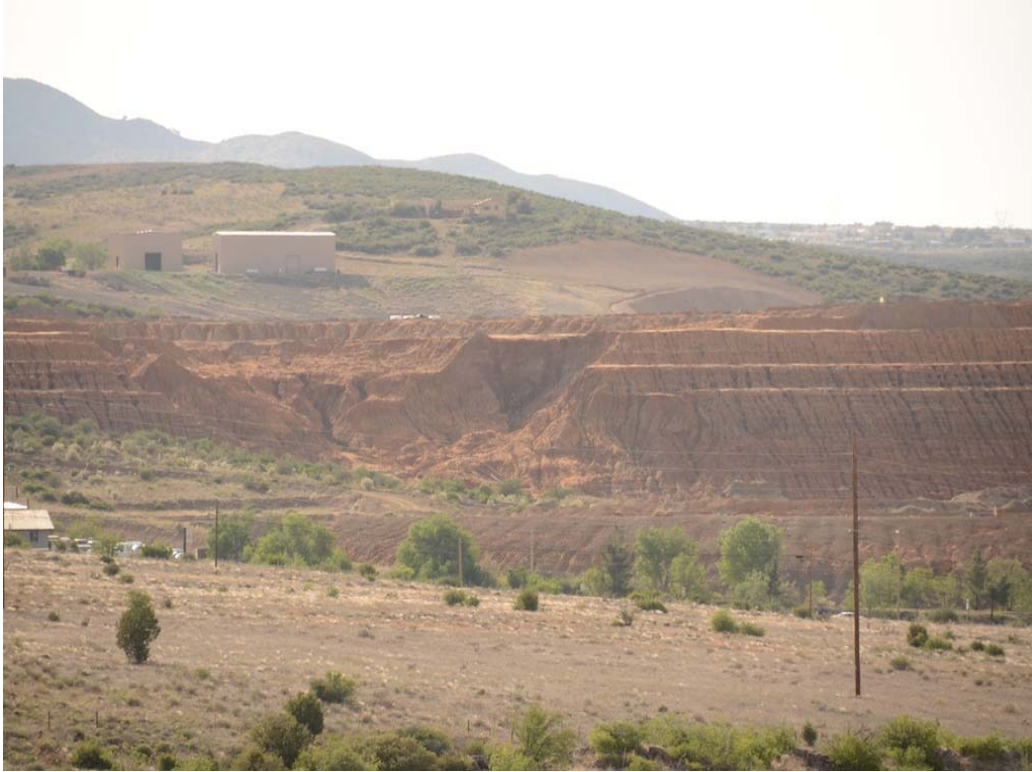
Photograph 2: Iron King Mine Main Tailings Pile at VP2

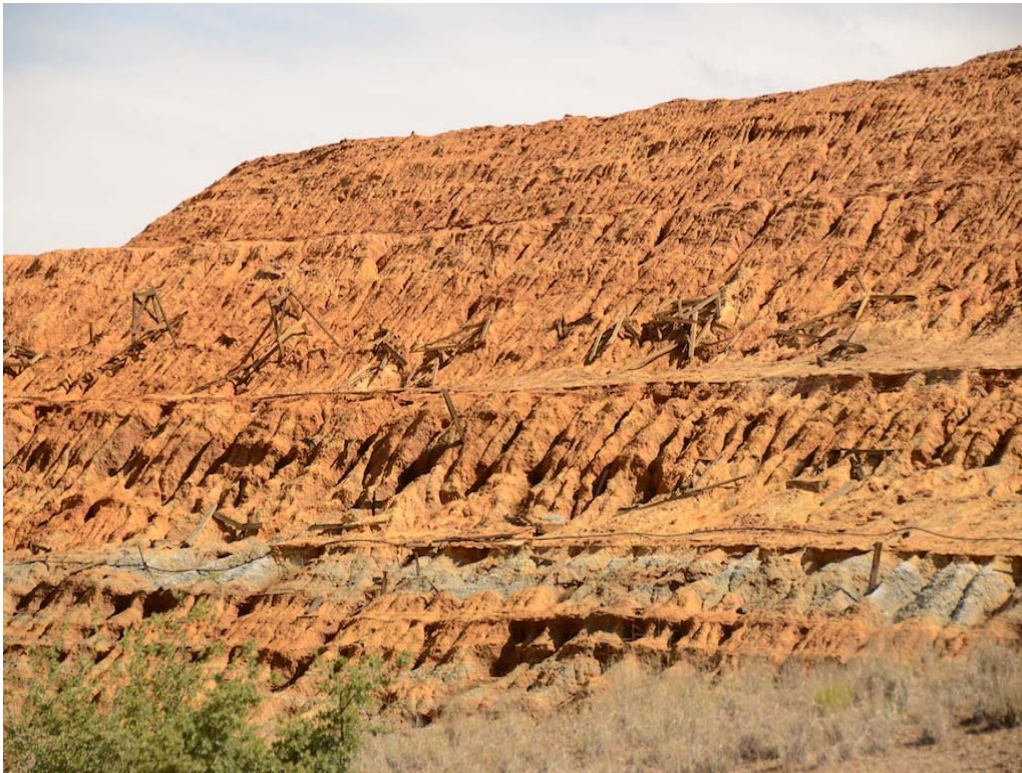
Photograph 3: Iron King Mine Main Tailings Pile at VP3

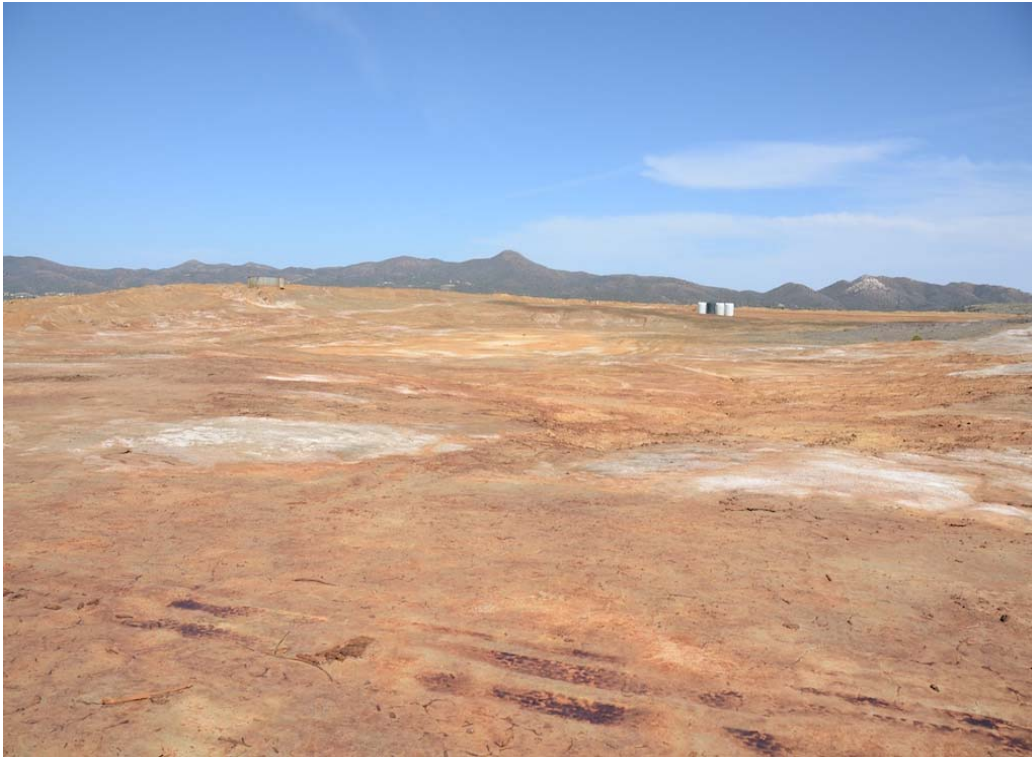
Photograph 4: Iron King Mine Main Tailings Pile at VP4

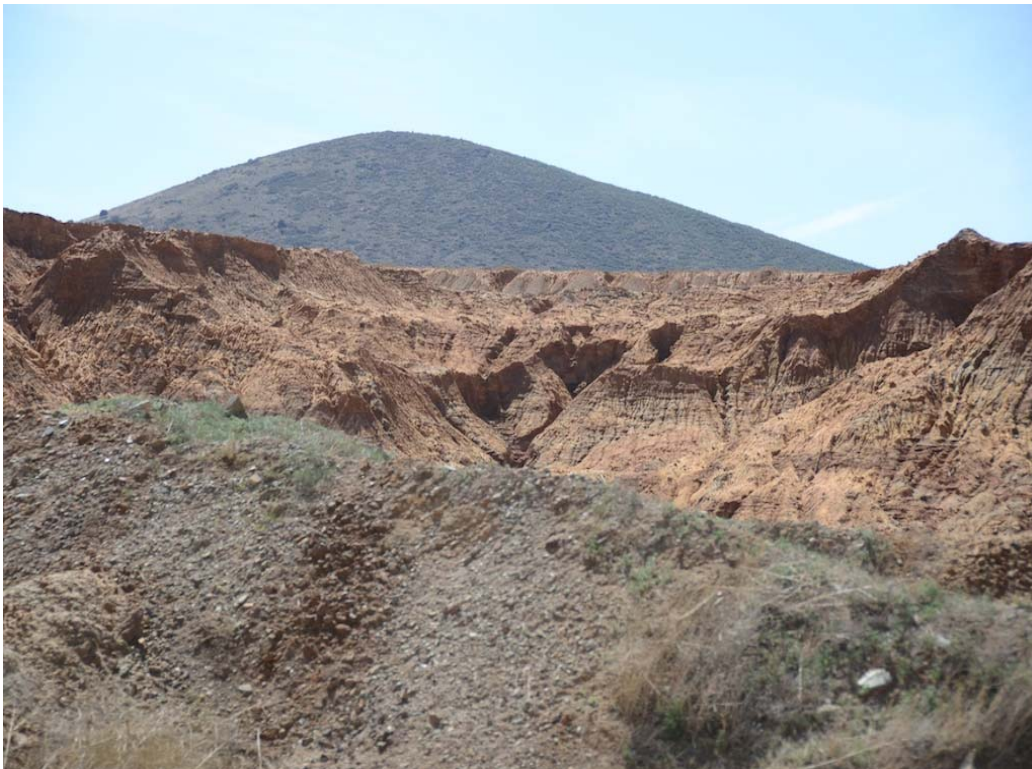
Photograph 5: Iron King Mine Main Tailings Pile, Blowout at VP5

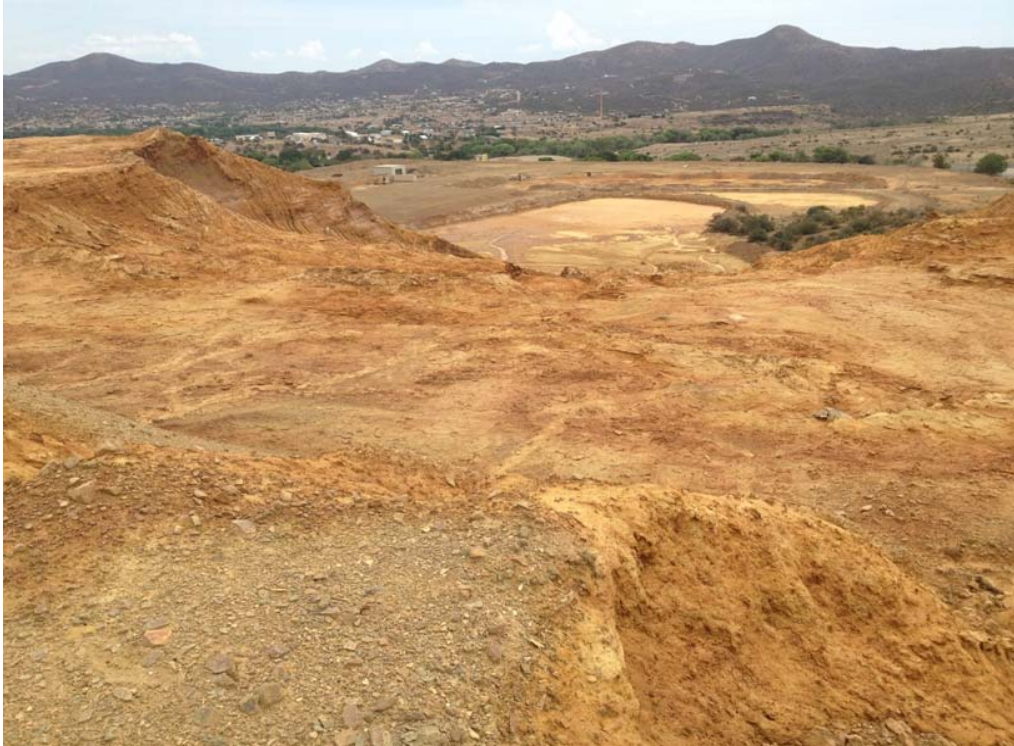
Photograph 6: Iron King Mine Main Tailings Pile, looking east toward former Humboldt Smelter at VP6

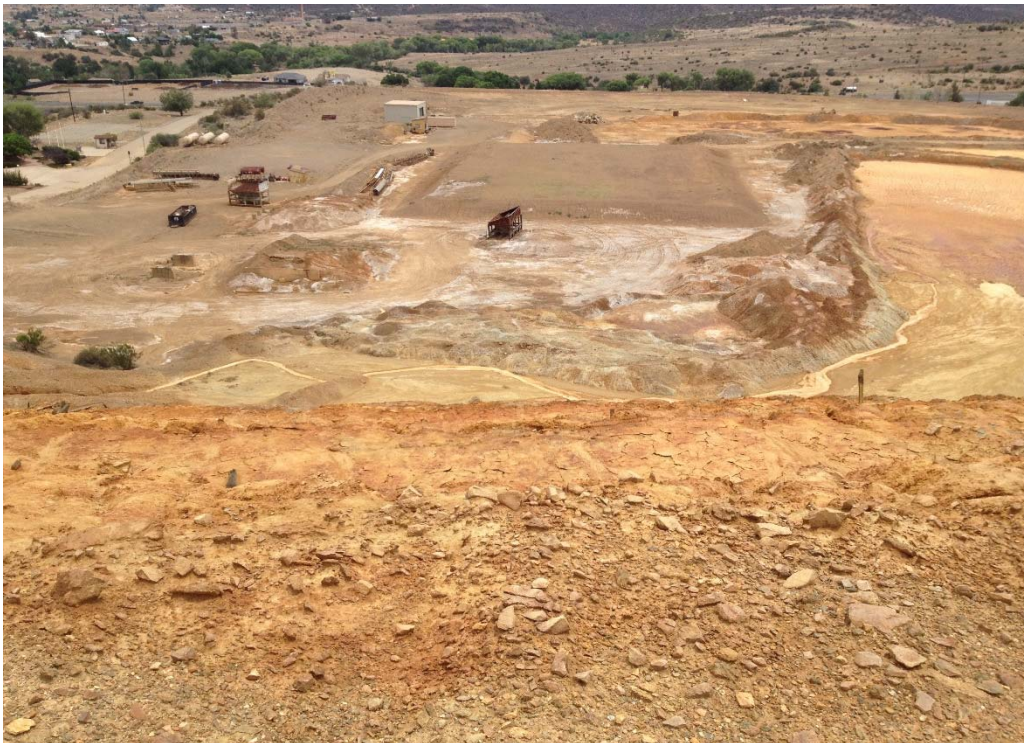
Photograph 7: Iron King Mine Main Tailings Pile, Retention Pond and NAI Operations area at VP6

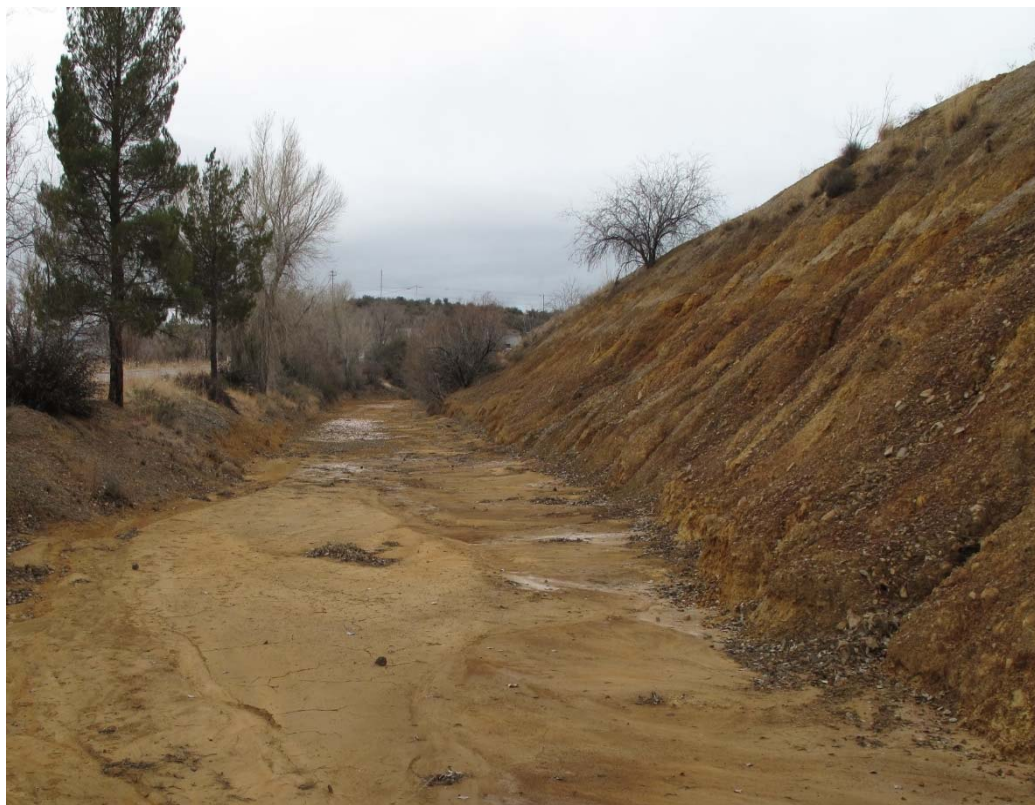
Photograph 8: Iron King Mine Main Tailings Pile, drainage channel west of Highway 69 at VP7

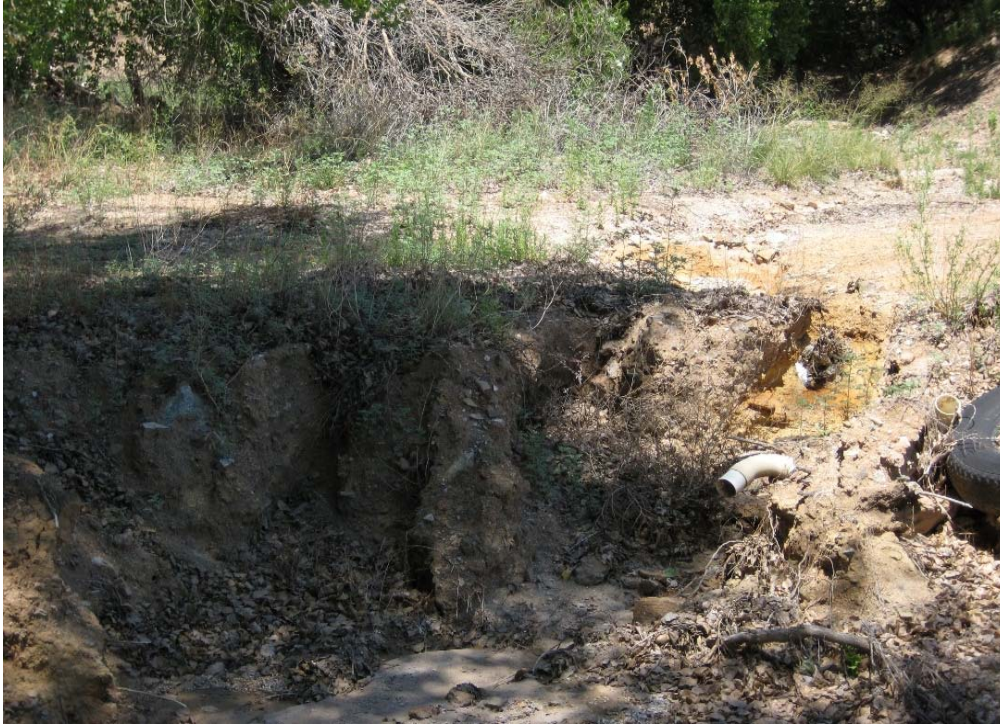
Photograph 9: Unnamed drainage near Blowout Path at VP8

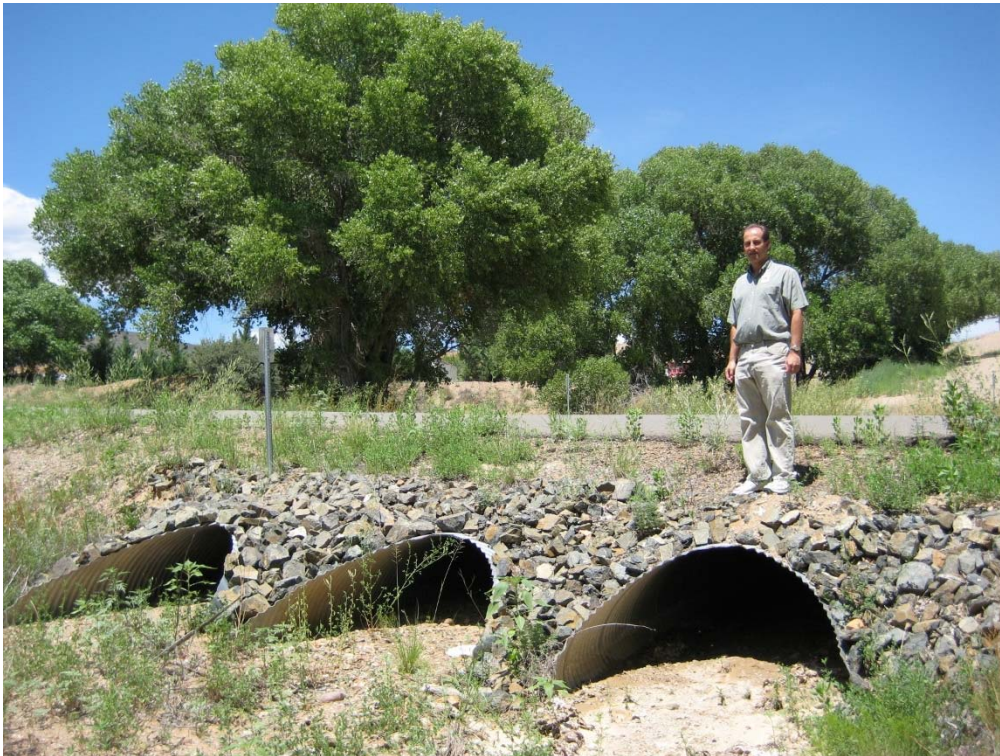
Photograph 10: Chaparral Gulch at 3rd Street, downstream of Highway 69 at VP9. Photograph taken in 2008; additional alluvium (from other sources in the drainage basin) has been deposited at this VP in recent years.

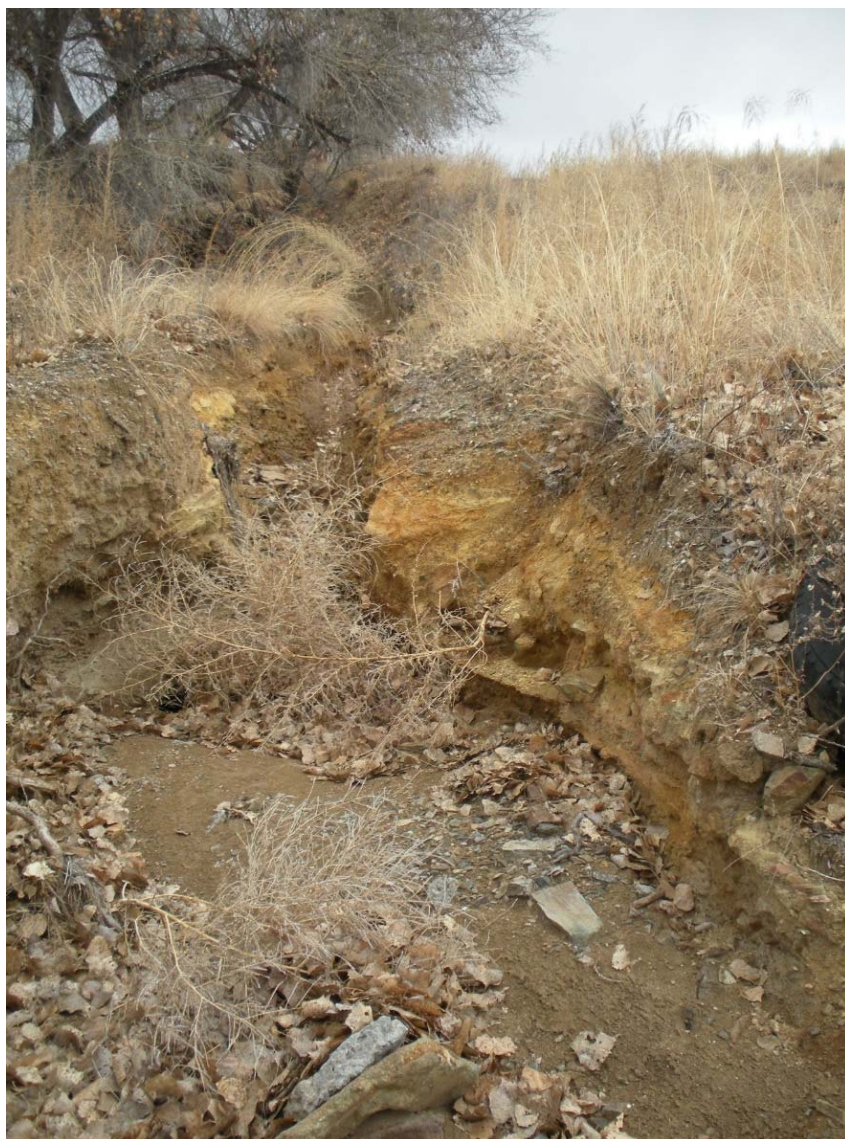
Photograph 11: Middle Chaparral Gulch at VP10; tailings evident along banks of southern channel

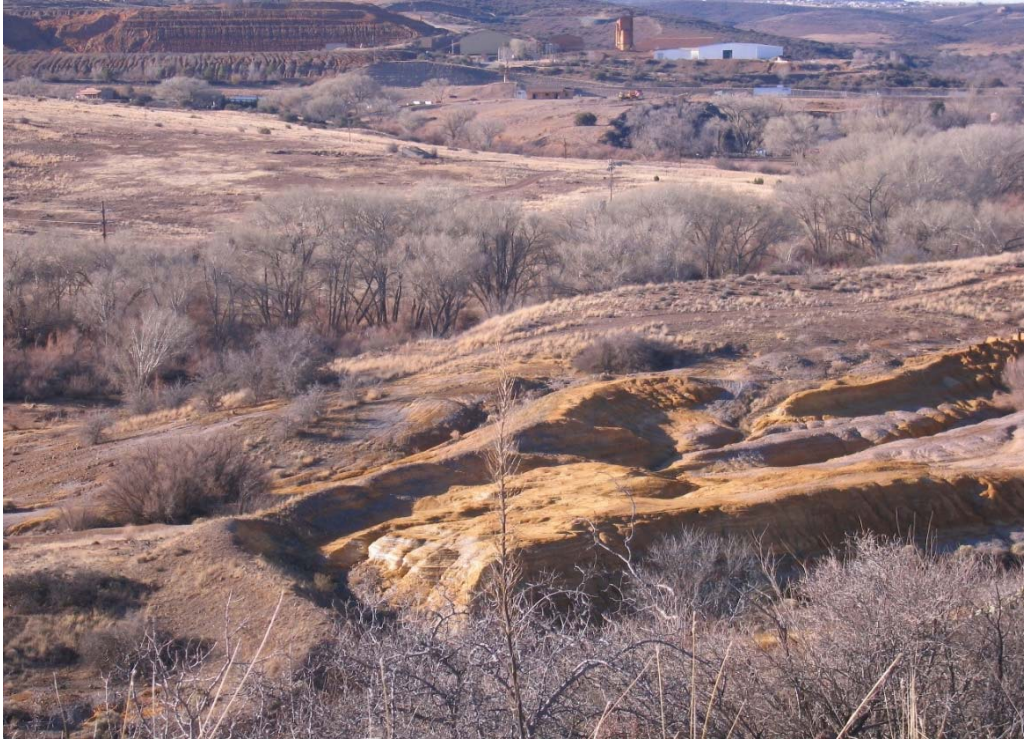
Photograph 12: Smelter Tailings Swale with former Iron King Mine in background at VP11

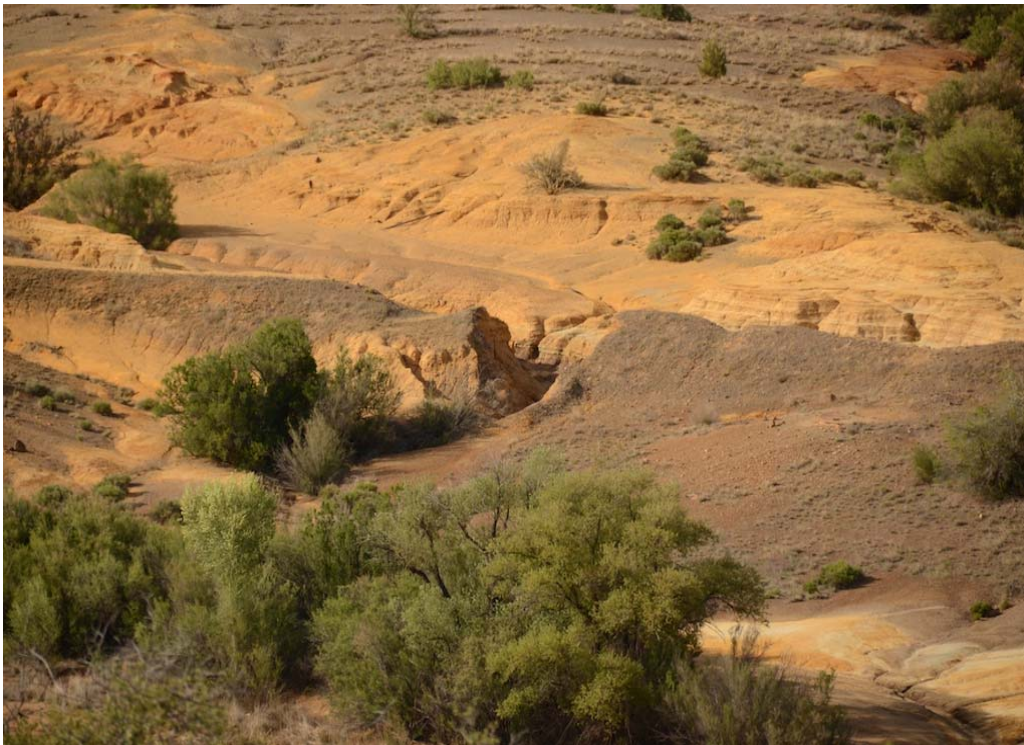
Photograph 13: Smelter Tailings Swale, tailings pond berm, and blowout at VP12

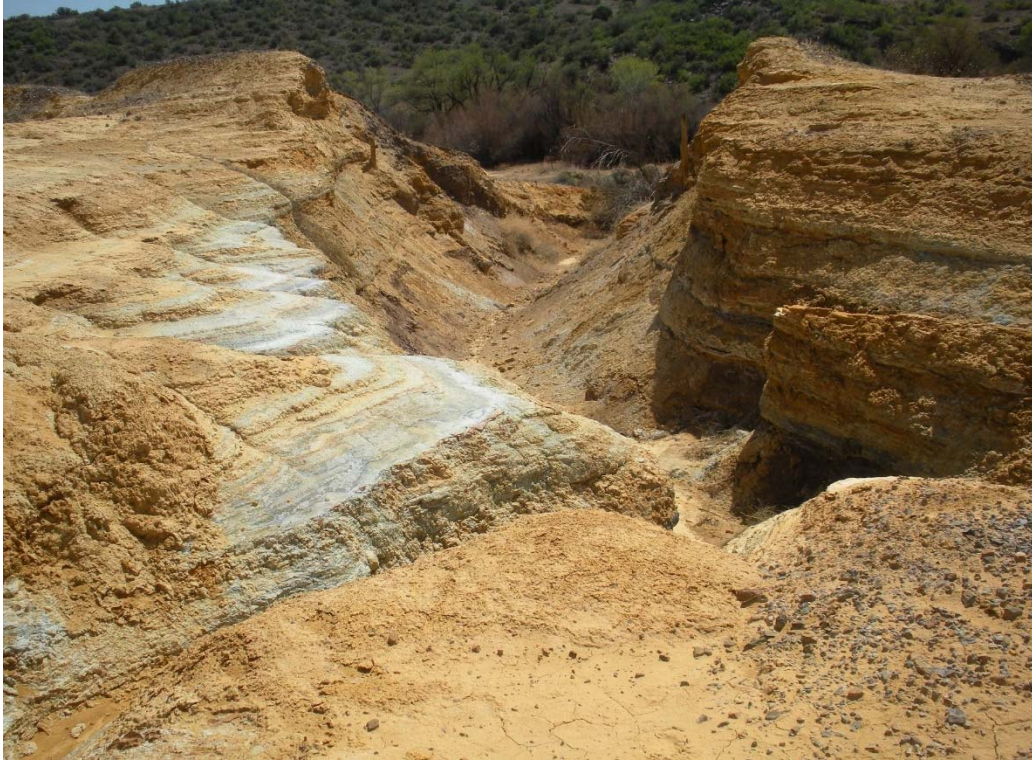
Photograph 14: Smelter Tailings Swale at VP13

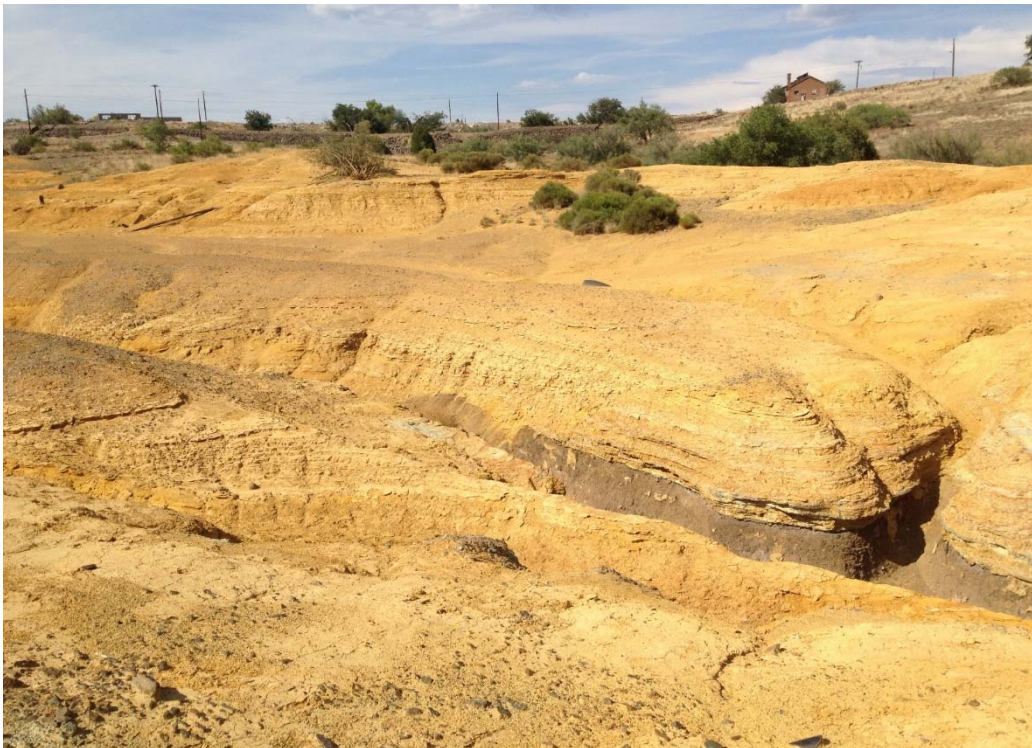
Photograph 15: Smelter Tailings Swale at VP14

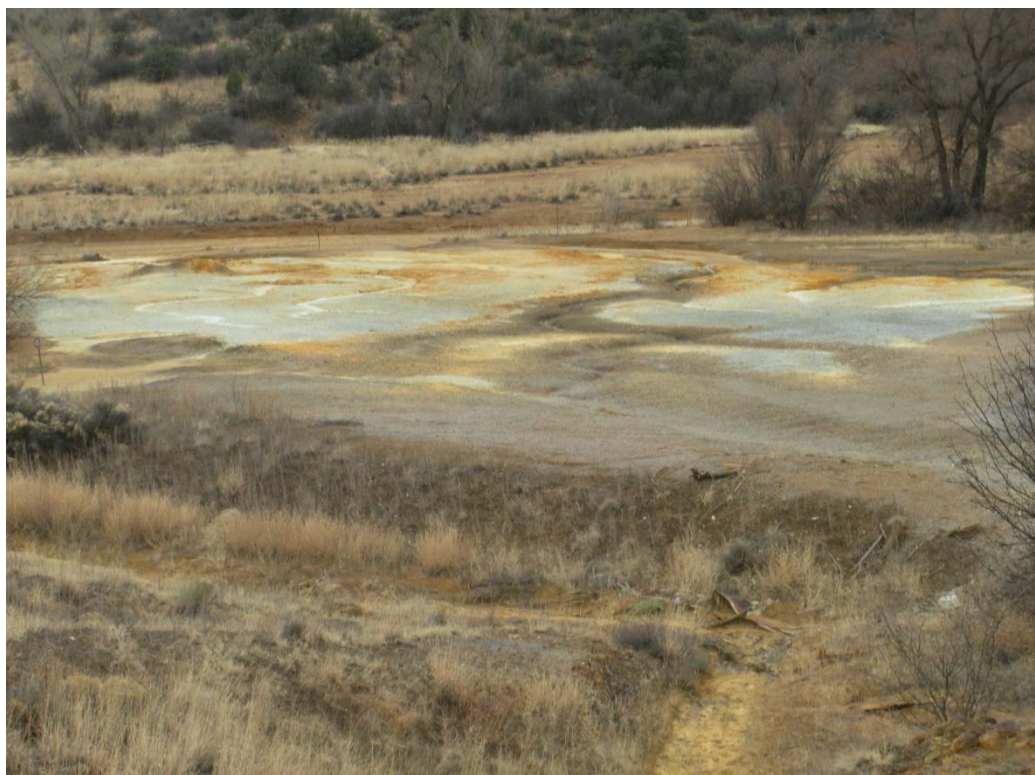
Photograph 16: Tailings Floodplain, efflorescent salts from repeated evapoconcentration at VP15

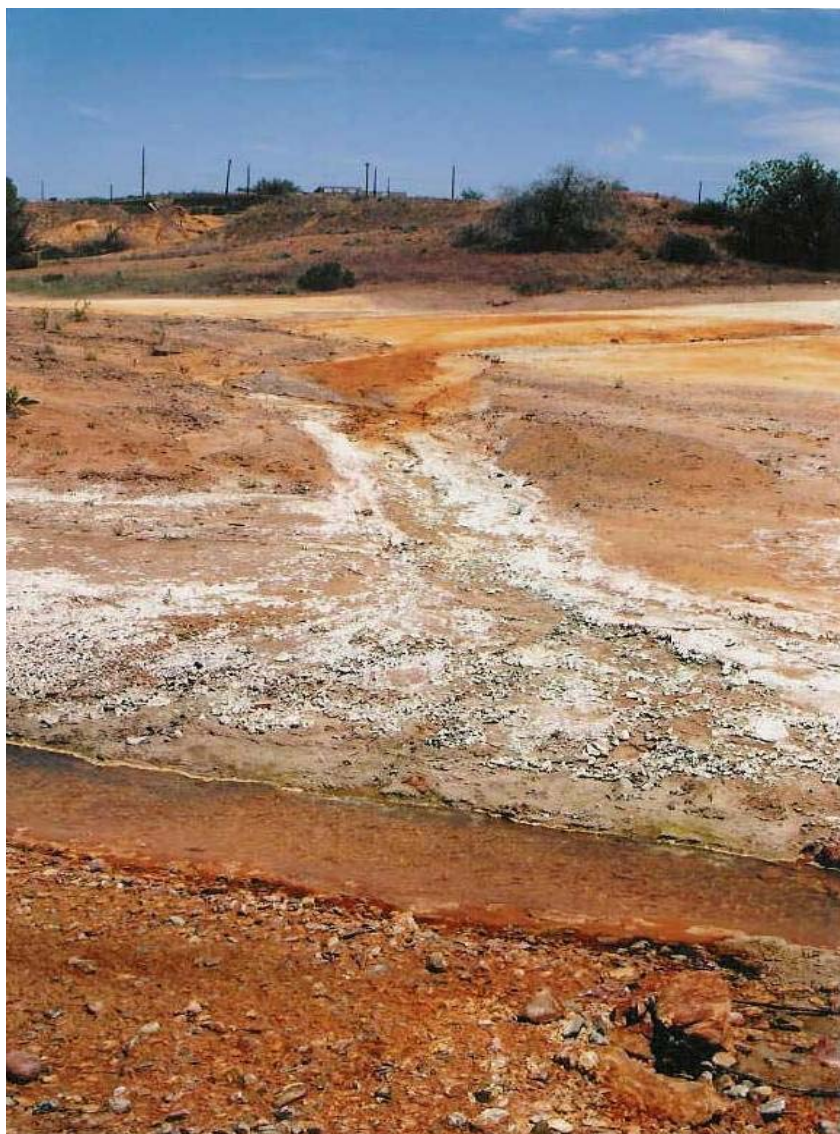
Photograph 17: Tailings Floodplain, efflorescent salts from repeated evapoconcentration at VP16

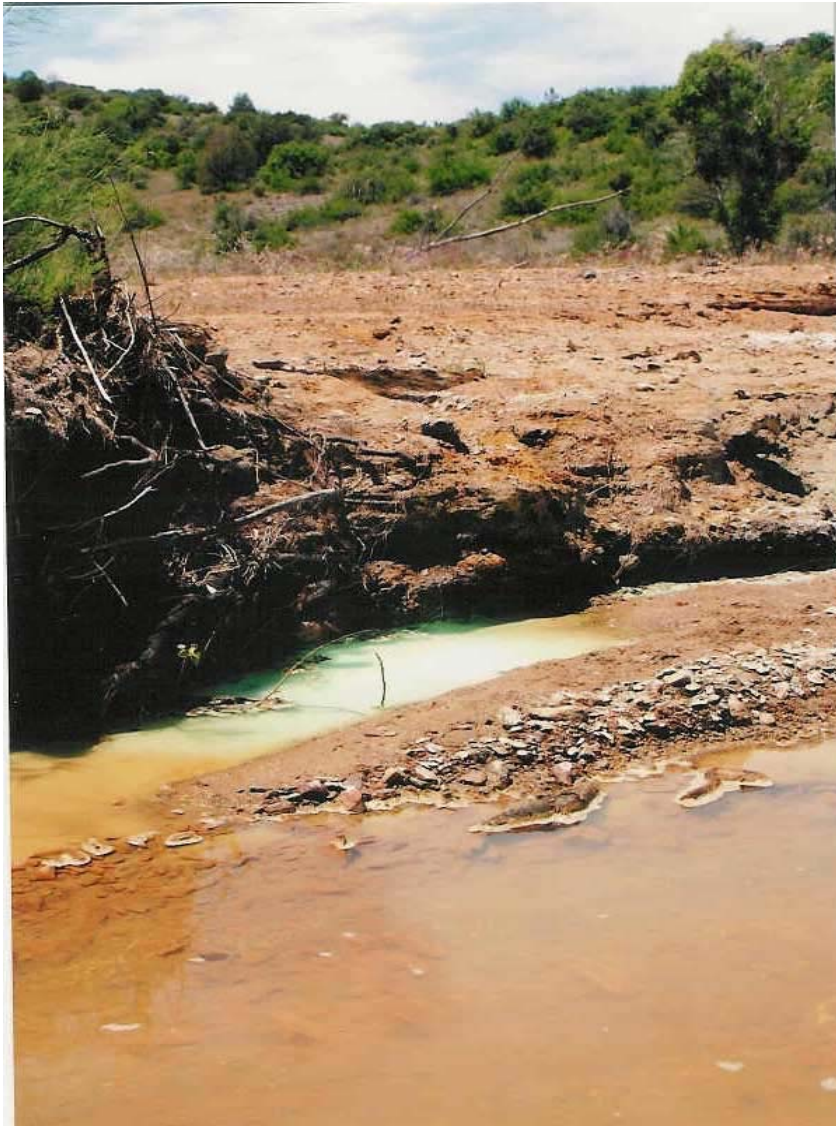
Photograph 18: Tailings Floodplain, Chaparral Gulch at VP17

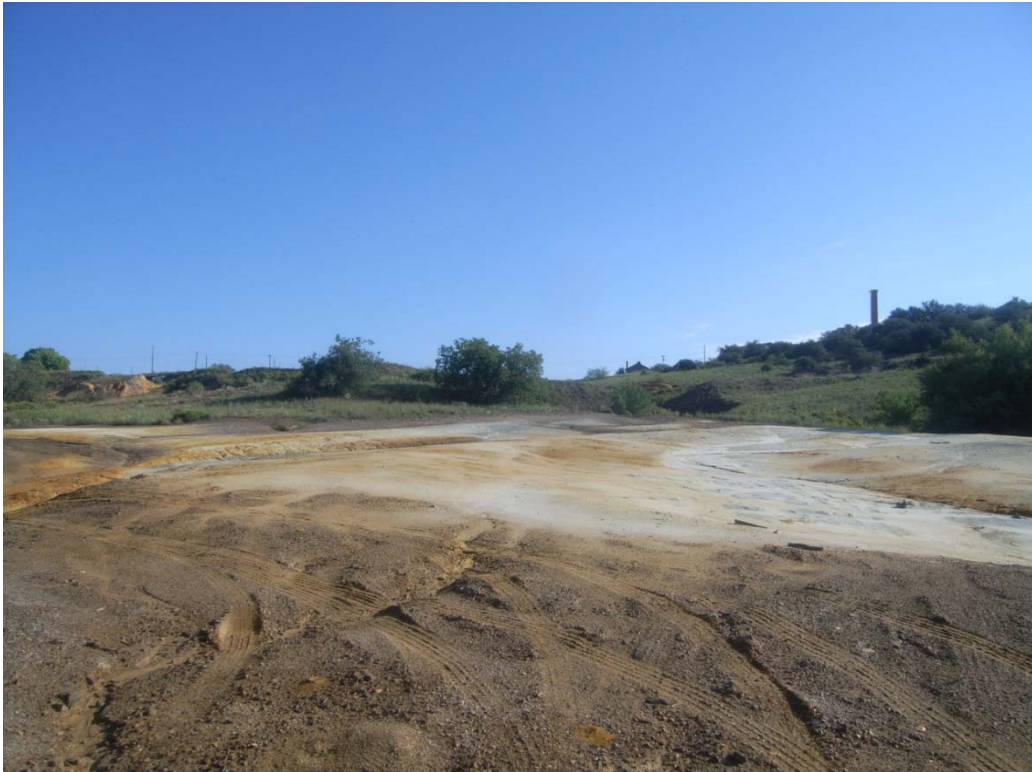
Photograph 19: Tailings Floodplain at VP18

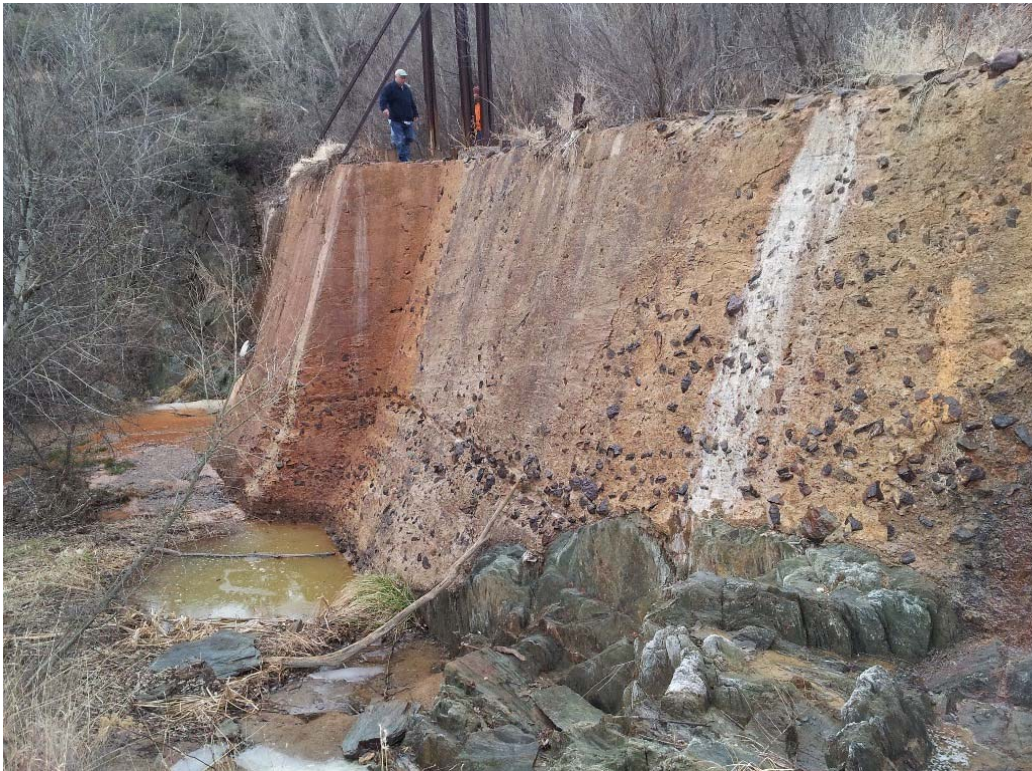
Photograph 20: Chaparral Gulch Dam at VP19

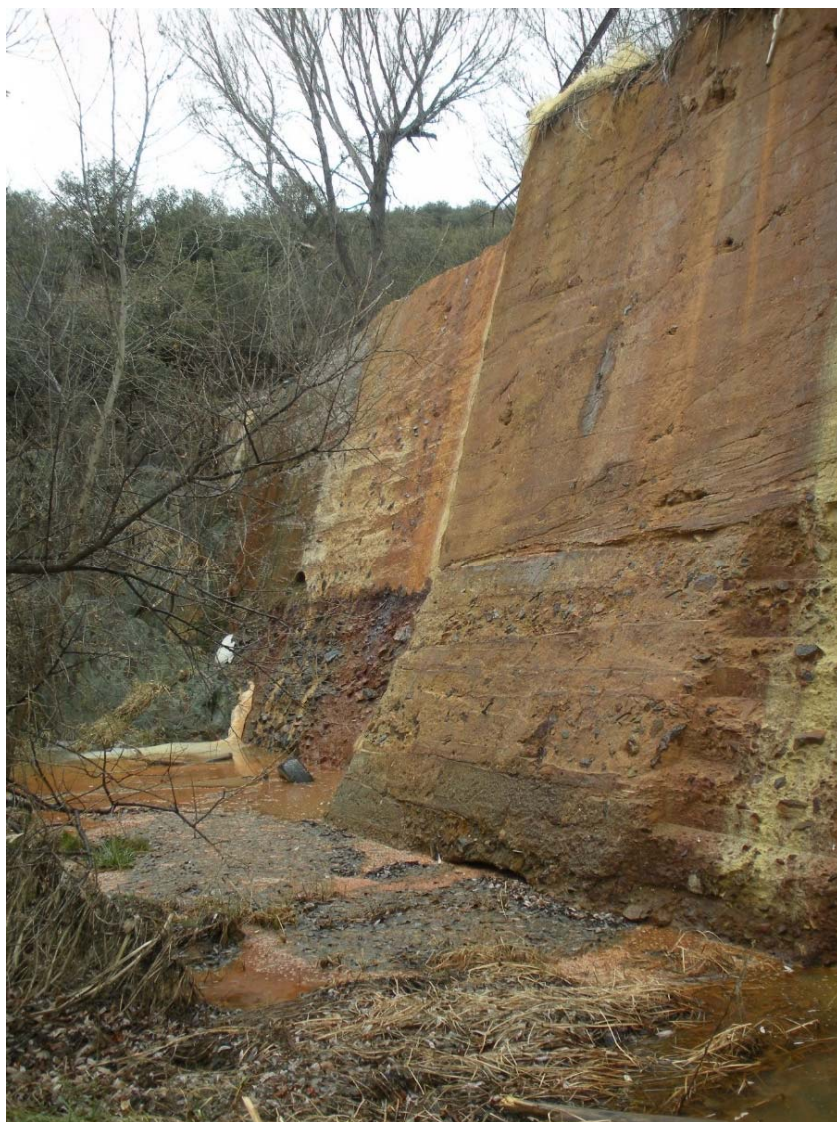
Photograph 21: Chaparral Gulch Dam at VP19

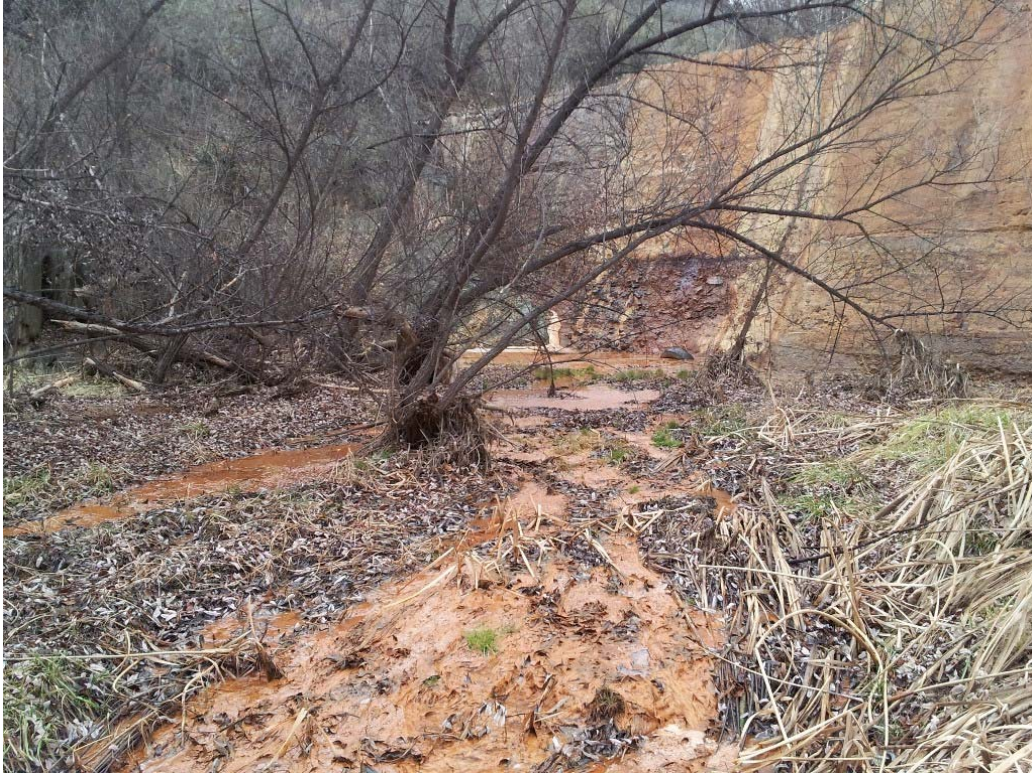
Photograph 22: Chaparral Gulch Dam at VP20

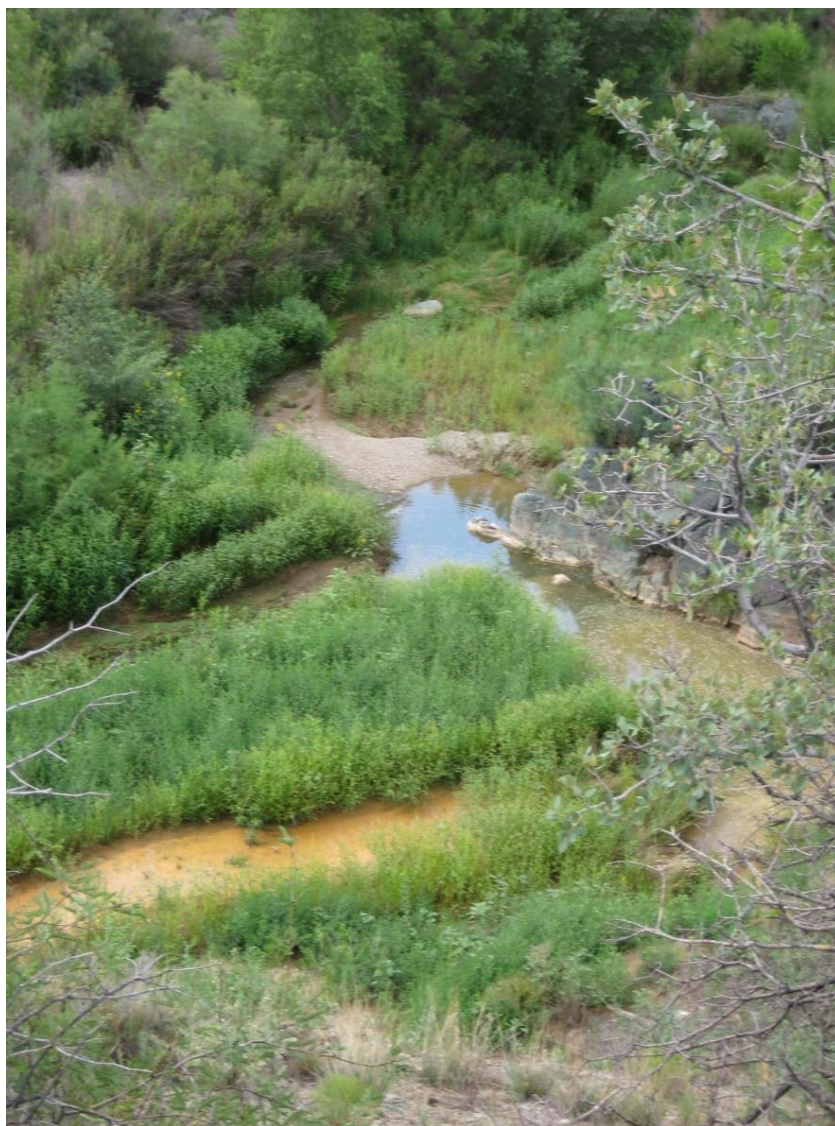
Photograph 23: Lower Chaparral Gulch at VP21

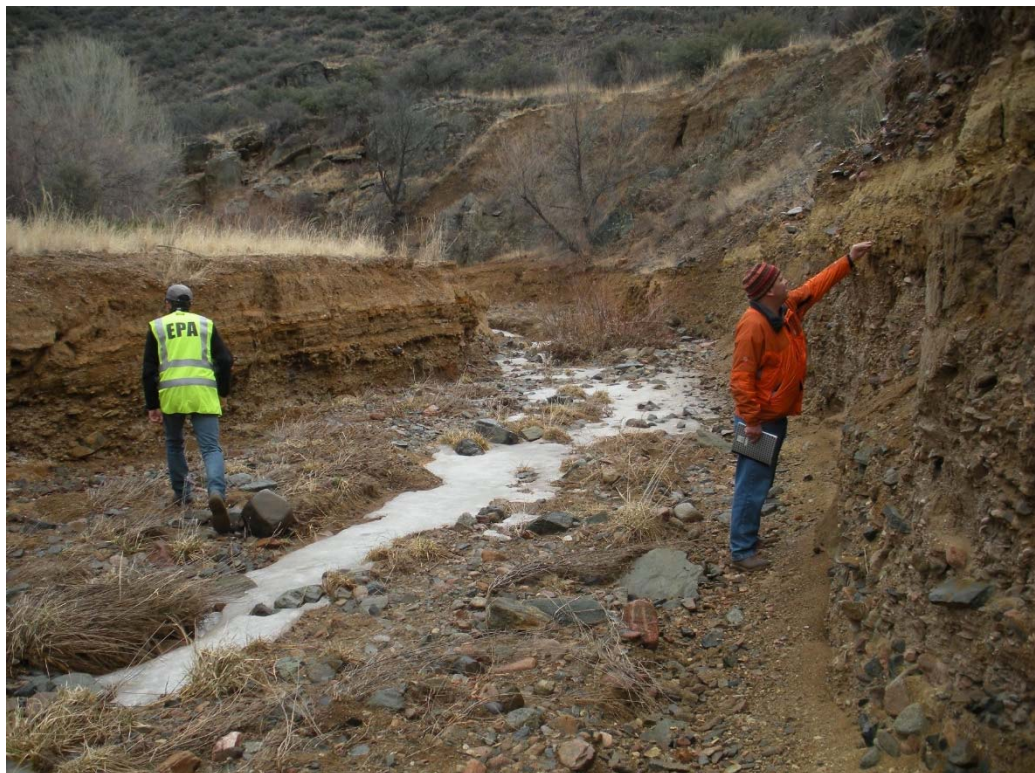
Photograph 24: Lower Chaparral Gulch at VP22

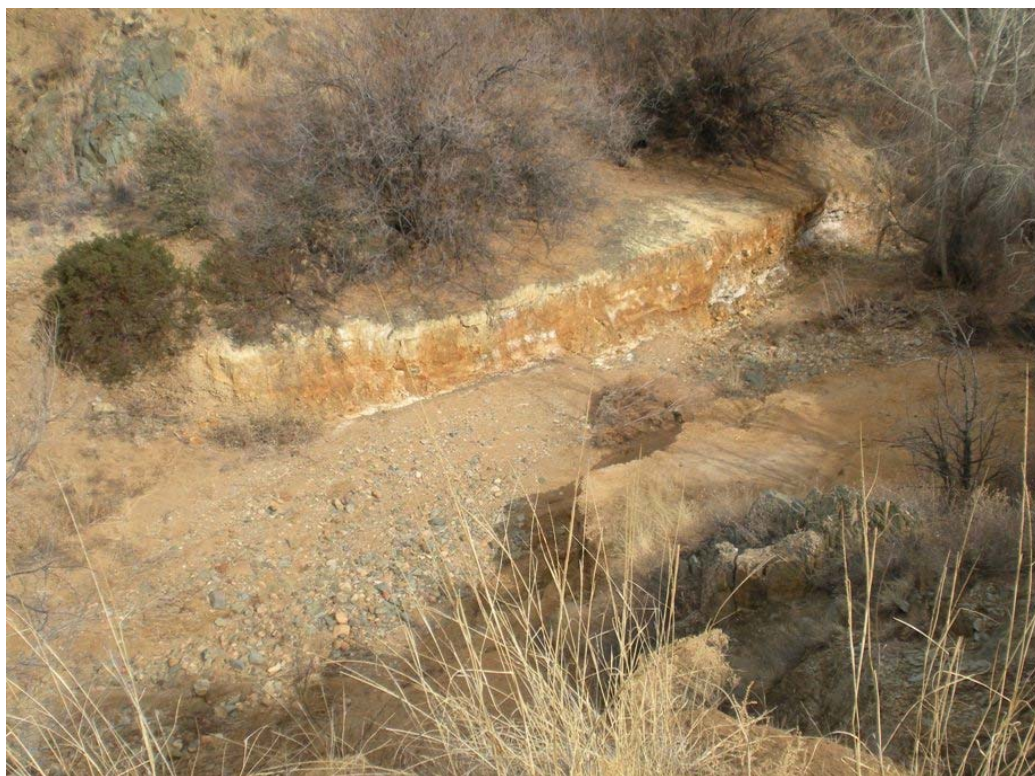
Photograph 25: Lower Chaparral Gulch at VP23

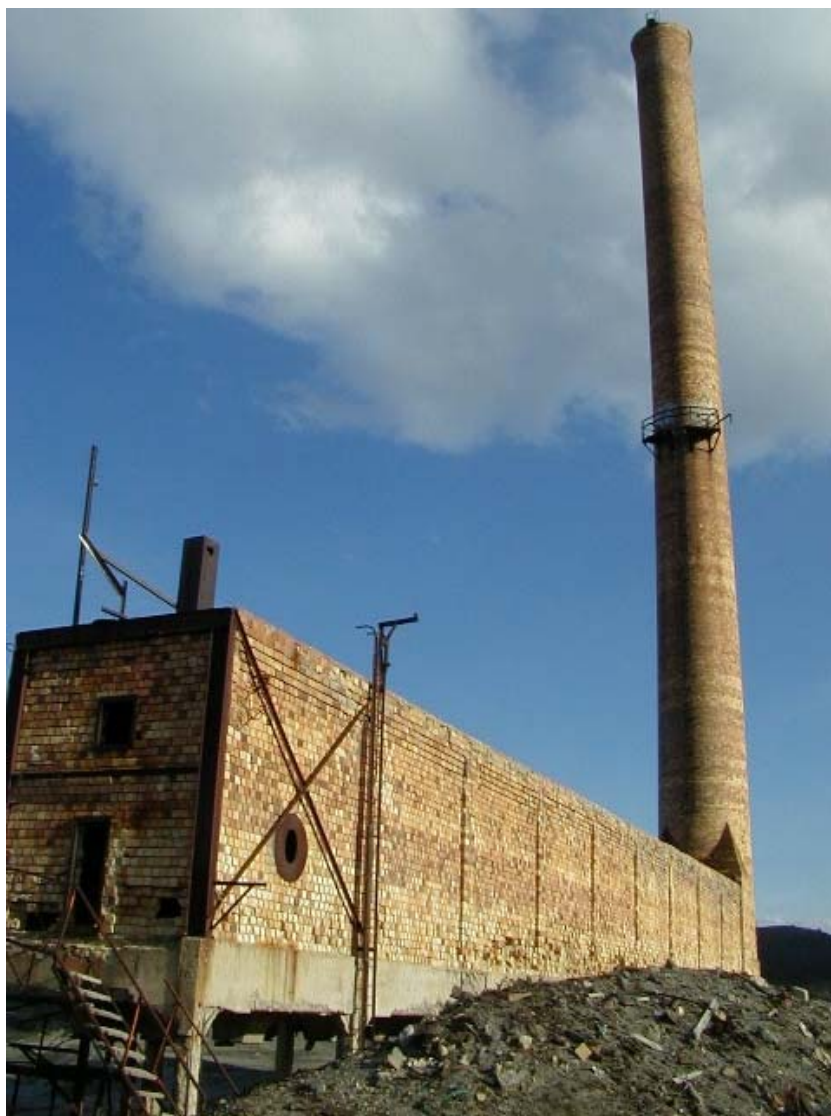
Photograph 26: Former Humboldt Smelter Pyrometallurgical Operations area, Smelter Stack and brick flue at VP24

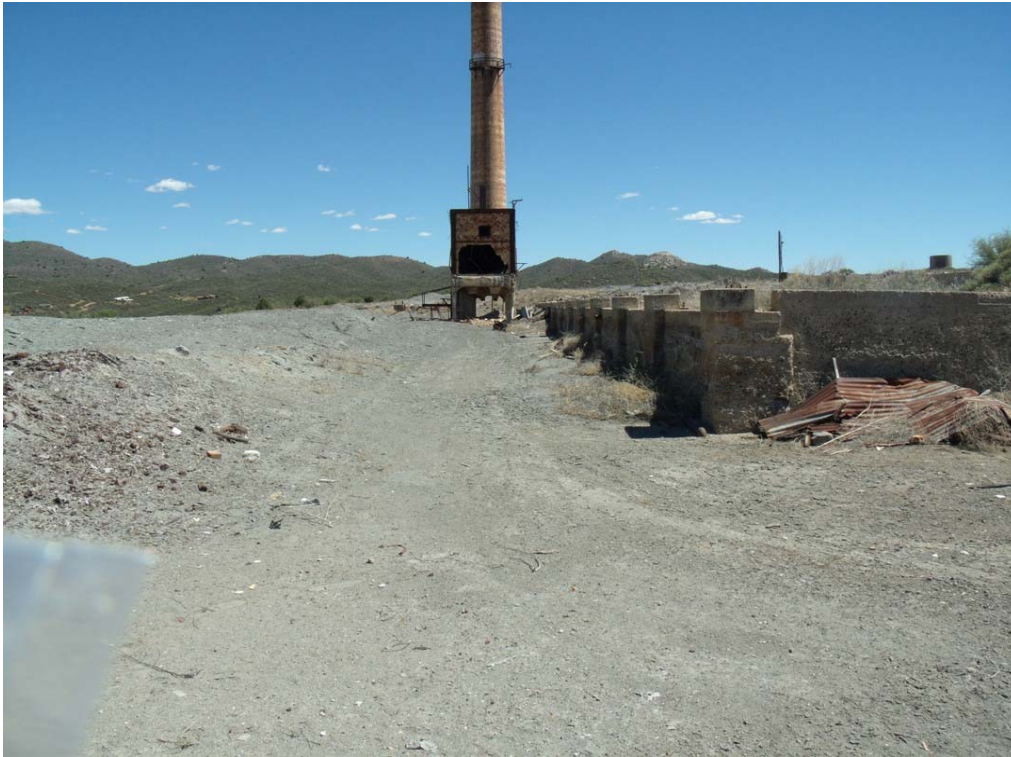
Photograph 27: Former Humboldt Smelter buildings, Smelter Stack, and dross at VP25
