Current Site Photographs, Iron King Mine – Humboldt Smelter Superfund Site

*Iron King Mine – Humboldt Smelter Superfund Site
Dewey-Humboldt, Yavapai County, Arizona*

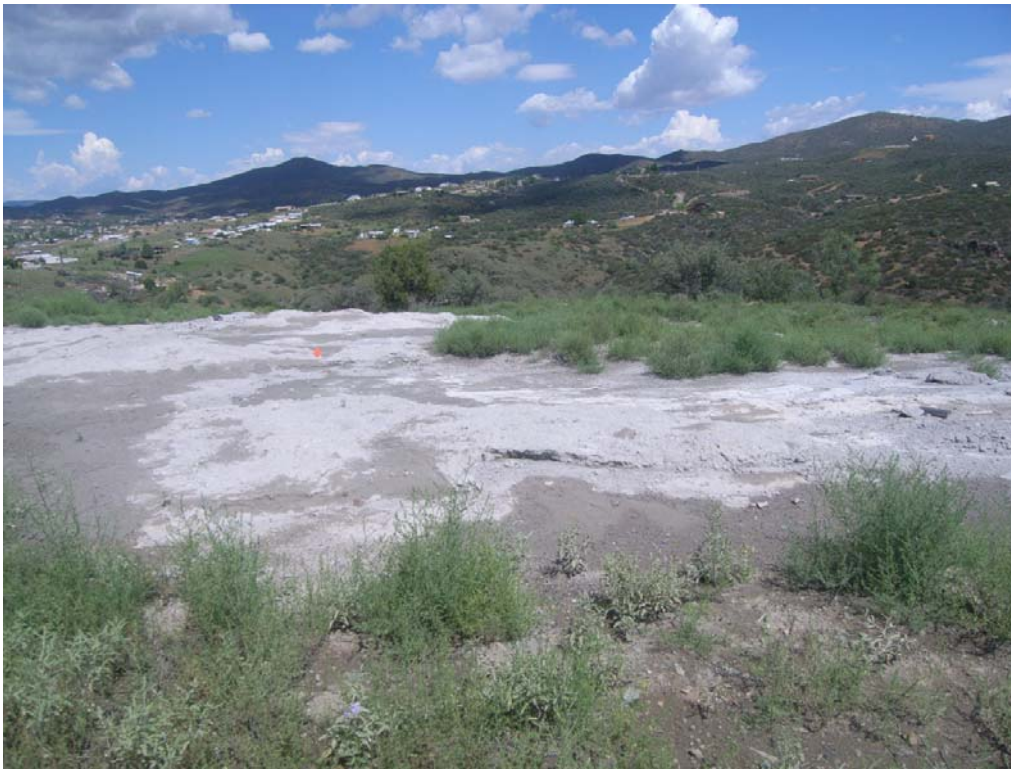
Photograph 28: Dross at VP26

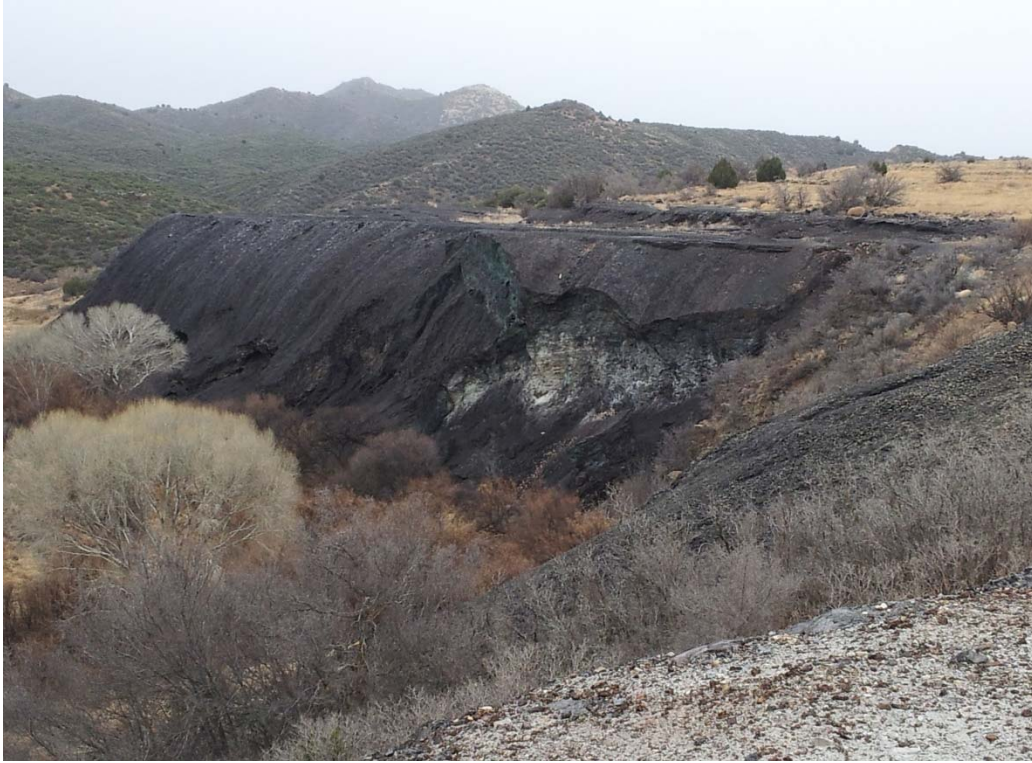
Photograph 29: Former Humboldt Smelter slag pile and Agua Fria River, looking southwest at VP27

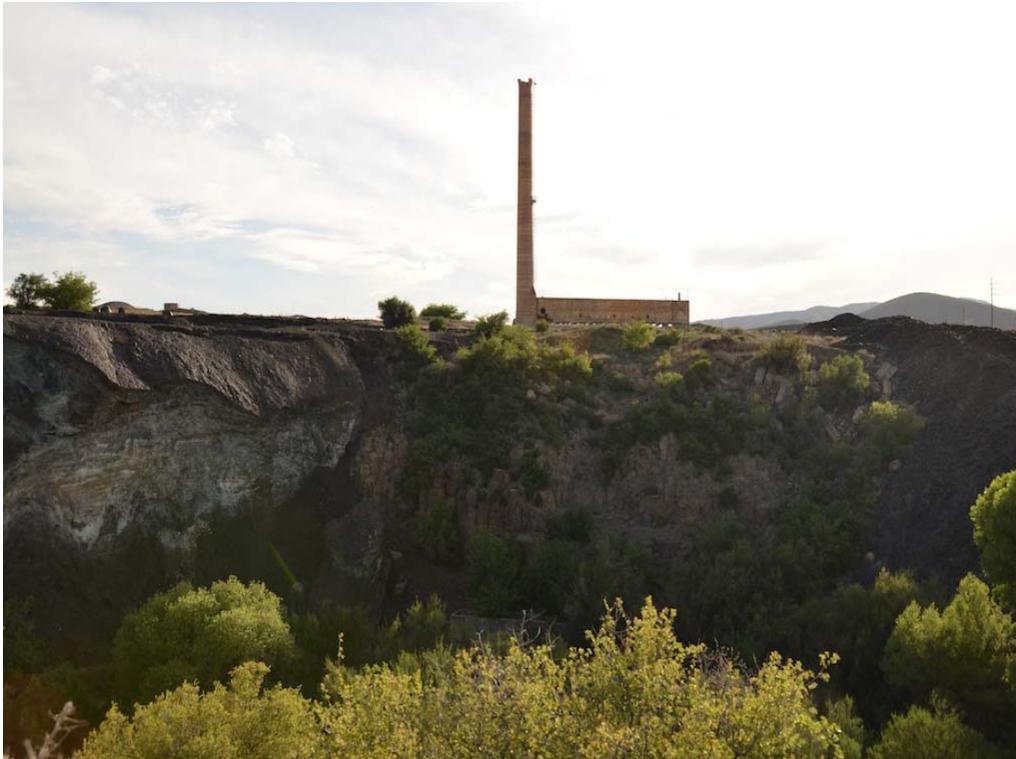
Photograph 30: Former Humboldt Smelter slag pile and Agua Fria River, looking west at VP27

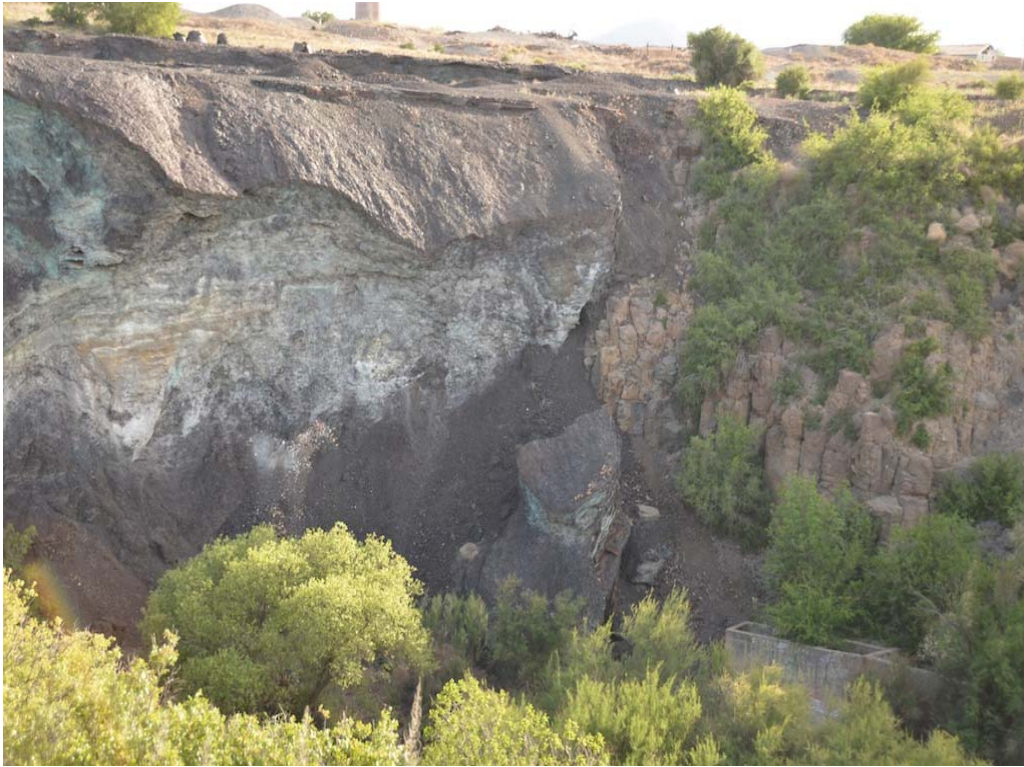
Photograph 31: Slag pile and Agua Fria River, looking west at VP27

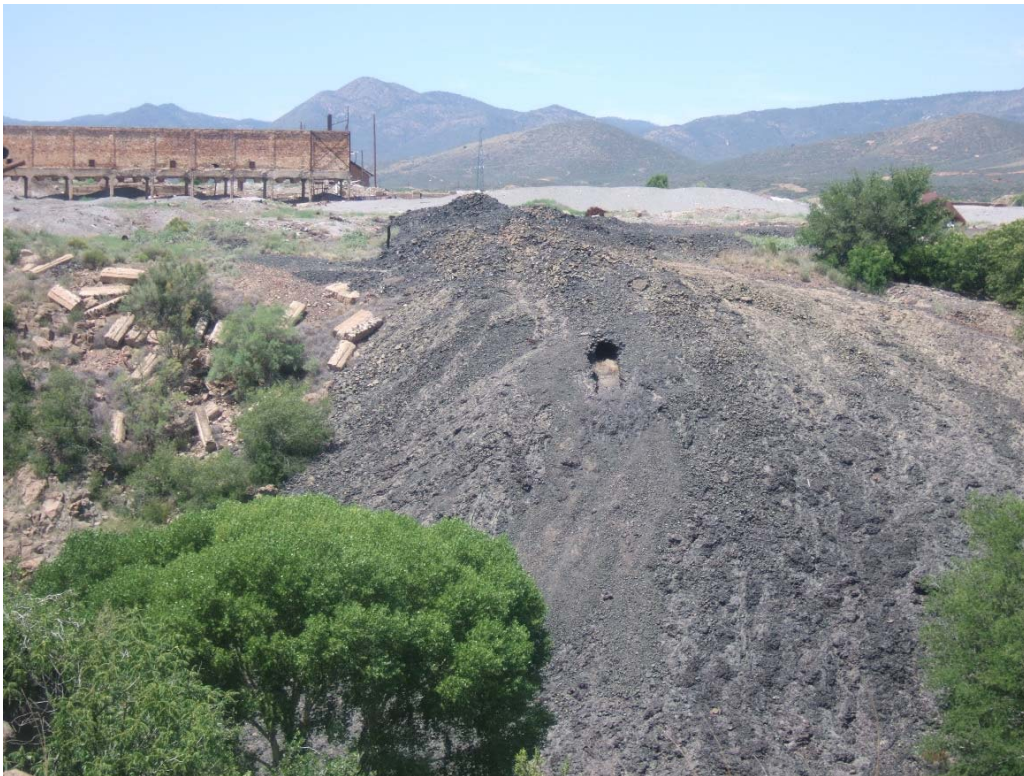
Photograph 32: Northeastern corner of the primary slag pile, looking northwest at VP27

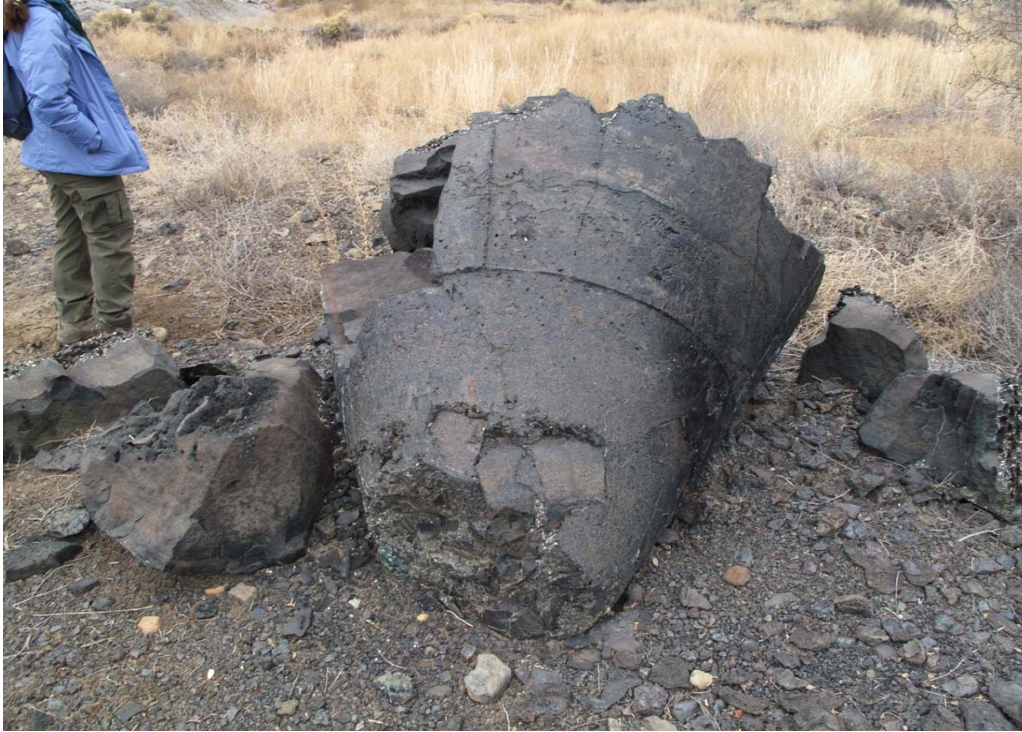
Photograph 33: Slag material dumped in a solid form from the retort or kiln, resulting in a funnel-shaped 3-foot-diameter fragment at VP28

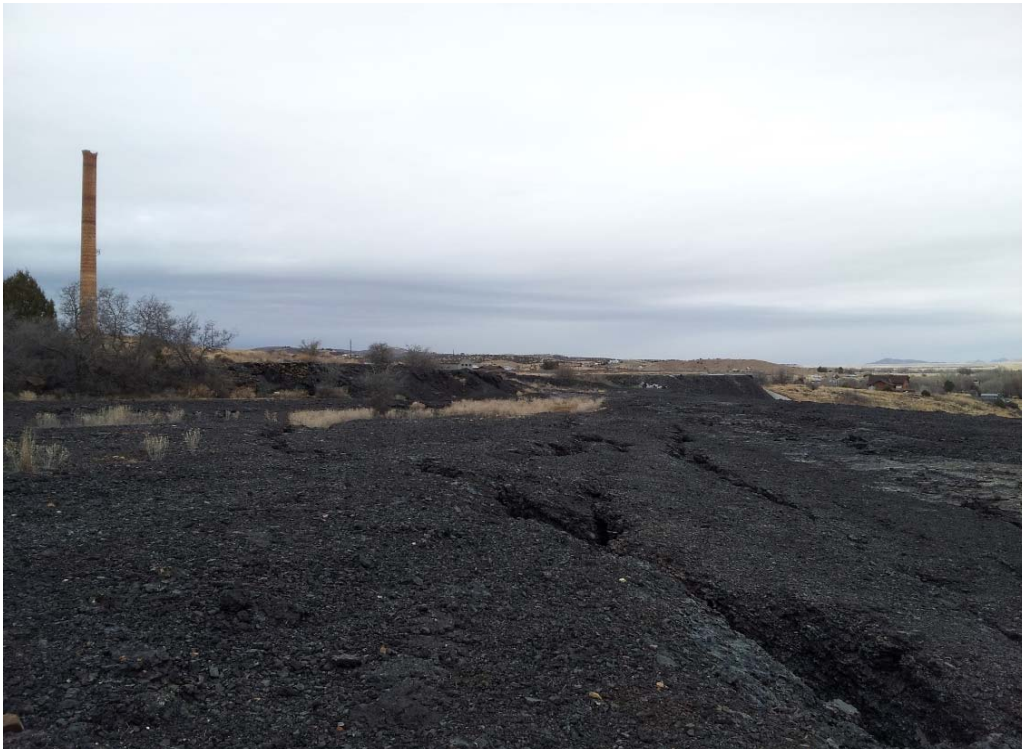
Photograph 34: Slag Pile at VP29

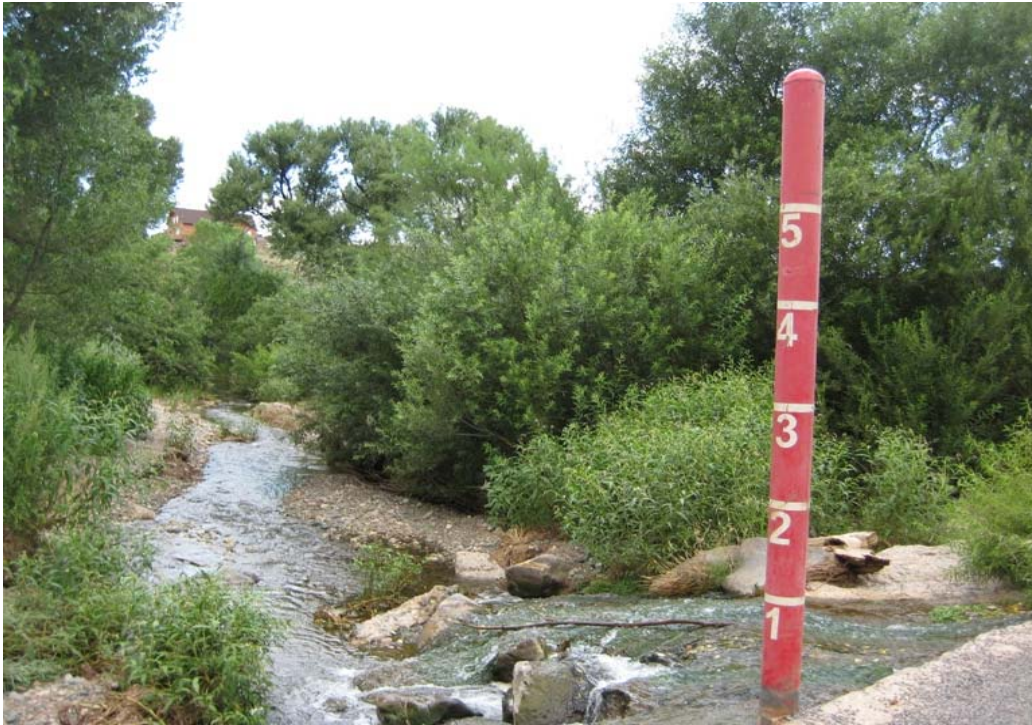
Photograph 35: Agua Fria River at Prescott Street, looking south at VP30

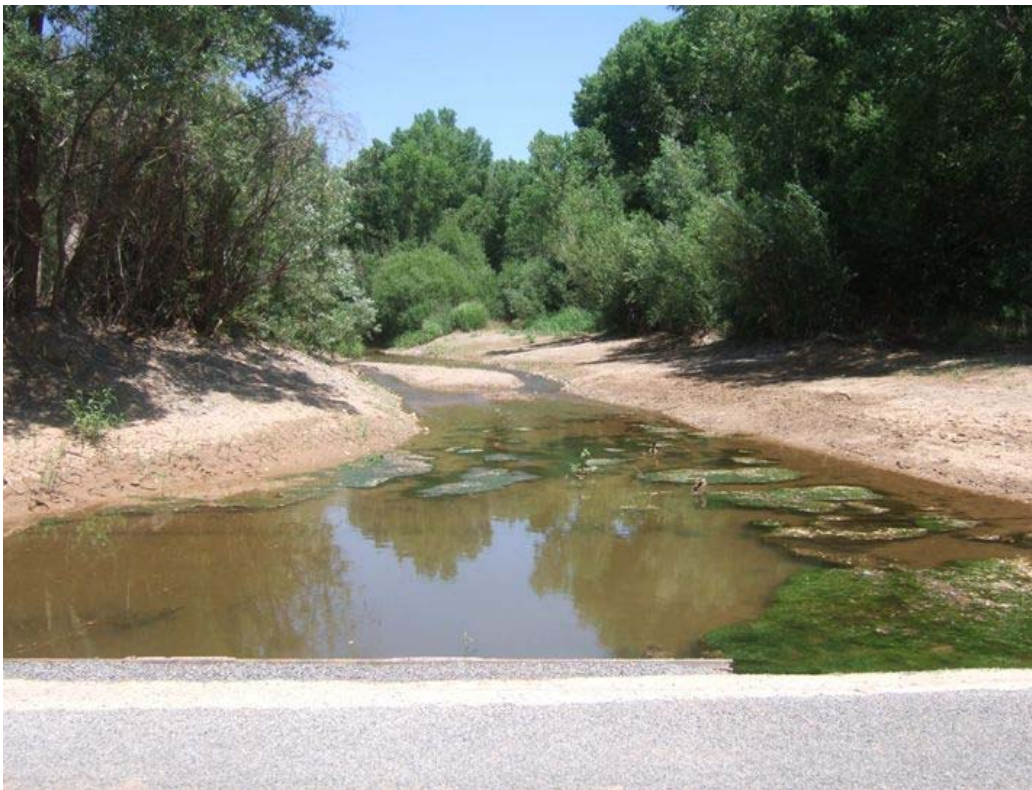
Photograph 36: Agua Fria River at Prescott Street, looking north at VP31

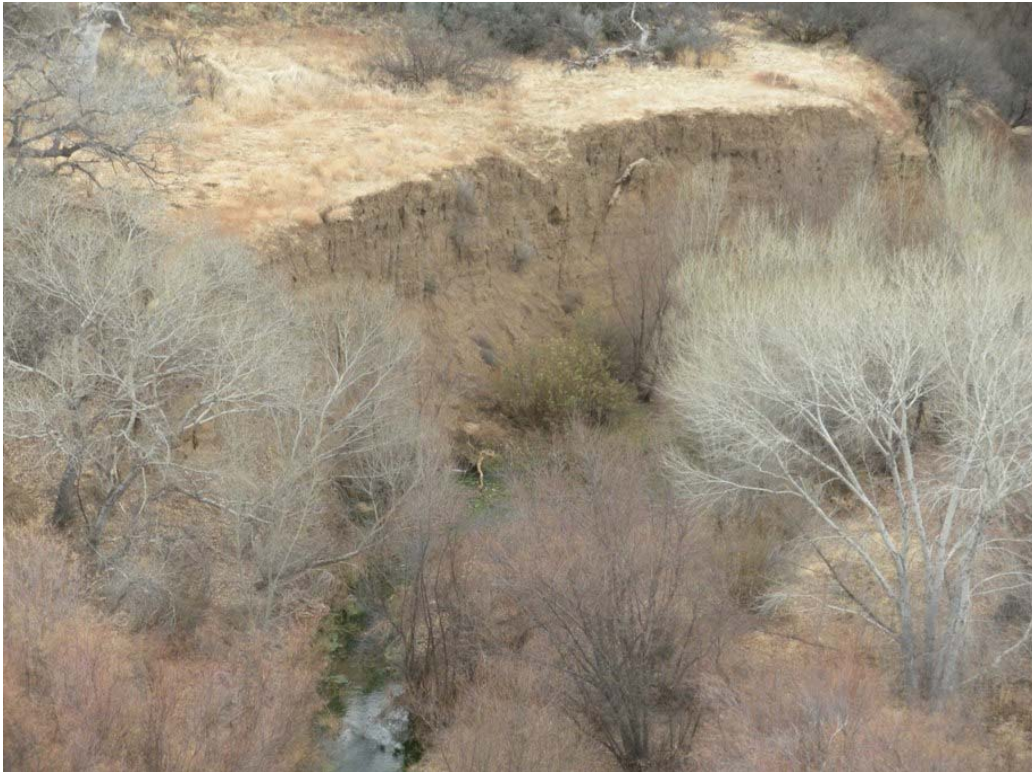
Photograph 37: Agua Fria Tailings Pile (NR10), just upstream of confluence with Chaparral Gulch at VP32

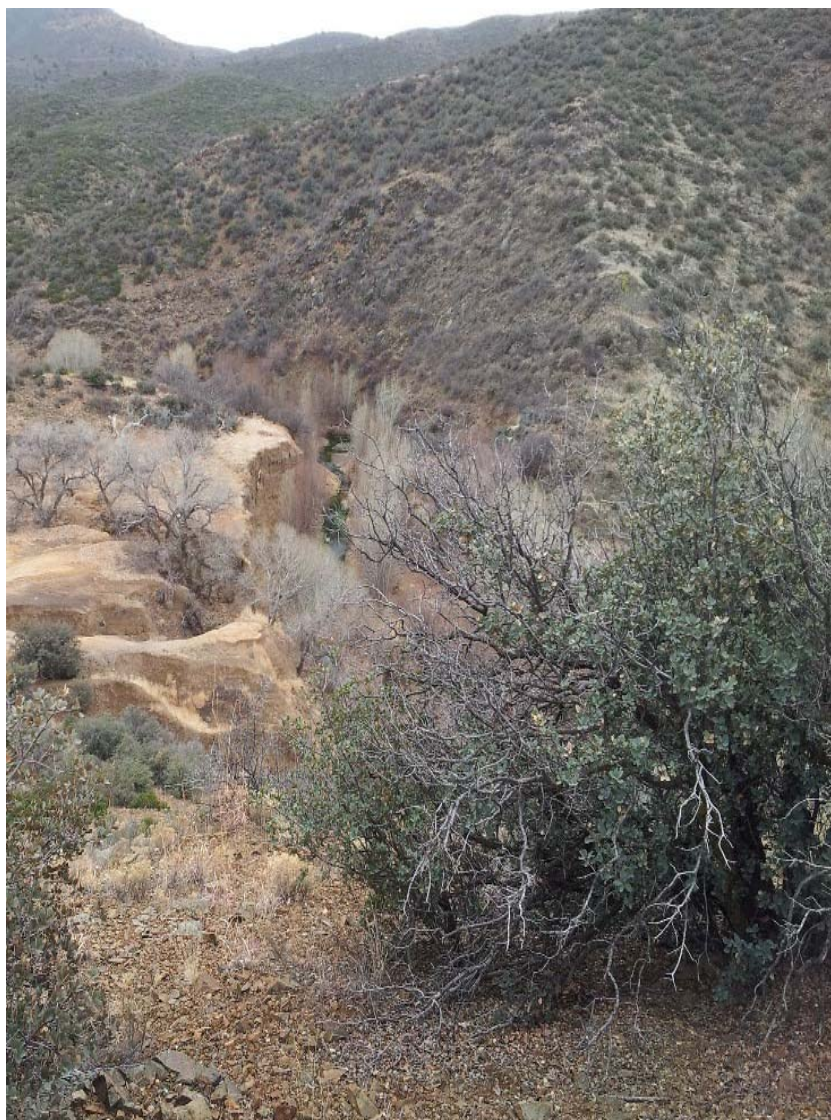
Photograph 38: Agua Fria River near confluence with Chaparral Gulch at VP33

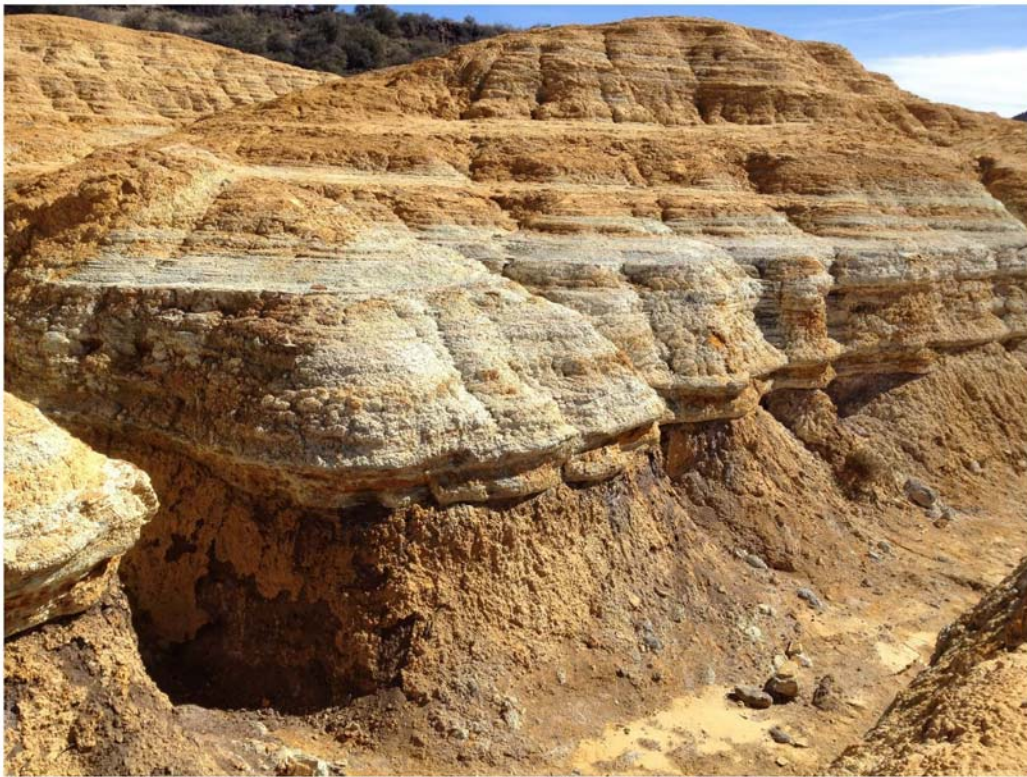
Photo D004 IMG_0830: Example of deep erosional gully cut through existing tailings in the Smelter Tailings Swale; shows underlying natural brown clay layer

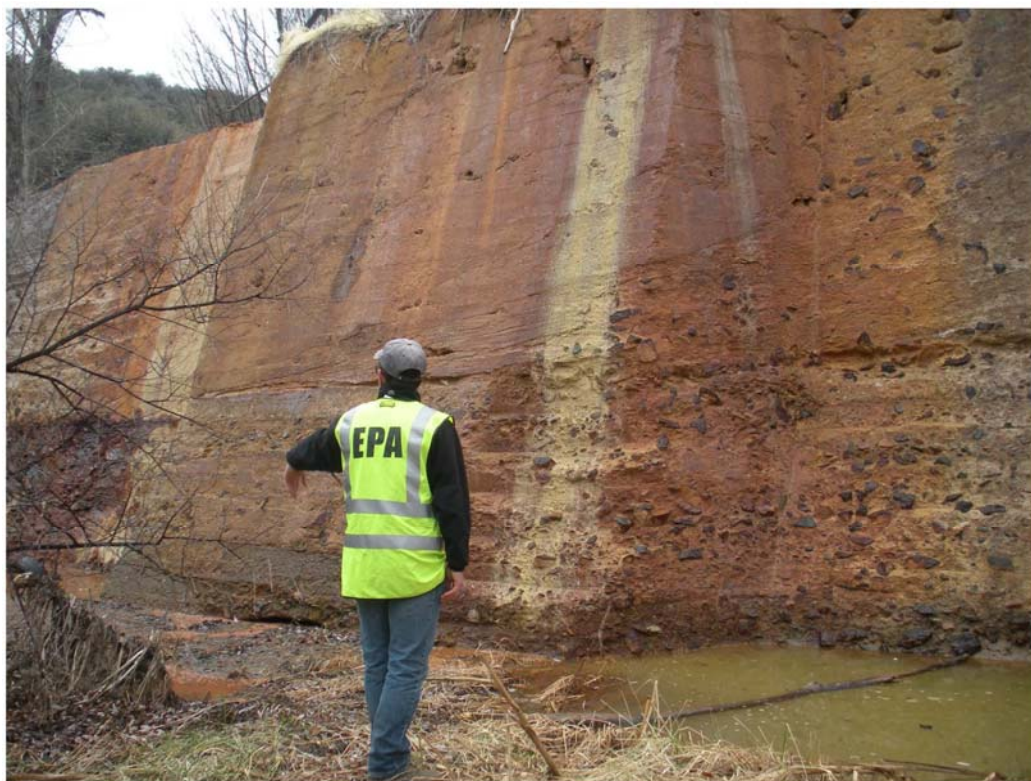
Photo F002 DSCN0939: Chaparral Gulch Dam

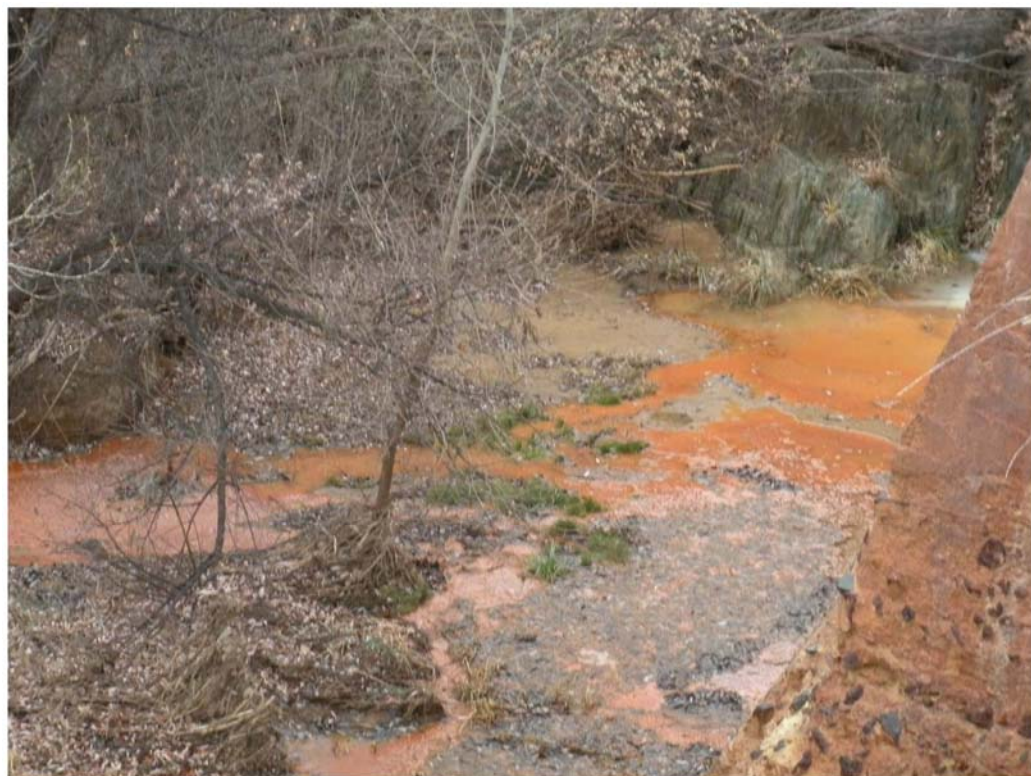
Photo F004: Ponds of water at the base (downstream) of Chaparral Gulch Dam

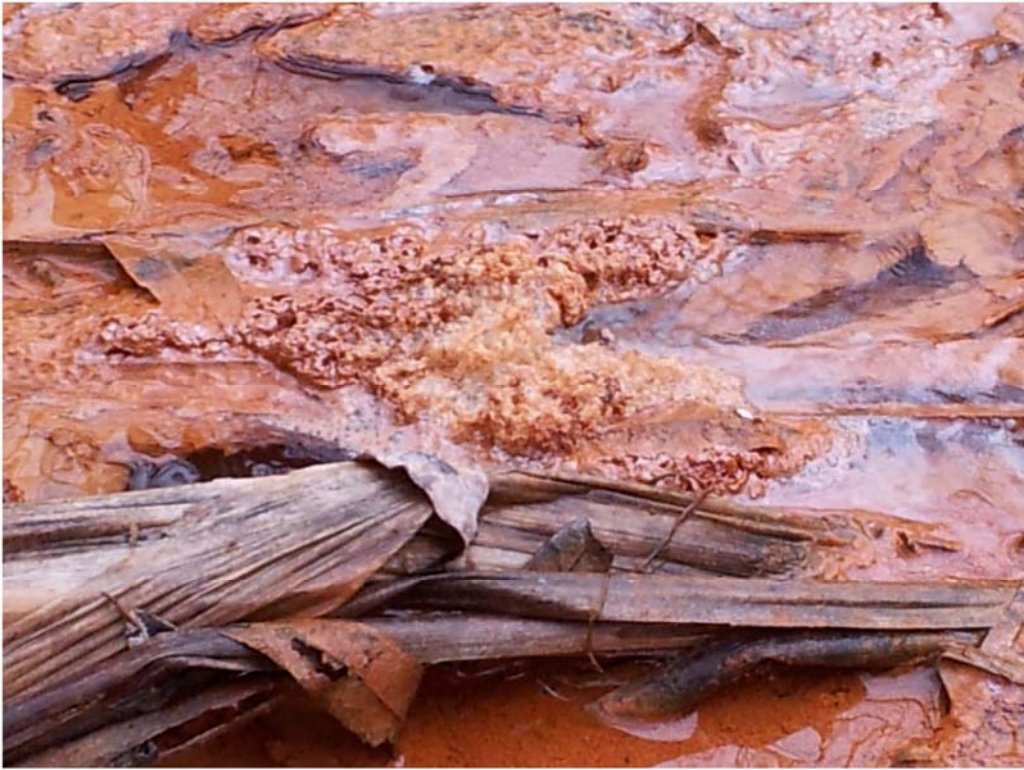
Photo F009: Red precipitate immediately downstream of Chaparral Gulch Dam

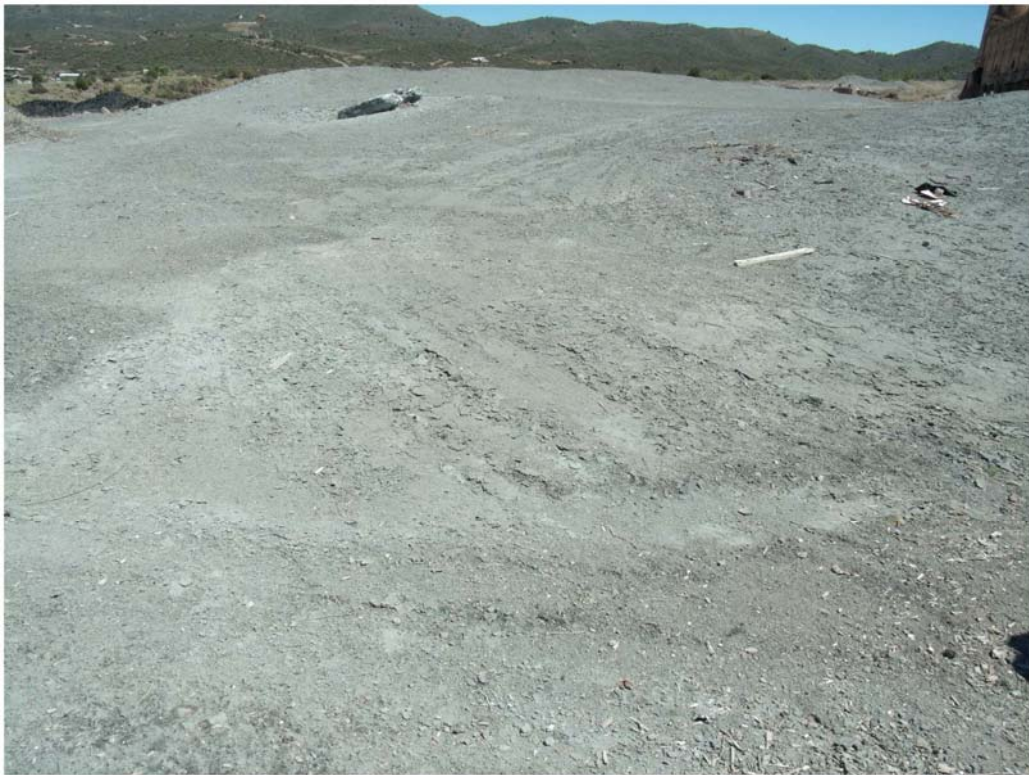
Photo GEDC1485: Dross material covering Pyrometallurgical Operations area

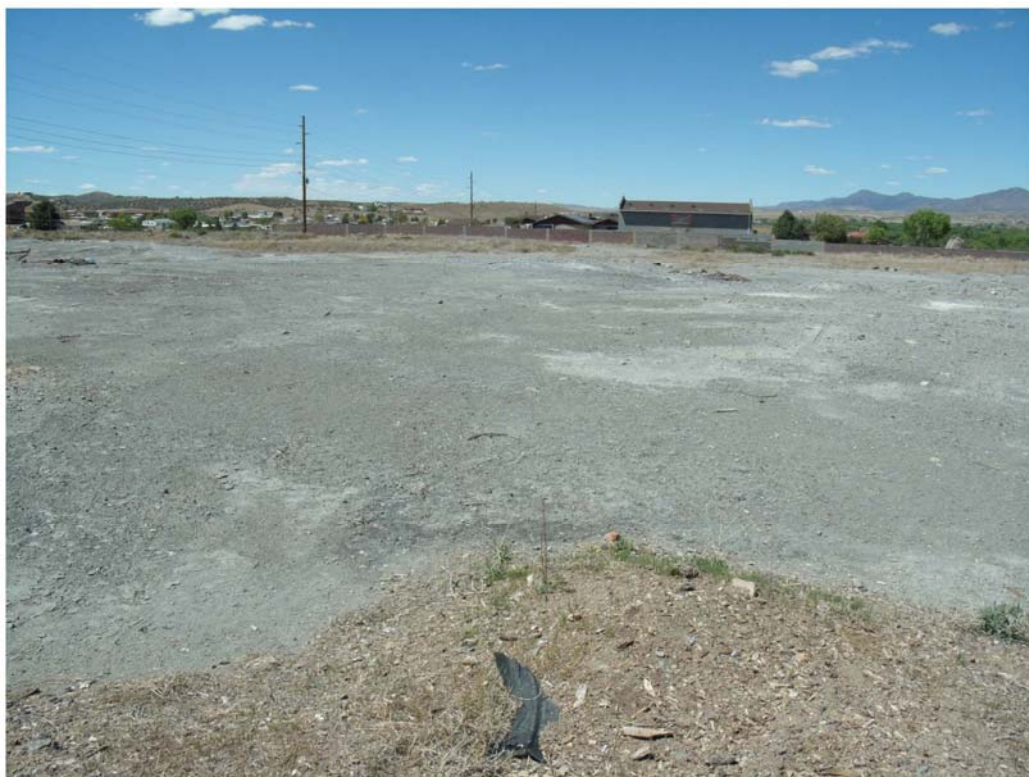
Photo GEDC1486: Dross material covering Pyrometallurgical Operations area

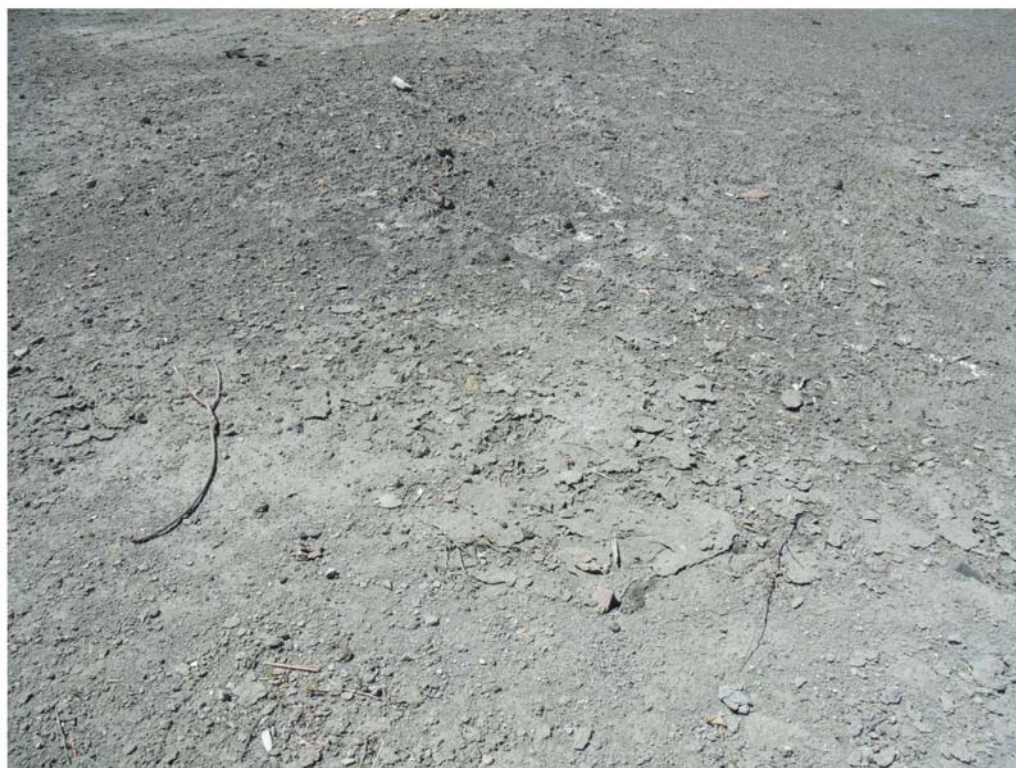
Photo GEDC1487: Dross material covering Pyrometallurgical Operations area

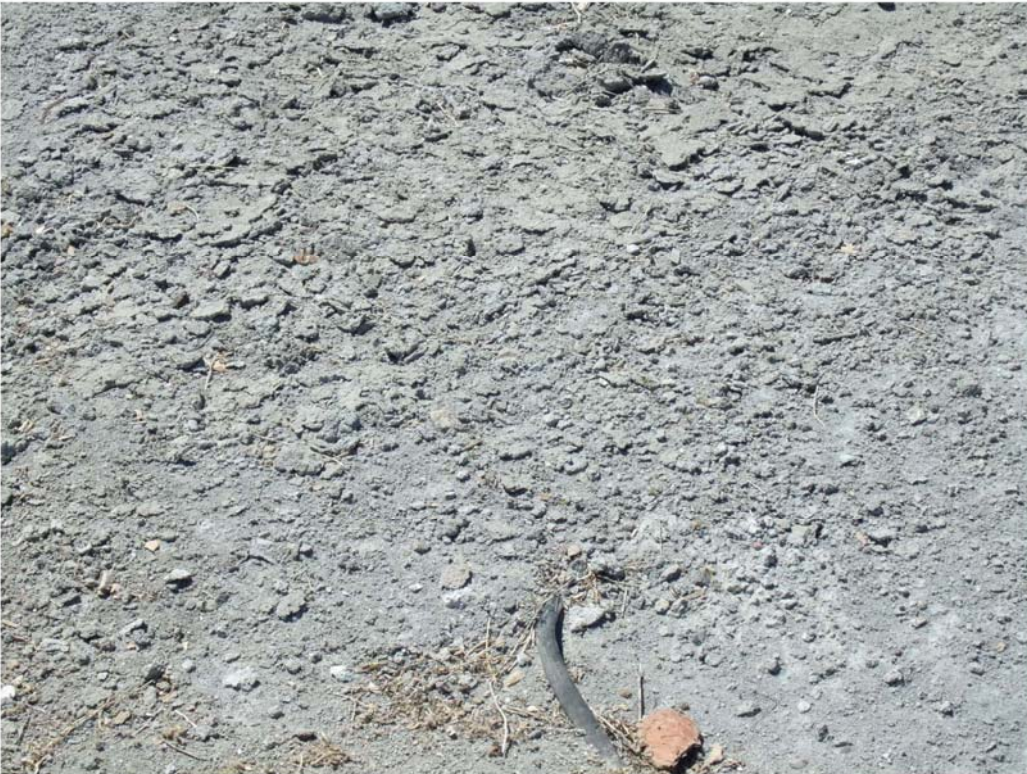
Photo GEDC1488: Dross material covering Pyrometallurgical Operations area

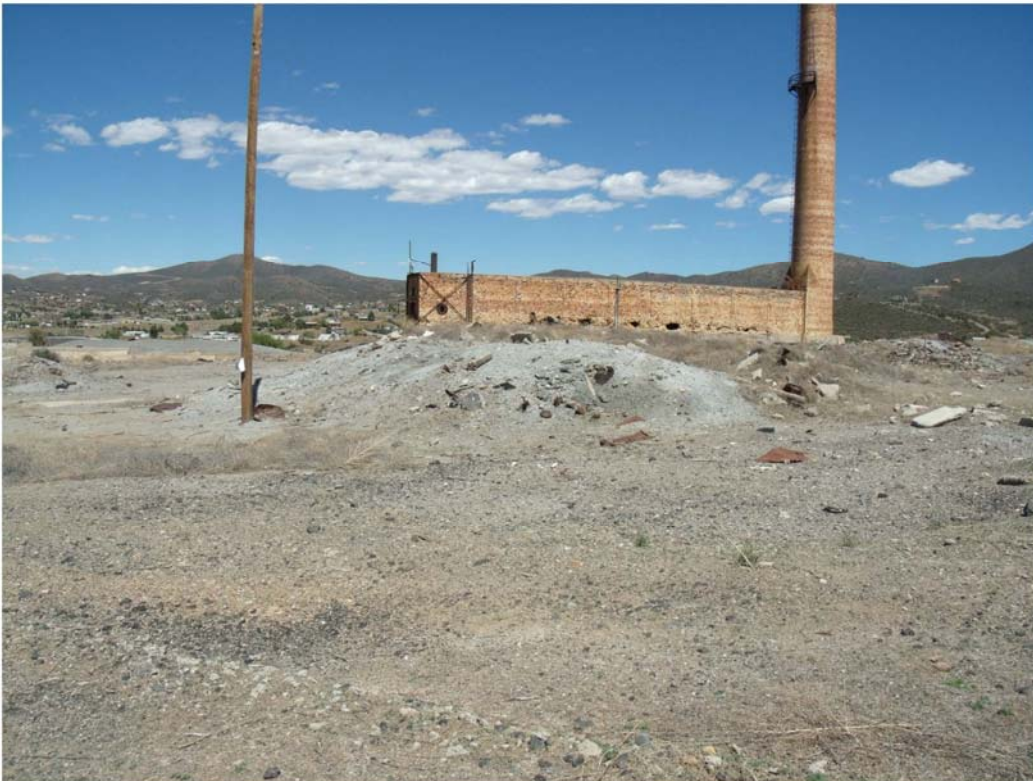
Photo GEDC1490: Dross material covering Pyrometallurgical Operations area at Humboldt Smelter

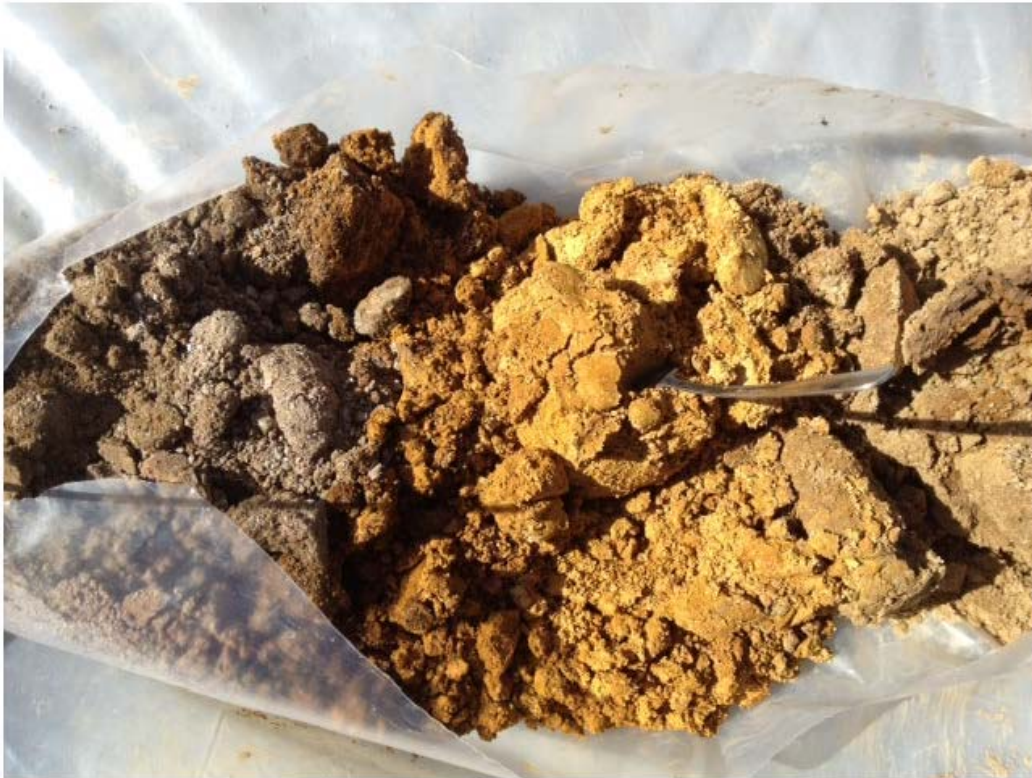
Photo 1: Part of a core into the Tailings Floodplain showing yellow-orange oxidized tailings layer on top of other deposit material

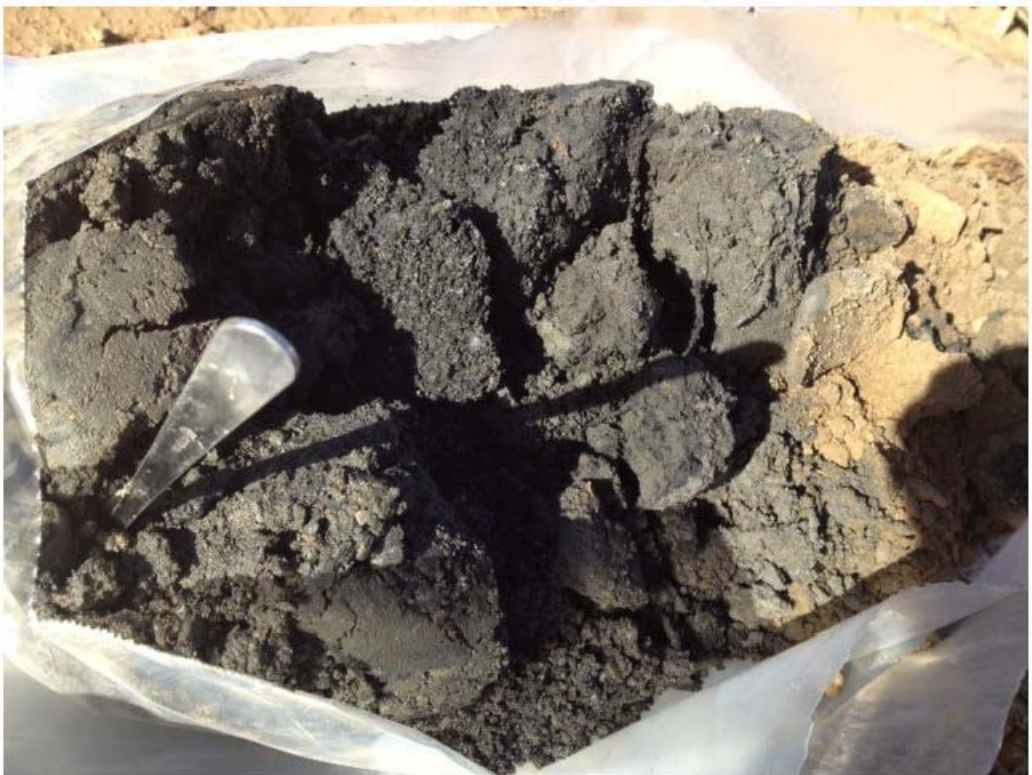
Photo 2: Part of a core into the Tailings Floodplain, showing black reduced (anoxic) tailings
