# AERIAL PHOTOGRAPHIC ANALYSIS OF IRON KING MINE/HUMBOLDT SMELTER SITE Dewey-Humboldt, Arizona Volumes 1 & 2 Combined

EPA Region 9

TS-PIC-20809961S/20909961S  
December 2008

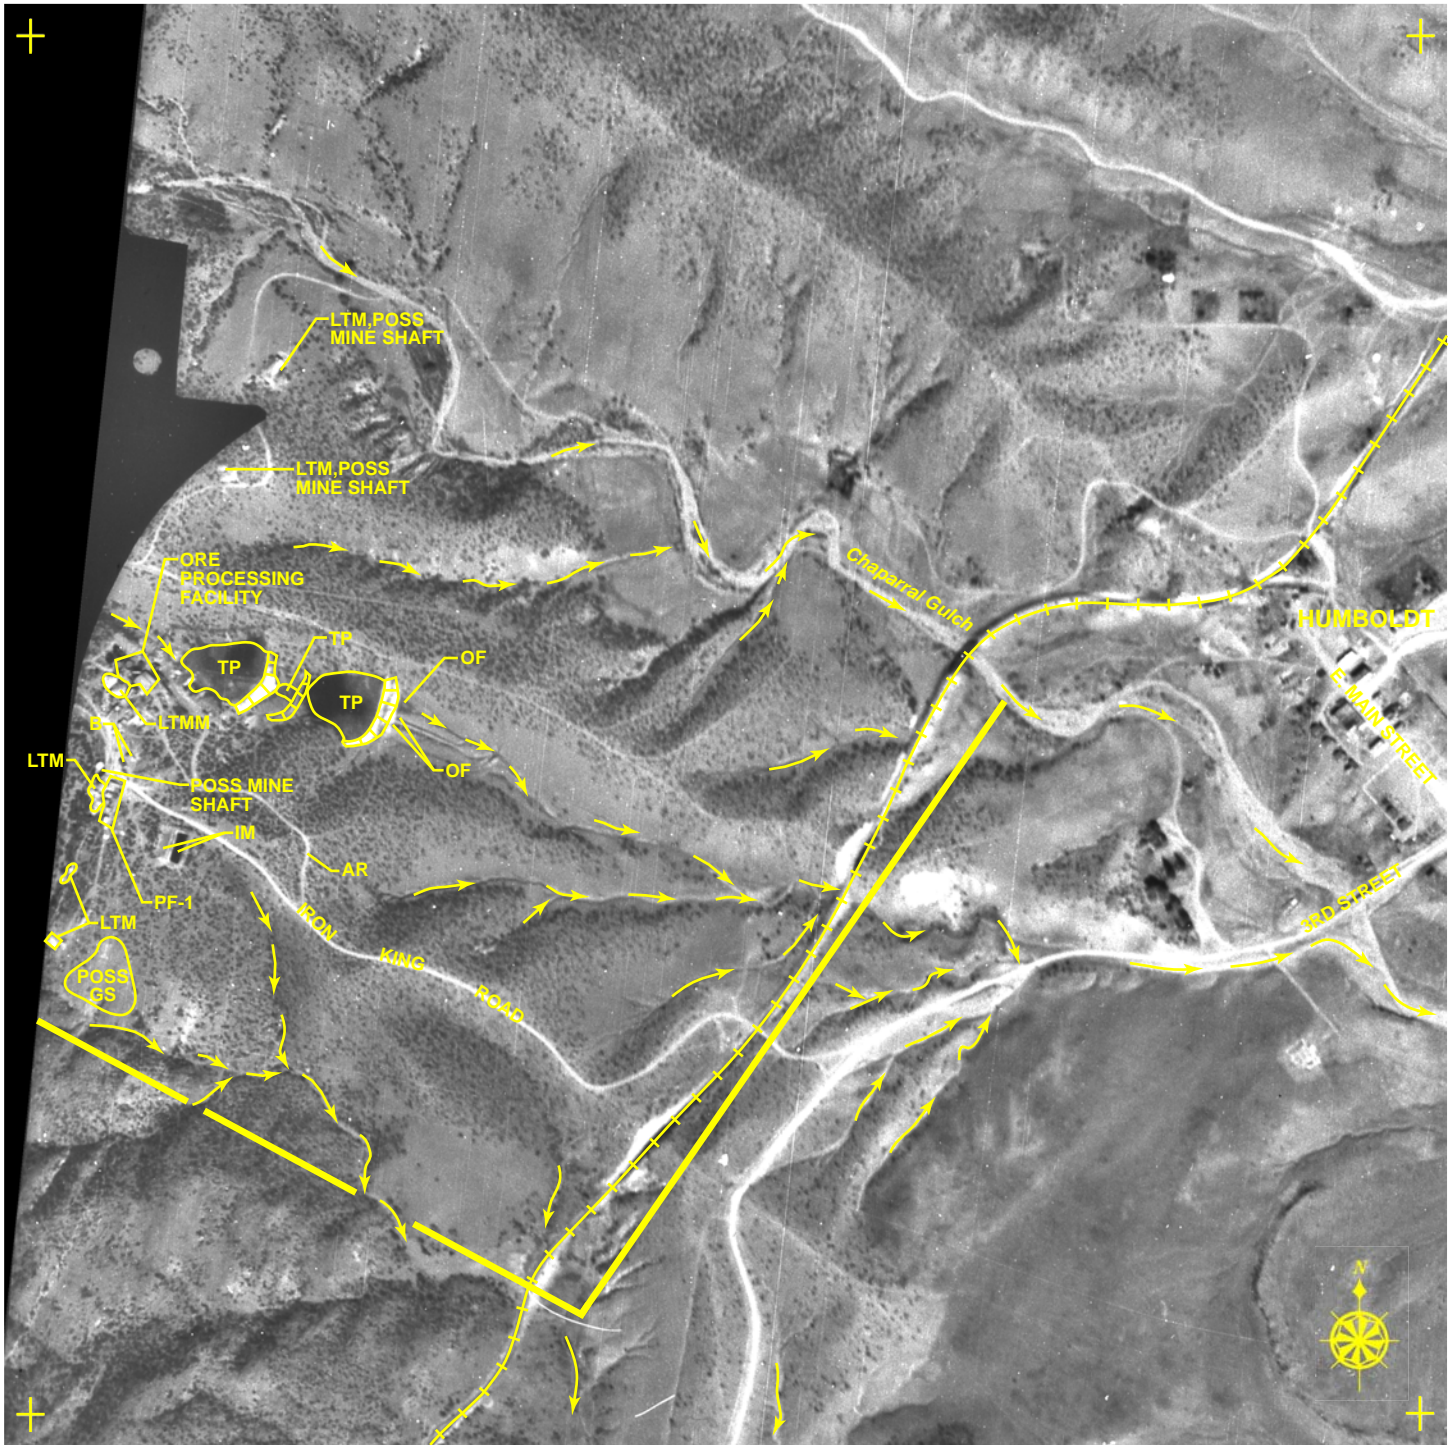
FIGURE 3. IROM KING MINE, OCTOBER 13, 1940. APPROX. SCALE 1:5,000.

A dirt access road (AR) leads north from the area of the Ore Processing Facility past two possible mine shafts, each of which has light-toned material (LTM) (likely spoil) adjacent to it.

Processing facility PF-1 appears to be operational and is located south of Iron Mine Road. Processing facility PF-1 is composed of four buildings and other associated nearby features: two impoundments (IM), light-toned material, and a nearby possible mine shaft. Drainage from processing facility PF-1 flows to the southeast through an unnamed tributary of the Galena Gulch. Light-toned material is noted at two locations south of processing facility PF-1. A dirt access road (not annotated) leads from the processing facility to a large possible ground scar (GS). The possible ground scarred area slopes to the south away from the access road to the edge of a drainage channel.

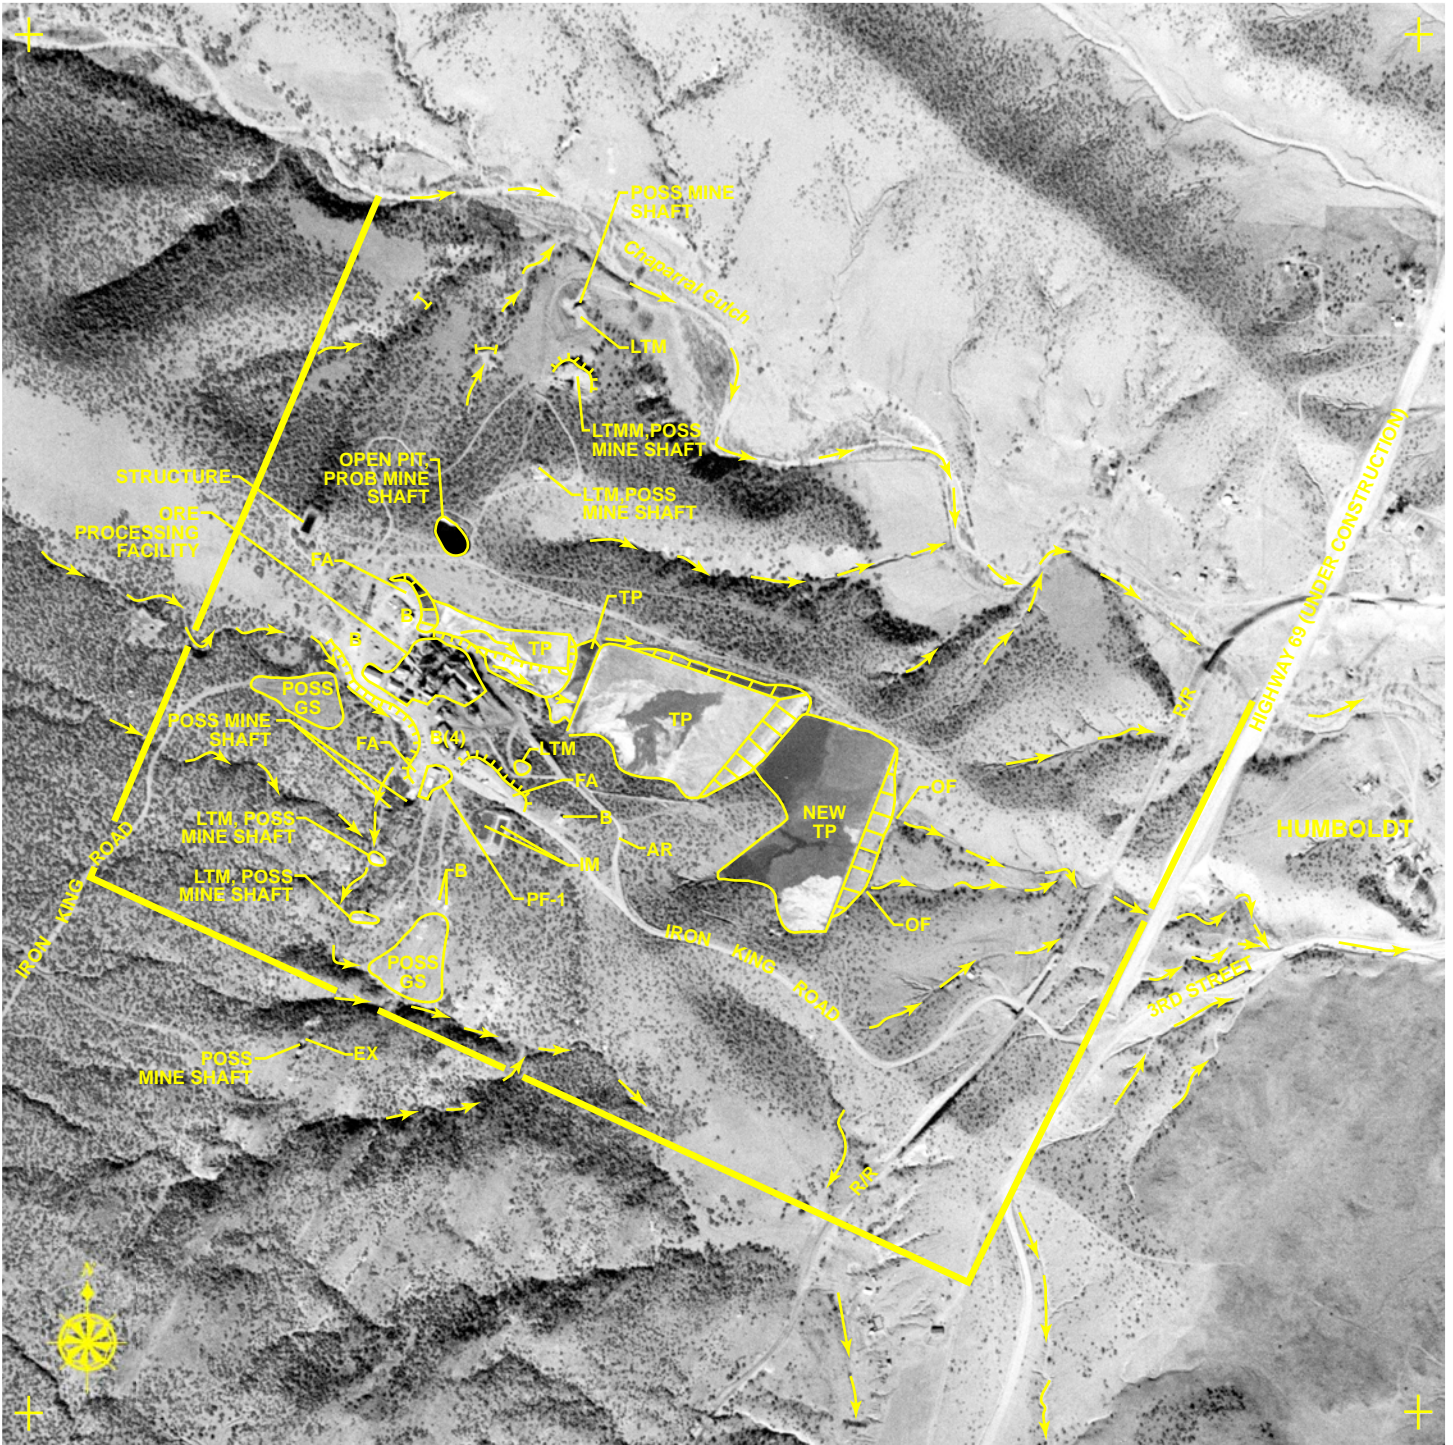
FIGURE 4. IRON KING MINE, NOVEMBER 25, 1953. APPROX. SCALE 1:5,300.

Since 1940 an open pit and a probable mine shaft have been excavated due north of the Ore Processing Facility. North of the Ore Processing Facility, near Chaparral Gulch, a new possible mine shaft and associated light-toned material are noted. Mining operations at the possible mine shaft located nearby to the south, in place in 1940, have been ongoing since 1940 at this location. More light-toned material (likely mine spoil) has been deposited around the entrance to the possible mine shaft.

Processing facility PF-1 remains operational and now is composed of three buildings, and a possible vertical tank, and a possible horizontal tank. Two possible mine shafts, not visible on the 1940 photographs, and associated light-toned material are located on the southwest side of processing facility PF-1. The two impoundments located to the east each contain standing liquid (not annotated). Two new small buildings (B) have been built south of the processing plant, at the end of the access road on the northern edge of the ground scarred area.

Fill material has been placed in fill areas (FA) around the Ore Processing Facility and processing facility PF-1 creating flat fill areas used to conduct facility operations. Numerous buildings have been constructed around the two facilities since 1940. These buildings likely serve support ancillary functions for operations at the two facilities.

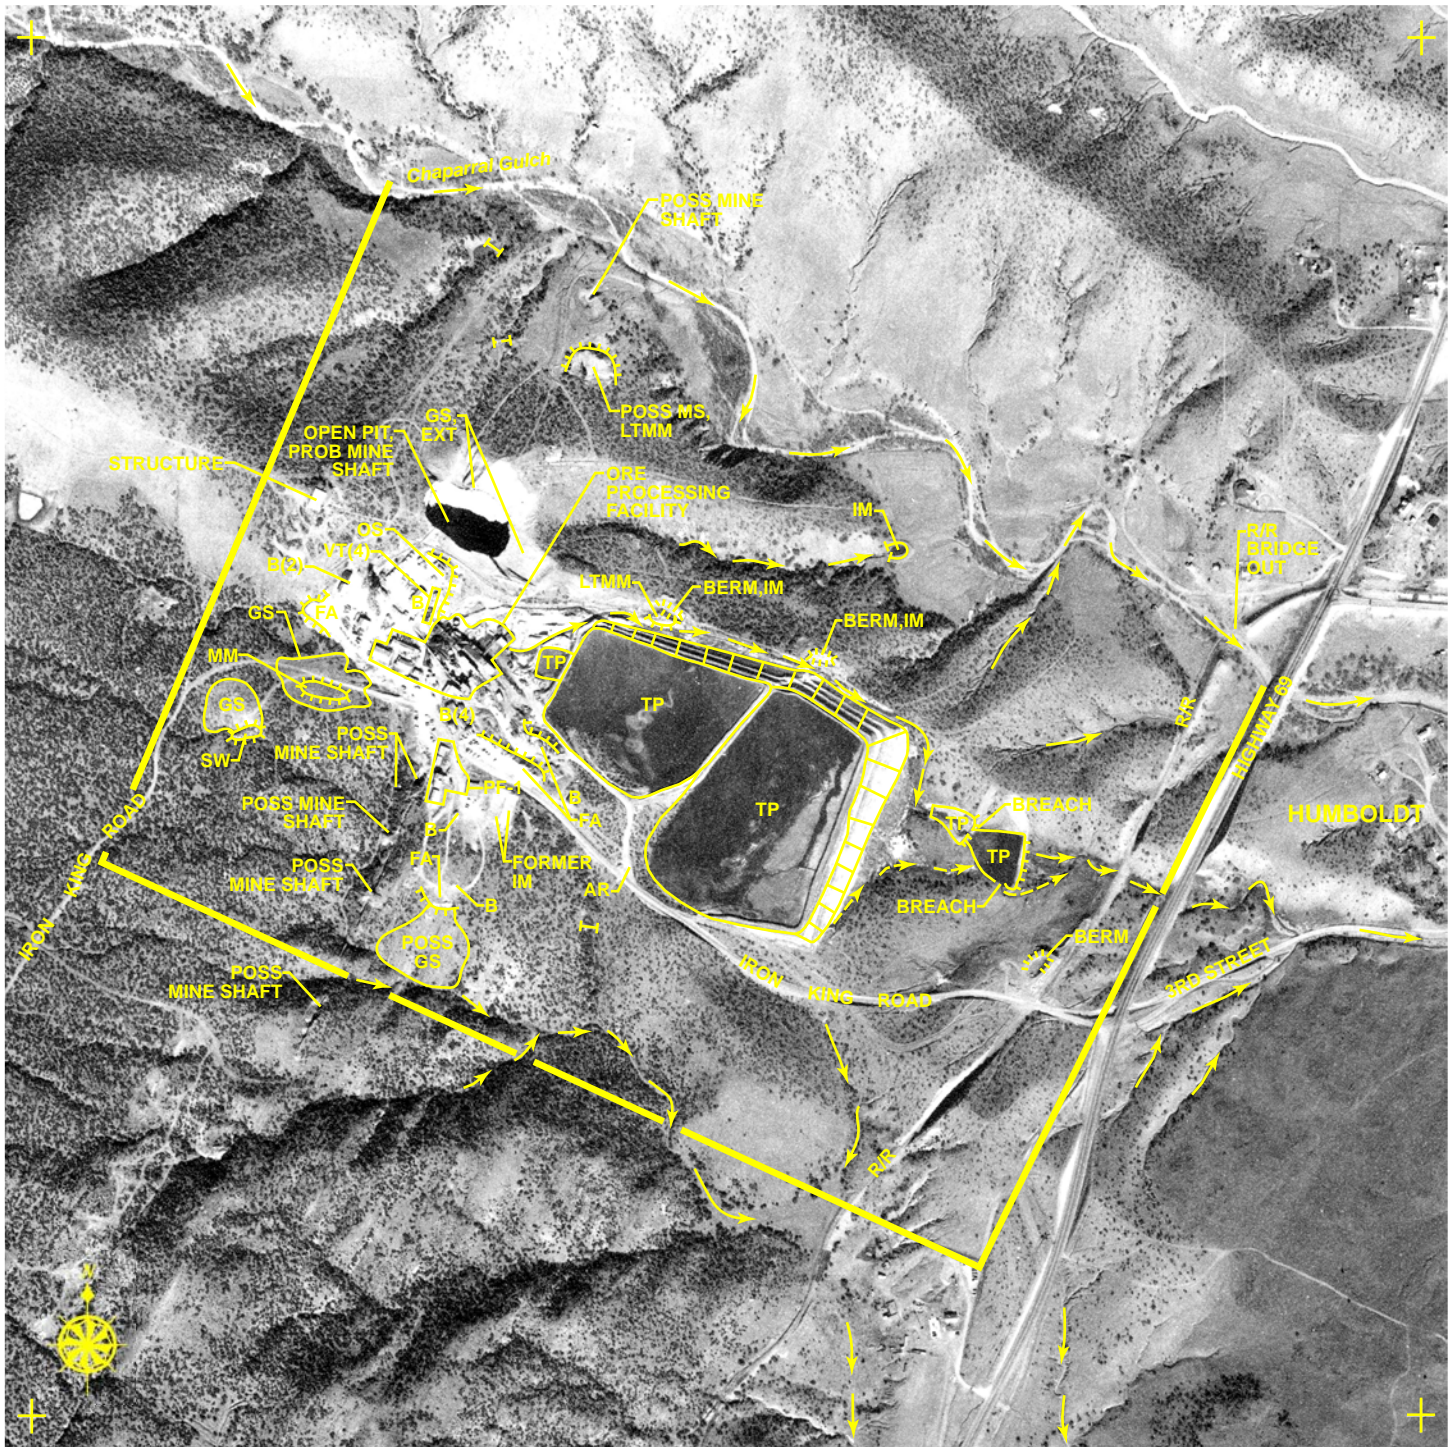
FIGURE 5. IRON KING MINE, JANUARY 15, 1964. APPROX. SCALE 1:5,300.

The Ore Processing Facility continues to be operational and has been significantly expanded since 1953. There are now ten buildings, eight vertical tanks, overhead pipes, and staining on the surface of the facility. The tailings ponds, operating at the Ore Processing Plant in 1953, have been reconfigured and expanded. A drainage channel and two impoundments that may function as overflow catchments have been constructed along the northern bottom edge of the tailings dam. The channel directs some of the discharge from the facility into two, relatively smaller tailings ponds that have been constructed to the east, downstream from the other tailings ponds. Breaches in the berms of the two new ponds appear to allow liquid to circumvent the ponds. An outfall into the drainage channel is also noted at the base of the easternmost tailings pond.

The fill areas around the Ore Processing Facility have been expanded, likely to accommodate expansion of activities at the facility. Four vertical tanks (VT), buildings (not all are annotated), and vehicles/equipment (not annotated) are on the fill area north of the Ore Processing Facility. The open pit, located north of the Ore Processing Facility, has been expanded and ground scars from the extraction (EXT) of materials from around the rim of the pit are noted. The amount of light-toned material deposited adjacent to the possible mine shaft northeast of the open pit has increased, indicating continued ore extraction at this location. An impoundment has been constructed along a tributary of the Chaparral Gulch that drains the area east of the open pit. The impoundment contains liquid (not annotated) at this time.

Processing facility PF-1 remains in operation. The facility is now composed of four buildings. The two impoundments, located to the east, are dry and no longer appear to be in use. The fill area (not annotated) around processing facility PF-1 has been expanded, likely to accommodate expansion of activities at the facility. A dirt access road leads south from the vicinity of processing facility PF-1 to a fill area located adjacent to the possible ground scarred area first noted in 1940.

The railroad bridge that crossed the Chaparral Gulch has been removed.

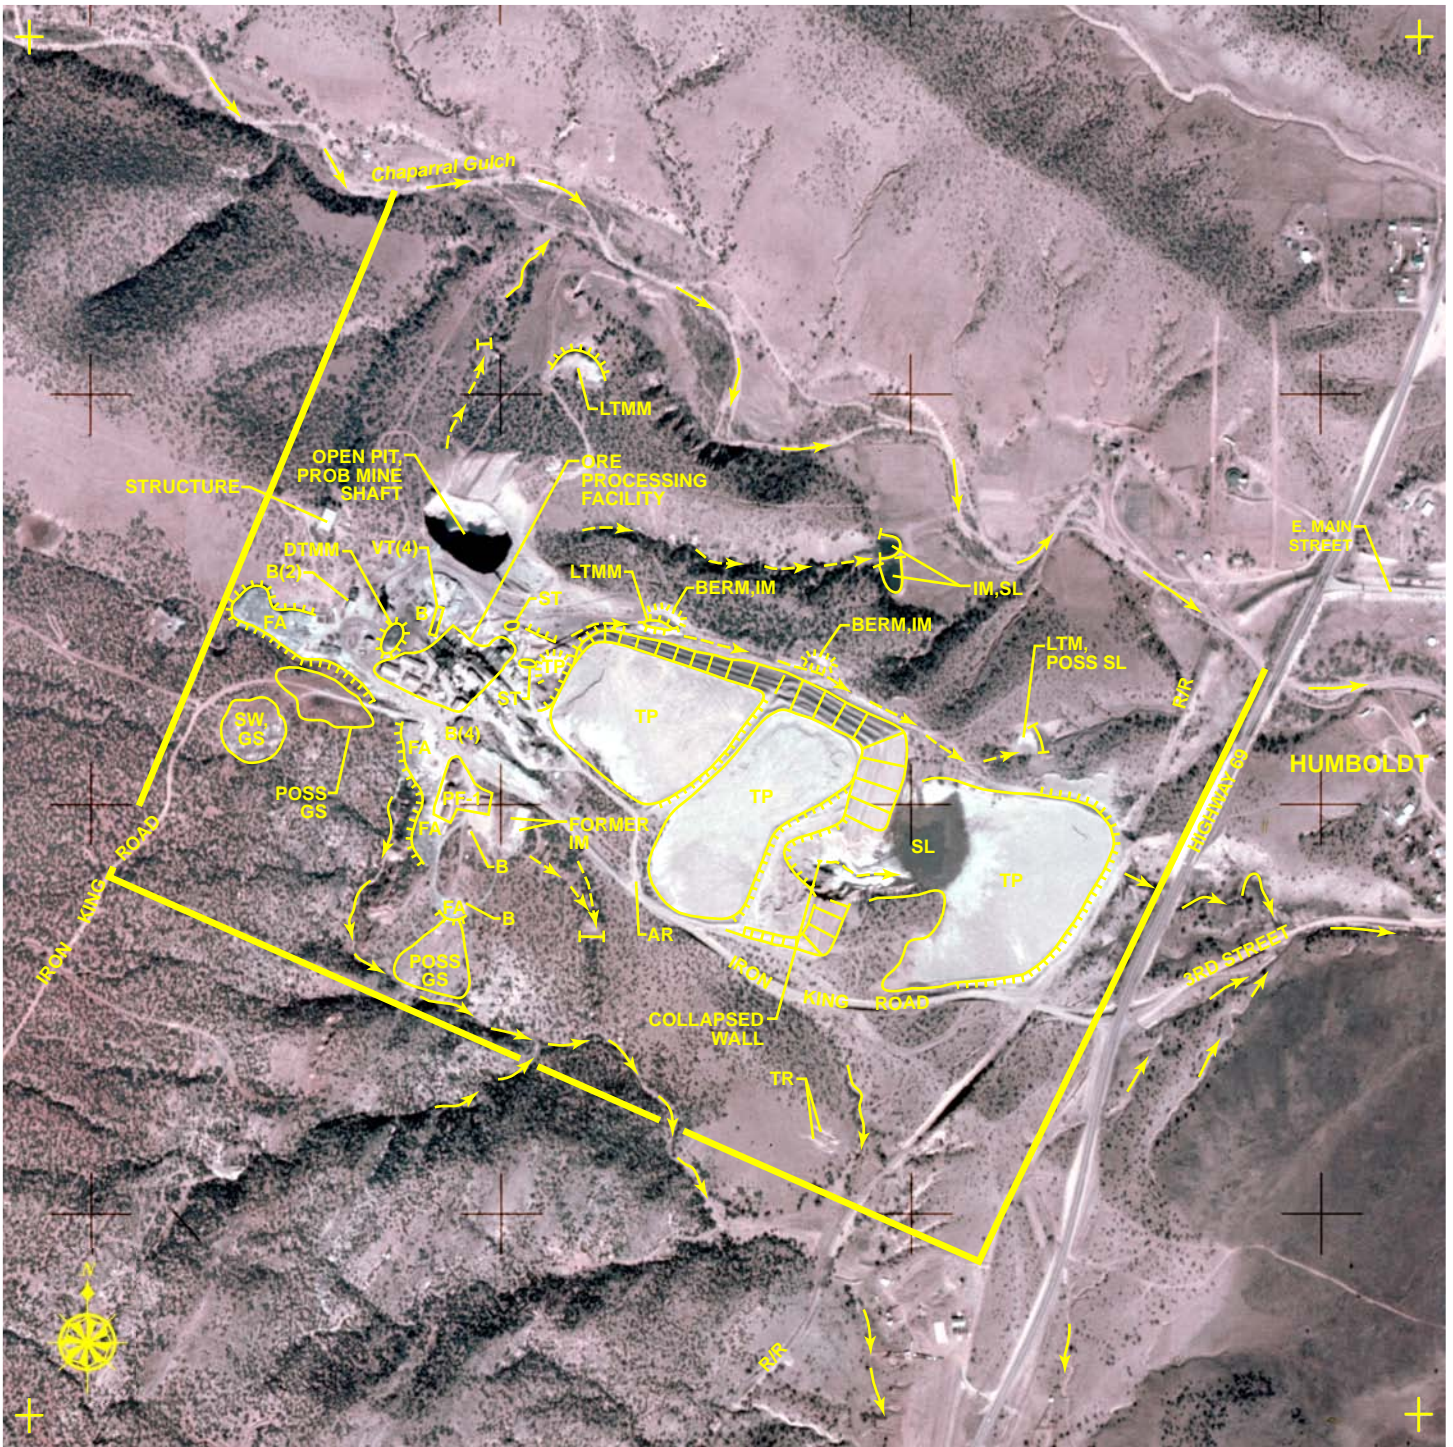
FIGURE 6. IRON KING MINE, FEBRUARY 6, 1970. APPROX. SCALE 1:5,300.

Processing facility PF-1 remains in operation. The fill area to the west and south of processing facility PF-1 has been enlarged, likely to accommodate operations at the facility. No other environmentally significant change is noted in association with the facility.

Two open trenches (TR) have been dug on the side of a hill south of Iron King Road near the railroad line (R/R). No established access road leads to this area.

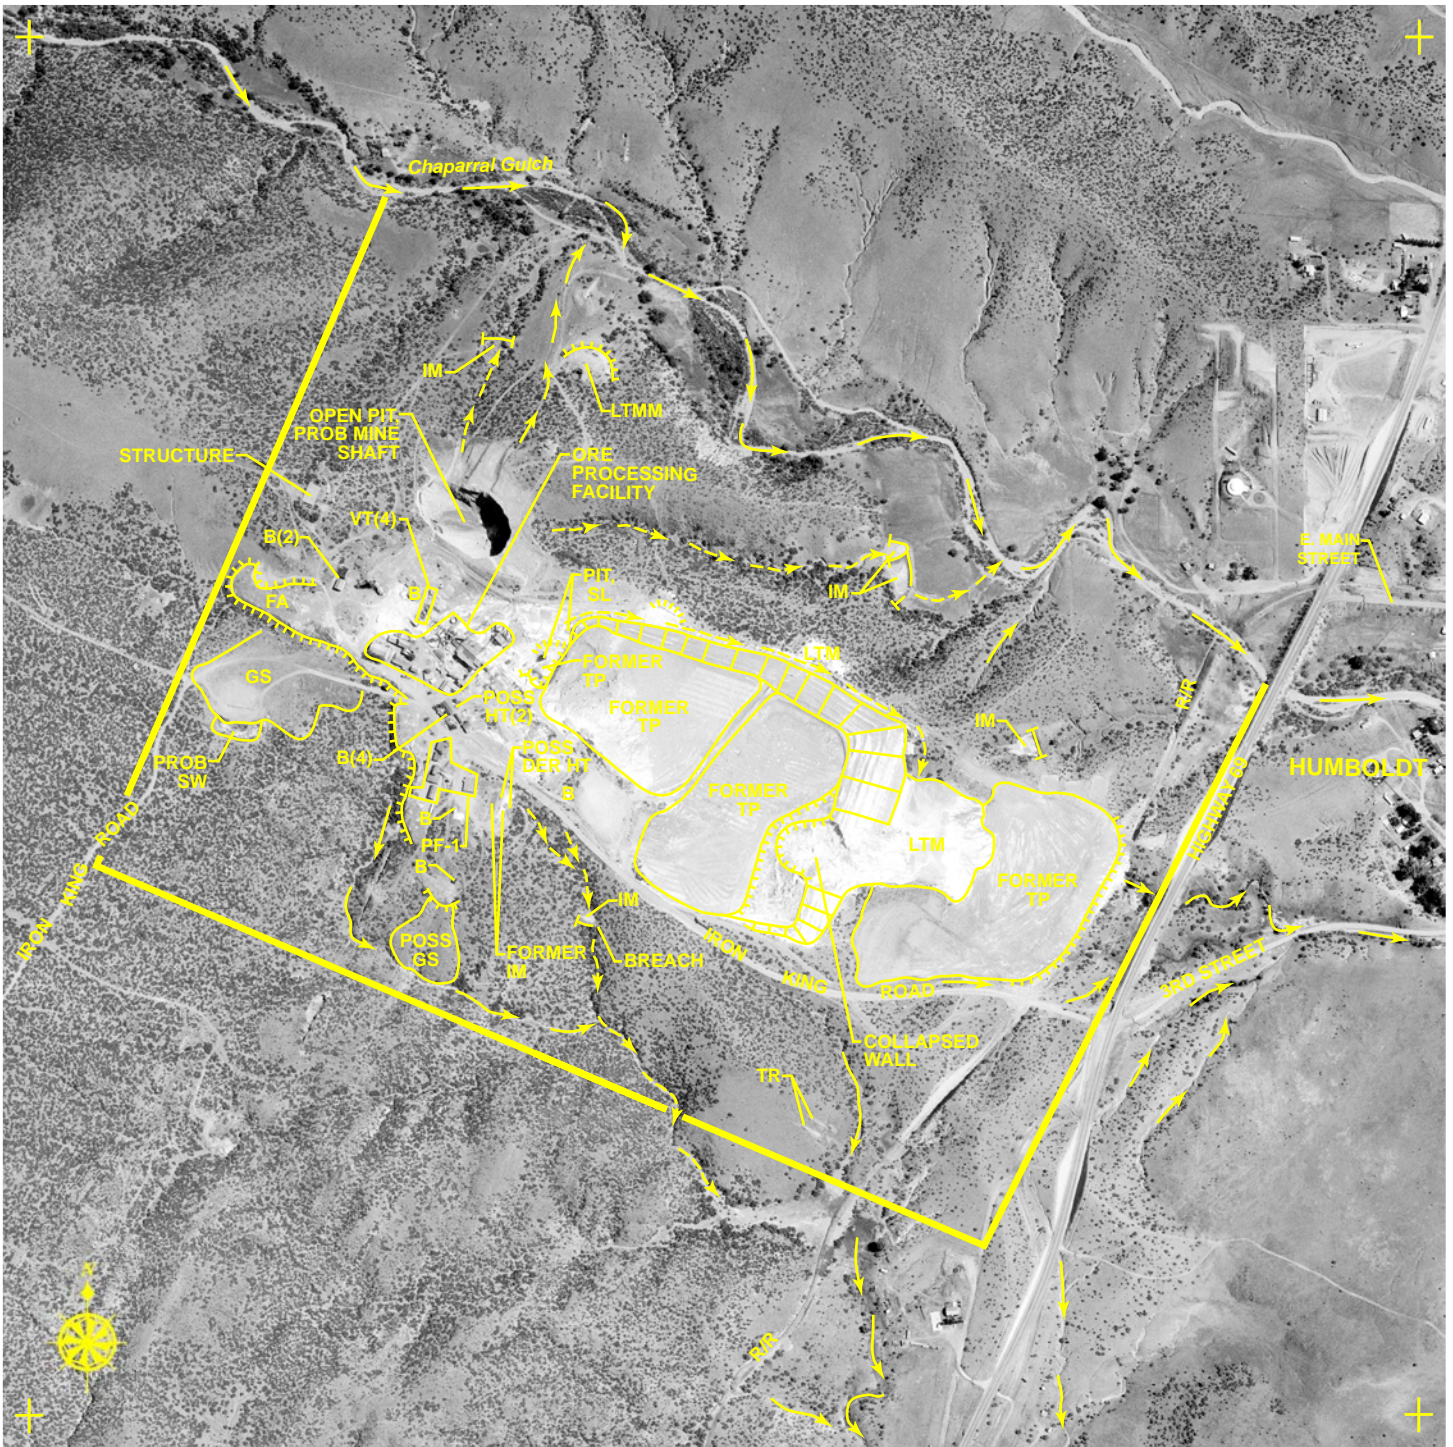
FIGURE 7. IRON KING MINE, JUNE 27, 1973. APPROX. SCALE 1:5,300.

The Ore Processing Facility no longer appears to be in operation. There are now ten buildings and ten empty vertical tanks on the facility that do not appear to be in use. The tailings ponds are empty and much of their upper surfaces have been graded. Few vehicles are parked in the area. The photography was taken on a Wednesday, a work day. The dark-toned mounded material noted west of the facility in 1970 has been removed. The ground scarred area, located west of the Ore Processing Facility, has been enlarged and the scattered waste noted on the surface of the area in 1970 is no longer visible. Probable solid waste continues to be visible along the southern edge of the area. The amount of probable solid waste material at this ground scarred area does not appear to have significantly changed since 1970. Material has been extracted (not annotated) from a section of the fill area noted north of the ground scarred area. Two depressions or pits containing standing liquid (SL) are visible in the dry bottom of the small, westernmost former tailings pond. The impoundments located along a tributary of the Chaparral Gulch that drains the area east of the open pit are empty. The southern impoundment has been breached.

Processing plant PF-1 appears to be in operation. Three vertical tanks, vehicles and equipment (not annotated), and five buildings are visible on the facility. East of the facility are two possible derelict (DER) horizontal tanks (HT) that have been placed in and adjacent to the easternmost former impoundment. The western former impoundment (not annotated) has been filled in.

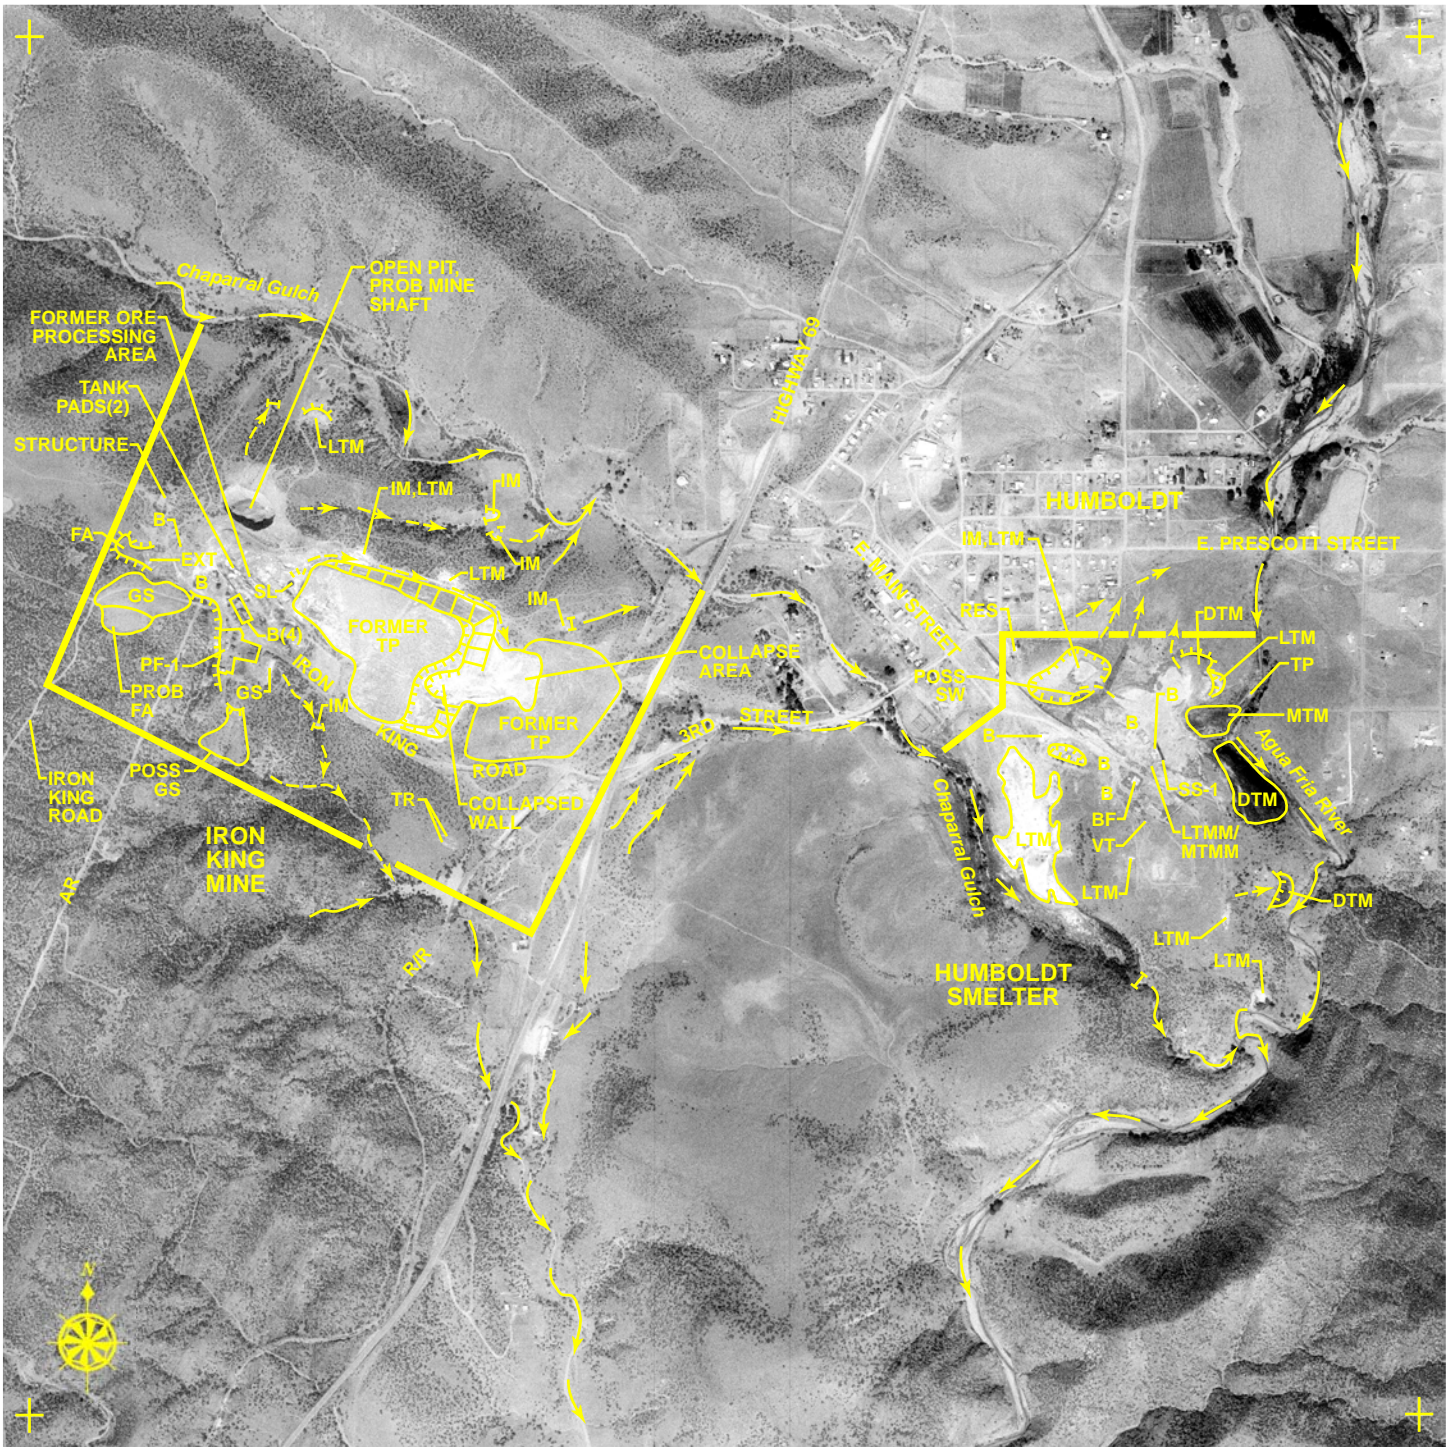
FIGURE 8. IRON KING MINE/HUMBOLDT SMELTER SITE, SEPTEMBER 25, 1980. APPROX. SCALE 1:9,800.

Most of the buildings and all the tanks have been removed from the location of the Former Ore Processing Facility. Two tank pads are visible at the location of the former facility. A probable fill area is located on the southern portion of the ground scarred area located west of the former facility. The probable fill area is located at the former location of probable solid waste, which is no longer visible. Material has been extracted from the fill area located north of Iron King Road.

Processing facility PF-1 appears to be in operation and eight buildings are on the facility. The two possible derelict horizontal tanks located near the former impoundment in 1970 have been removed. A ground scar remains at the locations of the easternmost former impoundment.

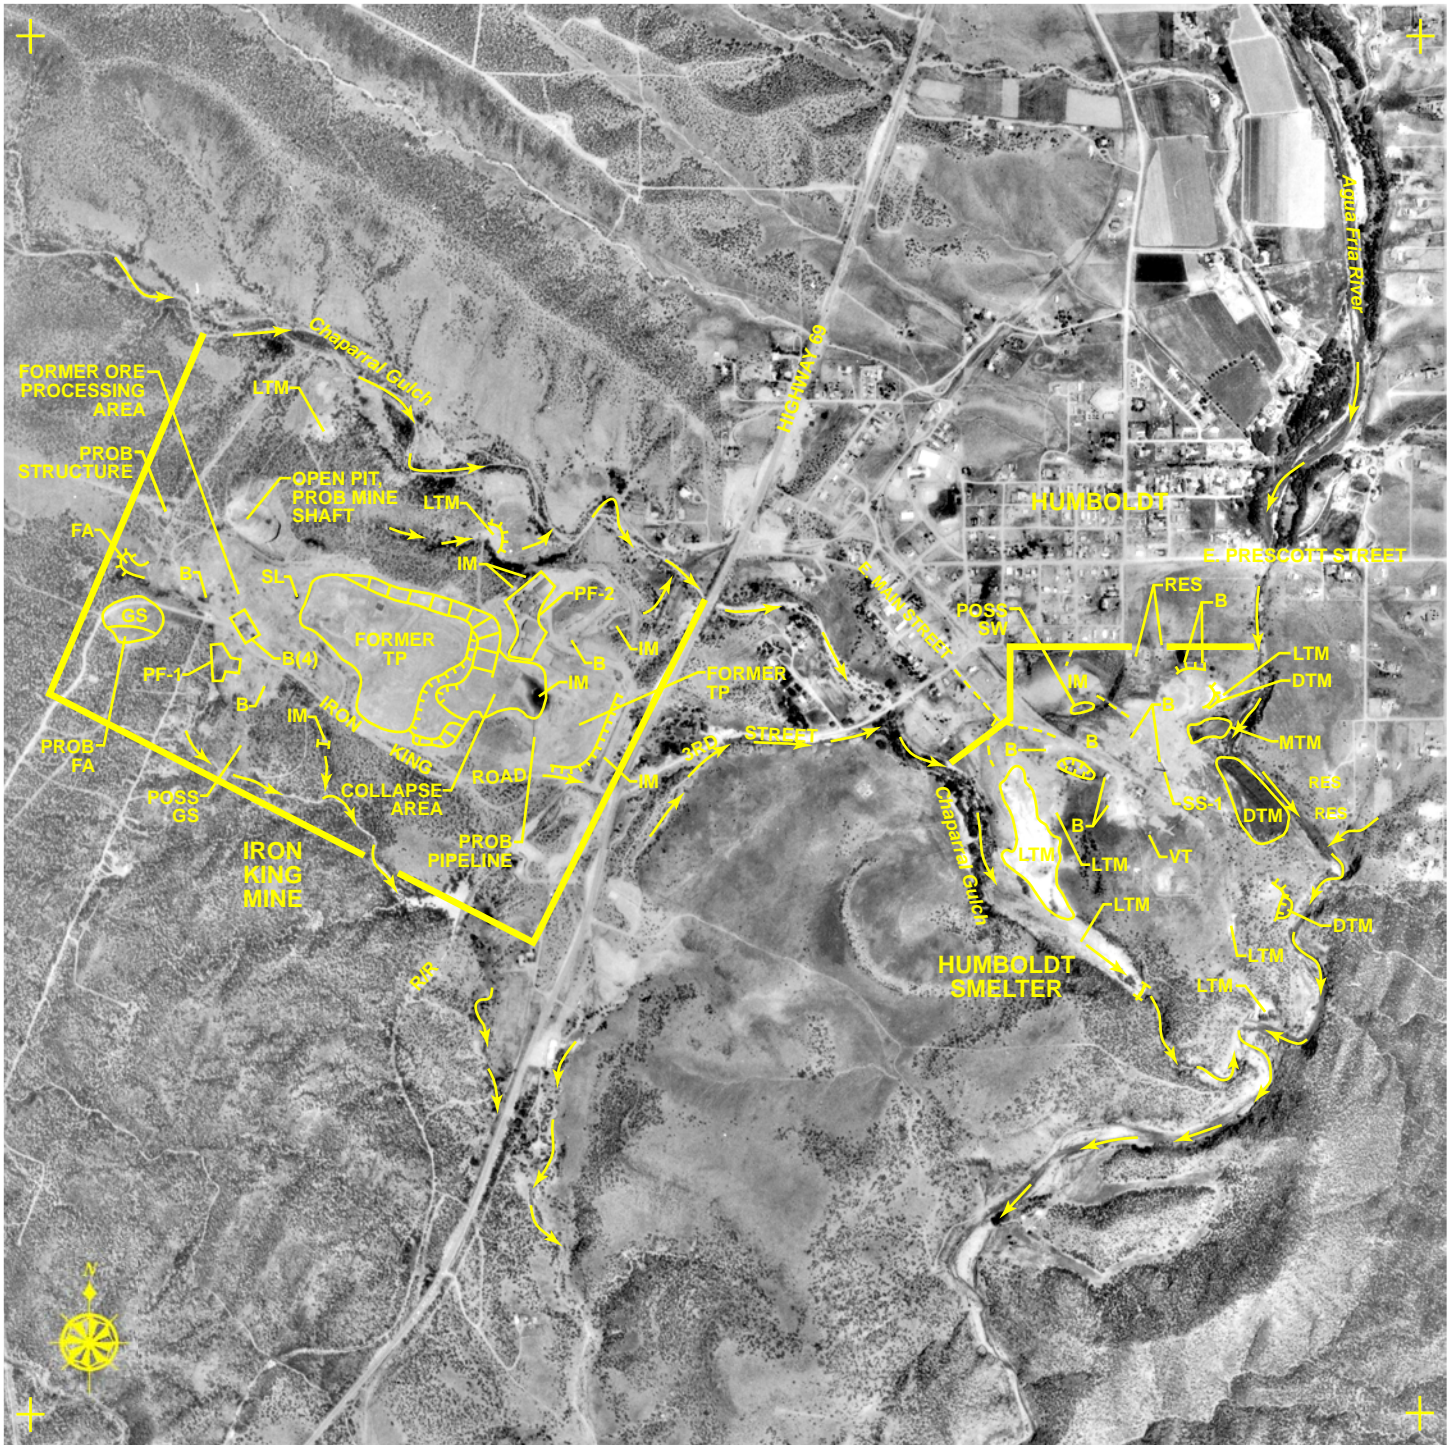
FIGURE 9. IRON KING MINE/HUMBOLDT SMELTER SITE, JUNE 5, 1992. APPROX. SCALE 1:9,800.

Processing facility PF-2 has been built north of the easternmost former tailings pond. The facility is composed of three buildings, five tanks, and overhead pipes and appears to be in operation. Two liquid-filled impoundments are located adjacent to the west side of the facility. A drainage channel (not annotated) links the impoundments to an unnamed tributary of the Chaparral Gulch.

South of processing facility PF-2 is a building and an impoundment, each of which is likely associated with the facility. The impoundment, which has been built in a tributary of the Chaparral Gulch, contains standing liquid (not annotated). Another impoundment is located in the collapse area of a former tailings pond. A probable pipeline or hose appears to drain liquid from the impoundment into an unnamed tributary of the Galena Gulch.

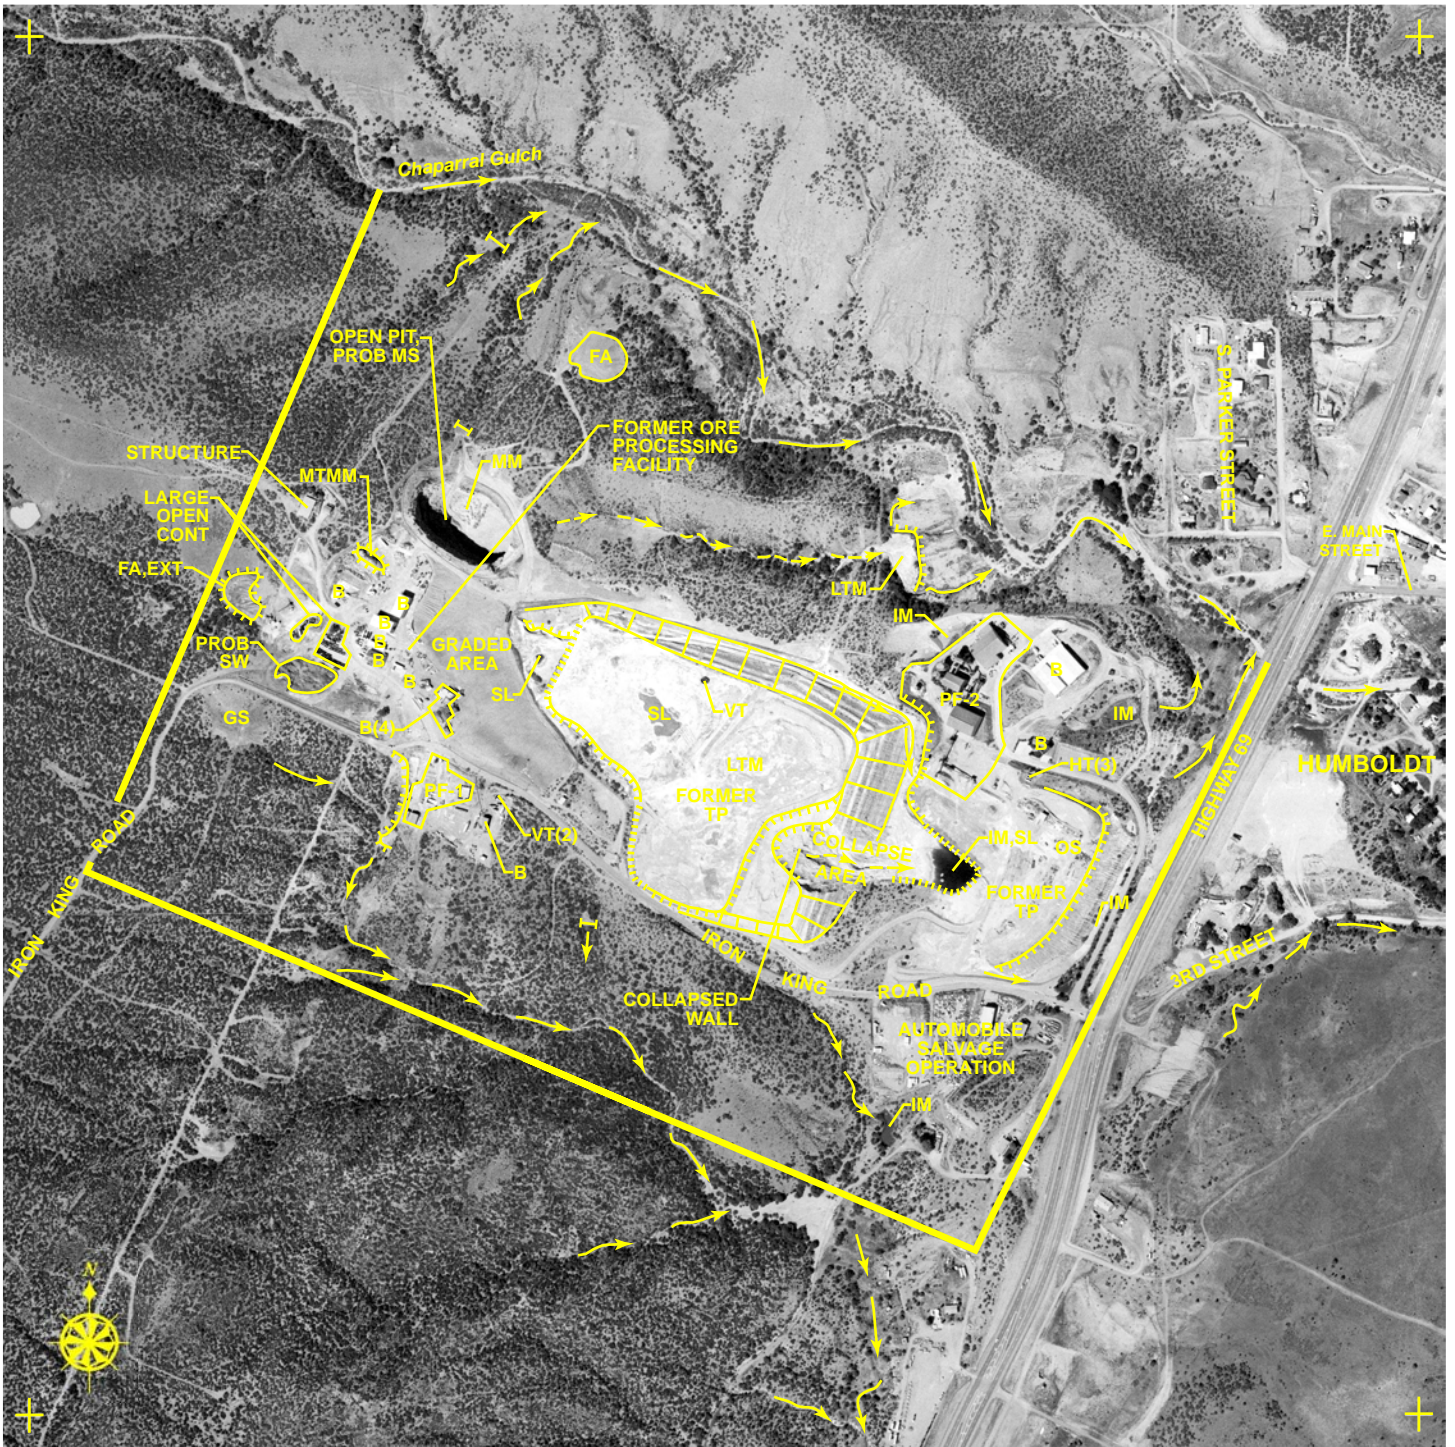
FIGURE 10. IRON KING MINE, SEPTEMBER 20, 2003. APPROX. SCALE 1:5,300.

Only two buildings remain at the location of processing facility PF-1. Two vertical tanks are located east of the area.

Processing facility PF-2 appears to be in operation and is composed of three buildings, seven vertical tanks, and overhead pipes. A new building has been constructed east of the facility and an impoundment has been constructed along Highway 69 at the eastern boundary of the mine. Part of a former tailings pond is being used as an open storage area for the processing facility. Three horizontal tanks stand north of the open storage area. The impoundment, which contains standing liquid, is located in the collapse area of a former tailings pond. A drainage channel located along the northern bottom edge of the tailings dam directs surface flow into the impoundment.

An automobile salvage facility is operating in the southeast corner of this section of the Iron King Mine/Humboldt Smelter site.

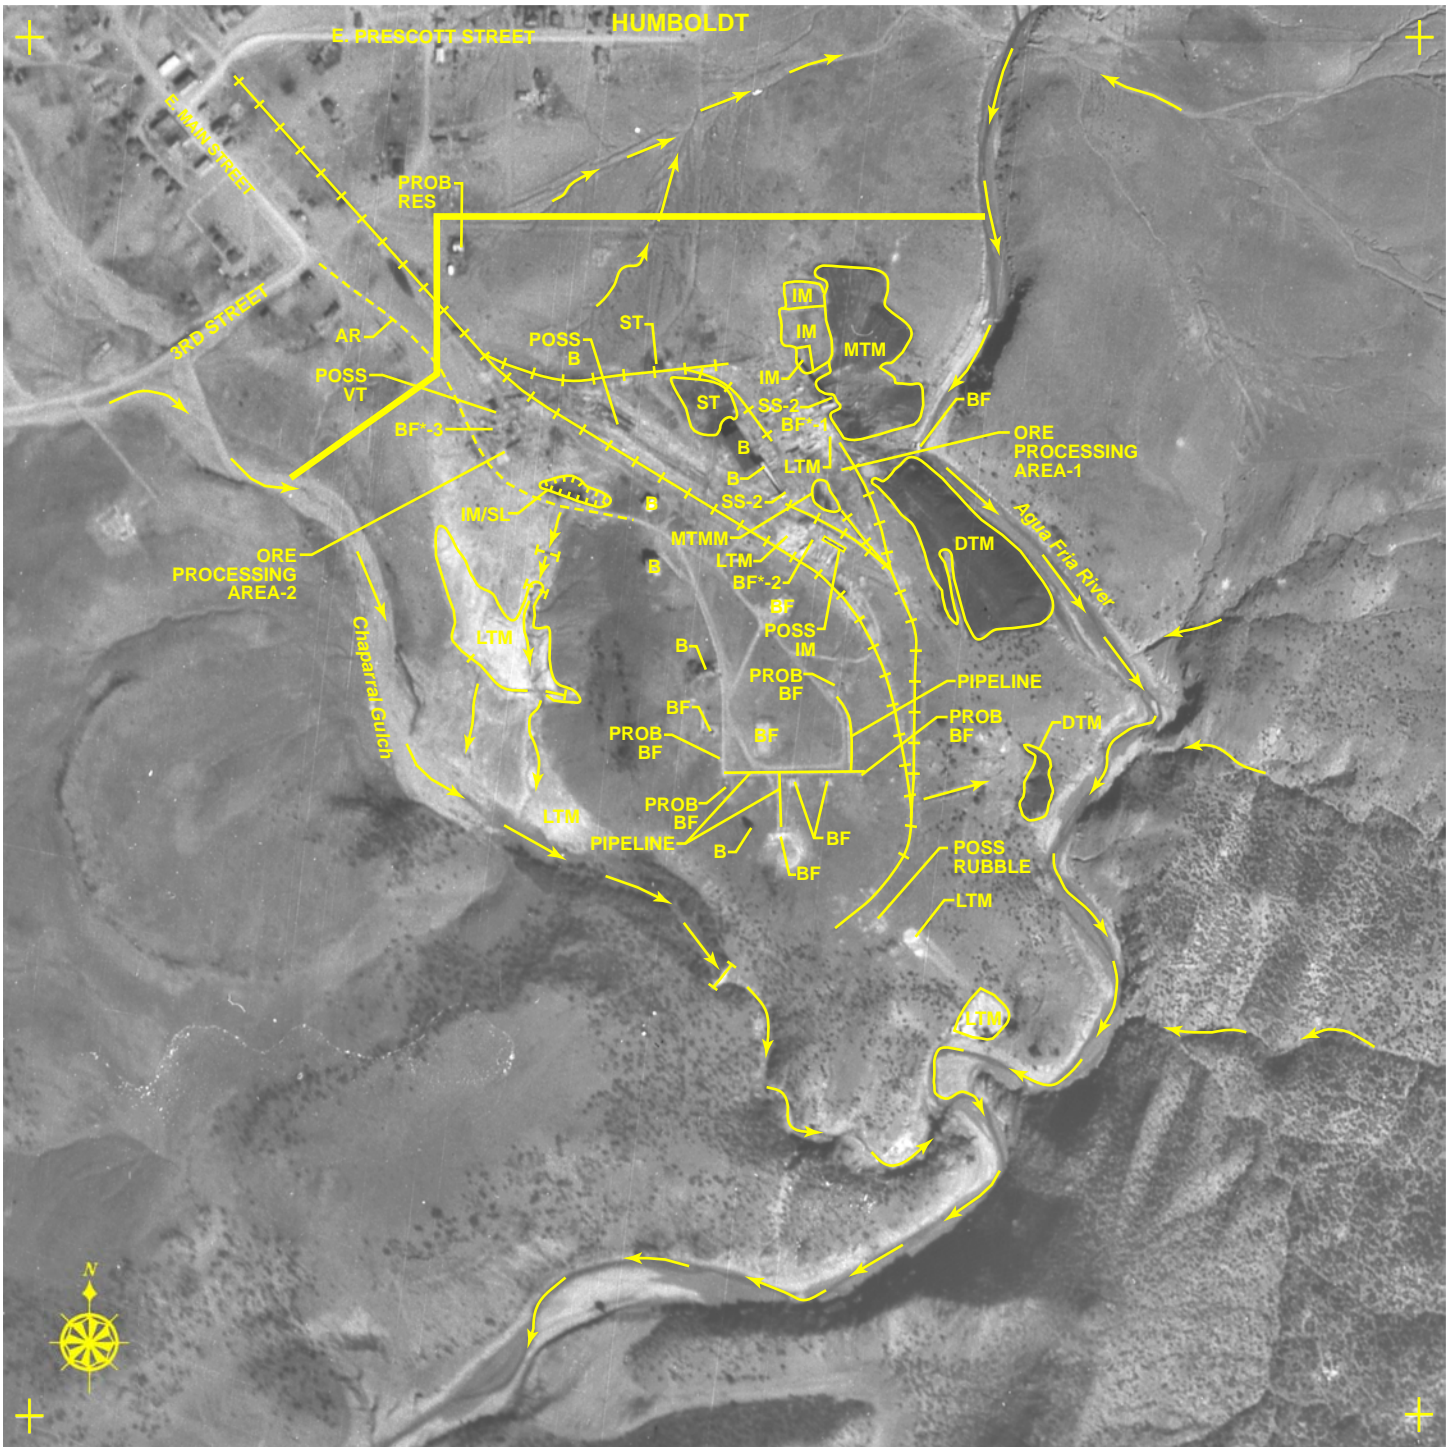
FIGURE 11. HUMBOLDT SMELTER, OCTOBER 13, 1940. APPROX. SCALE 1:4,500.

The Humboldt Smelter section of the Iron King Mine/Humboldt Smelter site is situated on a hill that overlooks the Agua Fria River, the Chaparral Gulch, and the confluence of these two drainageways. The Humboldt Smelter is located east of Highway 69 on the outskirts of the southern section of Humboldt, Arizona. A probable residence (RES) is located along the northwestern border of the smelter near 3rd Street. Access to the Humboldt Smelter is via both East Main Street and a network of rail lines that enter the Humboldt Smelter from the northwest. Features and conditions on the Humboldt Smelter indicate that ore processing activities have occurred in this section of the Iron King Mine/Humboldt Smelter site prior to 1940. Remnants of ore processing activities are located in two areas of the site (Ore Processing Area-1 and Ore Processing Area-2).

Ore Processing Area-1 is located in the eastern section of the Humboldt Smelter and is situated on top of a hill, overlooking the Agua Fria River. A network of rail lines and access roads, which provides access to the area, enters the area from Humboldt. Five railroad spurs end in this area. Remnants of former ore processing operations including building foundations, probable rubble, and areas covered with light-toned material (all are not annotated) are visible at Ore Processing Area-1. Two areas containing multiple building foundations (BF\*-1, BF\*-2) and associated rubble (not annotated) are visible. Two smokestacks (SS) and two buildings are visible near building foundation BF\*-1. One stack is connected to one of the two buildings in the area. Dark-toned ground stains cover the surface along the rail line north of the buildings. A lone smokestack stands in the northeast section of the site.

West of the large dark-toned mounded material, a mound of medium-toned material has been deposited in the form of a ramp at the end of a rail spur; an empty possible impoundment is located nearby. A possible former impoundment is located near building foundation BF\*-2.

Along the rivers edge, adjacent to the northeast corner of the large mound of dark-toned material is a building foundation, likely a former pump house.

Ore Processing Area-2 includes the area atop and along a hillside overlooking the Chaparral Gulch in the western portion of the Humboldt Smelter section of the site. Multiple building foundations (BF\*-3), likely remnants of an ore processing facility, are located between the main rail line and the access road that leads into the area from East Main Street. A possible vertical tank still remains at this location. To the east an impoundment that contains standing liquid is located in a depression formed by the bed the access road and the headwaters of a drainage channel that flows into the Chaparral Gulch. Down slope to the south, toward the Chaparral Gulch, dams have been built astride drainage channels so as to form a series of tailings ponds (not annotated). All the dams are breached. Light-toned materials (tailings) have been deposited in and along the drainage channel behind the southernmost dam. Some light-toned material also appears to have been washed down the slope to the banks of the Chaparral Gulch.

channel leads down slope from the area of a rail spur to the dark-toned material. On the slope above the light-toned material is probable rubble. The arrangement of the rubble suggests that this is the location of a former processing facility.

In the center of the smelter, south of Ore Processing Area-1, is an array of buildings and building foundations that are connected to one another by a network of sidewalks (not annotated). The function of the apparently associated buildings that were located at this location cannot be ascertained from the aerial photographs. The building foundations in this area of the smelter will no longer be annotated or discussed unless significant environmental change is noted in association with them.
