# AERIAL PHOTOGRAPHIC ANALYSIS OF IRON KING MINE/HUMBOLDT SMELTER SITE Dewey-Humboldt, Arizona Volumes 1 & 2 Combined

EPA Region 9

TS-PIC-20809961S/20909961S  
December 2008

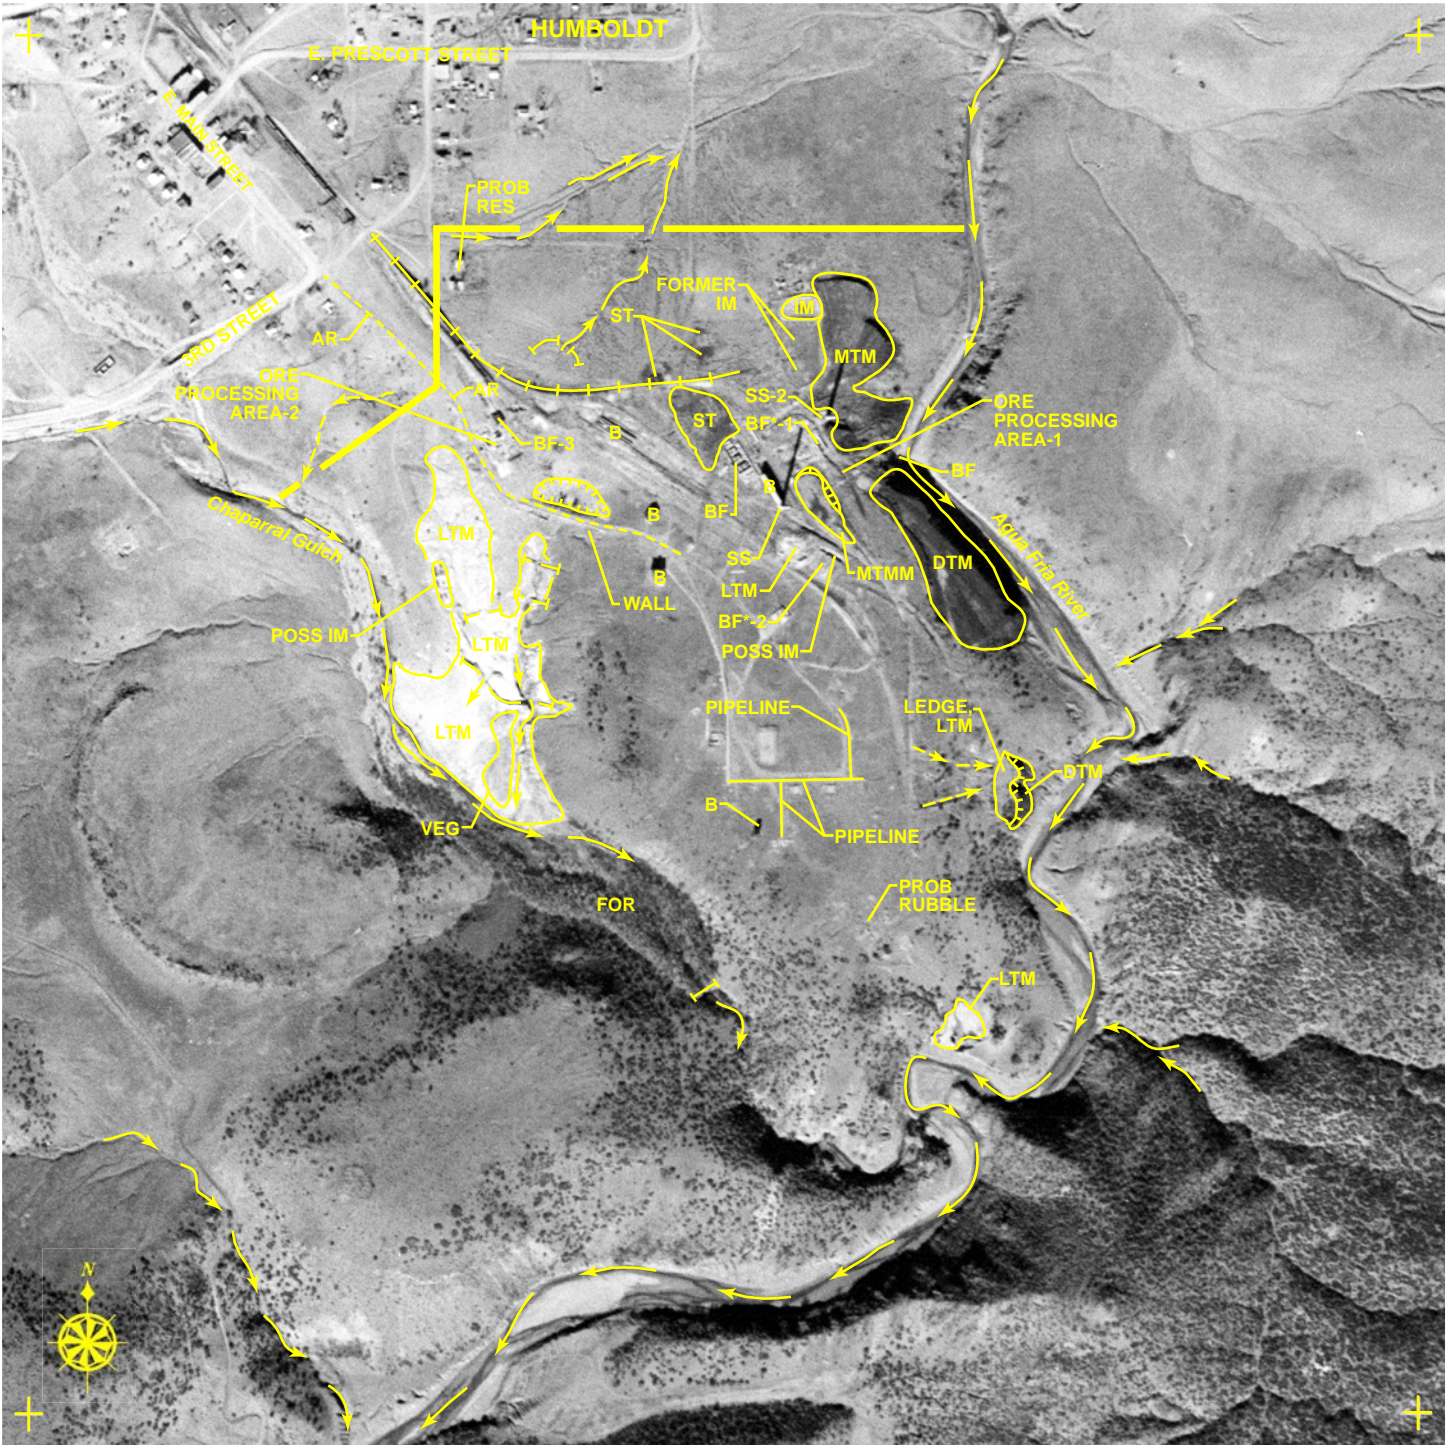
FIGURE 12. HUMBOLDT SMELTER, NOVEMBER 25, 1953. APPROX. SCALE 1:4,500.

Much of the Humboldt Smelter section of the Iron King Mine/Humboldt Smelter site is relatively unchanged since 1940. Most of the buildings and features noted in 1940 remain in place.

Much of the area on and around Ore Processing Area-1 is relatively unchanged since 1940. Each of the two smokestacks remains in place and the mounds of dark- and medium-toned material, located along the Agua Fria River, are relatively unchanged. A building, located north of one of the smokestacks in 1940, has been partially removed and a building foundation is all that remains at the location. Of the three impoundments noted in 1940 west of the medium-toned mound material only the northernmost impoundment appears to be in use. The berms surrounding this impoundment have been improved. Some building foundations and rubble have been removed from the areas around building foundations BF\*-1 and BF\*-2.

Much of the area on and around Ore Processing Area-2 is relatively unchanged since 1940. The possible vertical tank noted in 1940, however, is no longer in place. The areal extent of the light-toned material that covers the hill side above the Chaparral Gulch has increased. One continuous area of light-toned material now extends down to the Chaparral Gulch. More dams have been placed in the drainage channel leading down to the gulch. All the dams appear to have been breached. Since 1940 three possible contiguous impoundments, which are no longer in use, have been built on the up slope western edge of the light-toned material. A dirt access road (not annotated), which does not appear to have been heavily used recently, leads to the area from the north.

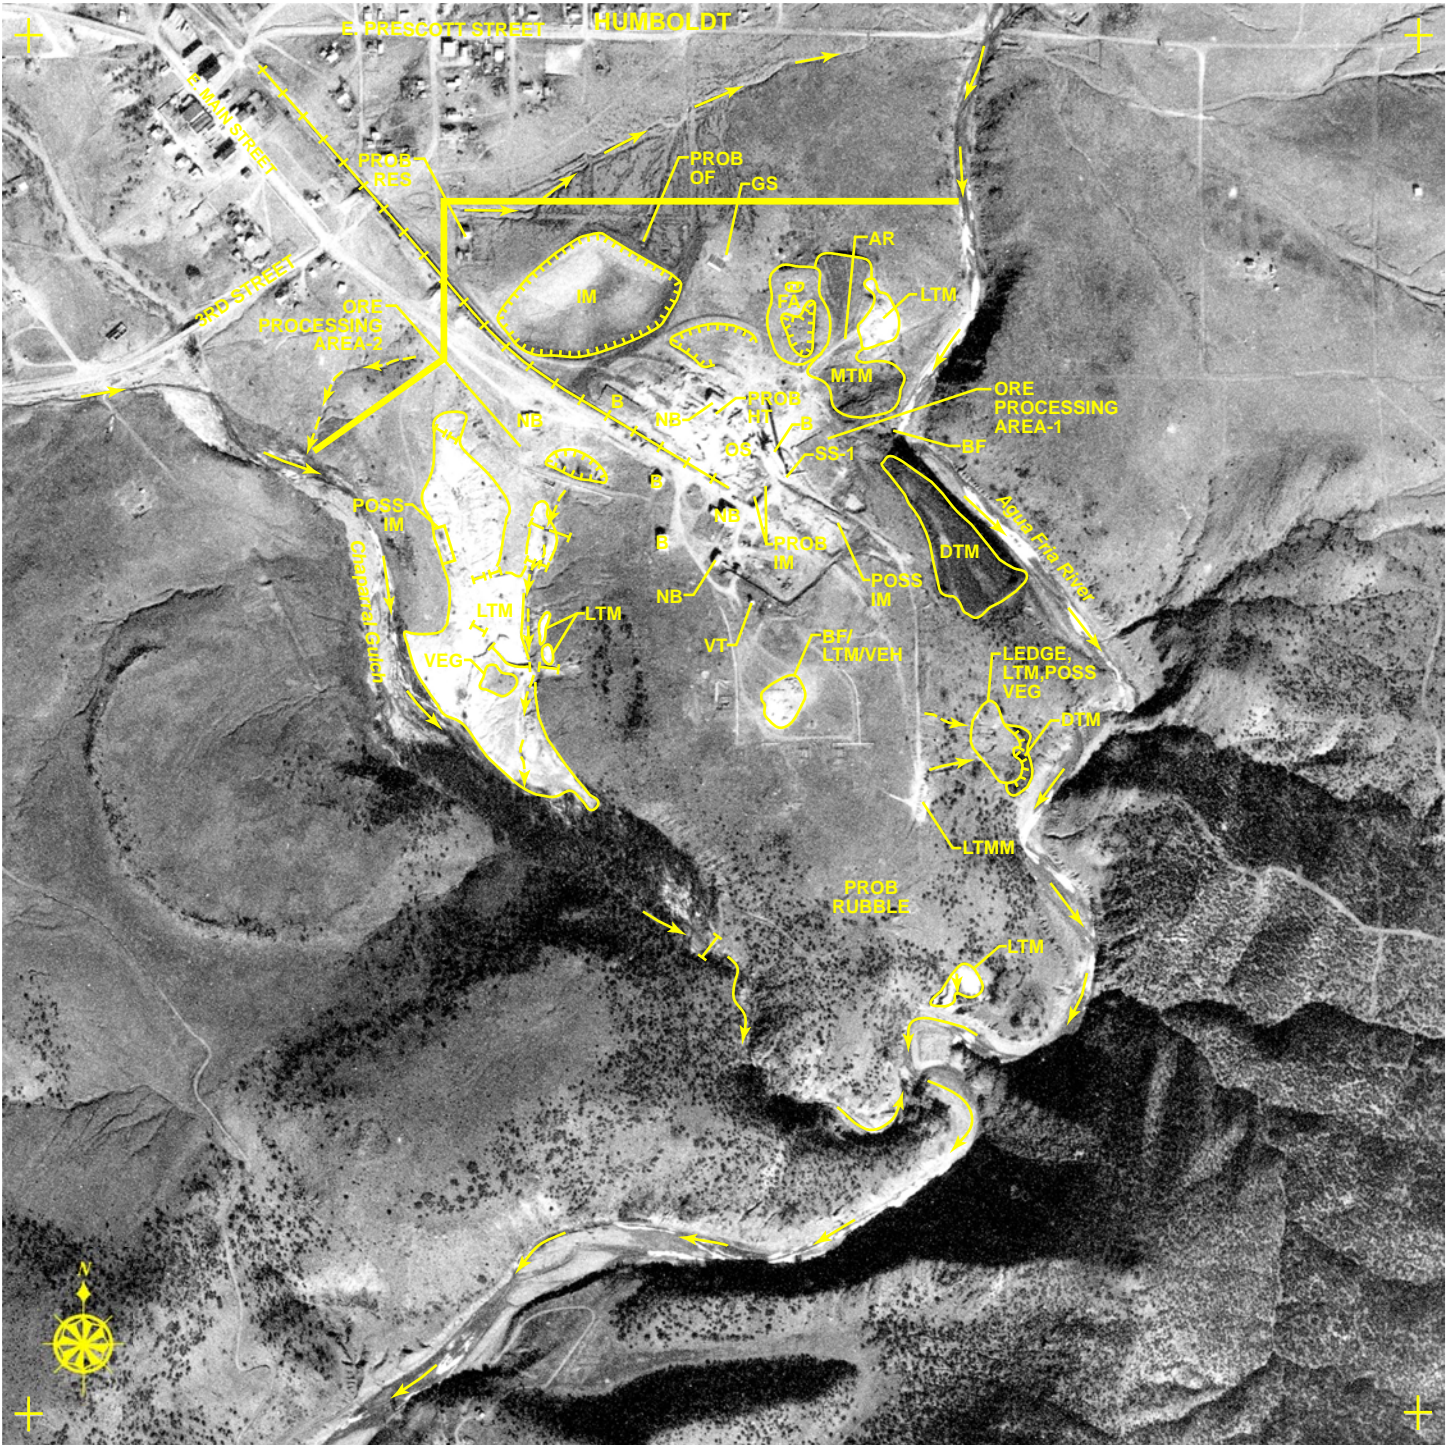
FIGURE 13. HUMBOLDT SMELTER, JANUARY 15, 1964. APPROX. SCALE 1:4,500.

Ore processing is ongoing at Ore Processing Area-1 in the northern section of the smelter. Ore processing activity in the area appears to be centered on smokestack SS-1. Light-toned material has been spread over the surface of the area around the stack. Three new buildings, a probable horizontal tank, two probable impoundments, and an open storage area containing probable equipment and probable crates are now in this area. Open hopper railcars (not annotated) are on the rail lines in the area. A large impoundment has been excavated and formed in a drainage channel in the northwest corner of the smelter. The impoundment is empty and a probable outfall is located on the north side of the impoundment. Light-toned material has been deposited on top of the mound of medium-toned material located east of the Agua Fria River. An access road, likely used for hauling waste material to the location, leads from the ore processing area west to the top of the mound. The impoundment, noted in 1953 west of the medium-toned mounded material, has been partially covered over with fill material. Smokestack SS-2, noted in place in this area since 1940, has been removed.

Little observable environmentally significant change has occurred on or around Ore Processing Area-2 since 1953. The dams located in the wash leading down to the Chaparral Gulch in this area of the smelter will no longer be annotated or discussed unless significant environmental changes is noted in association with them.

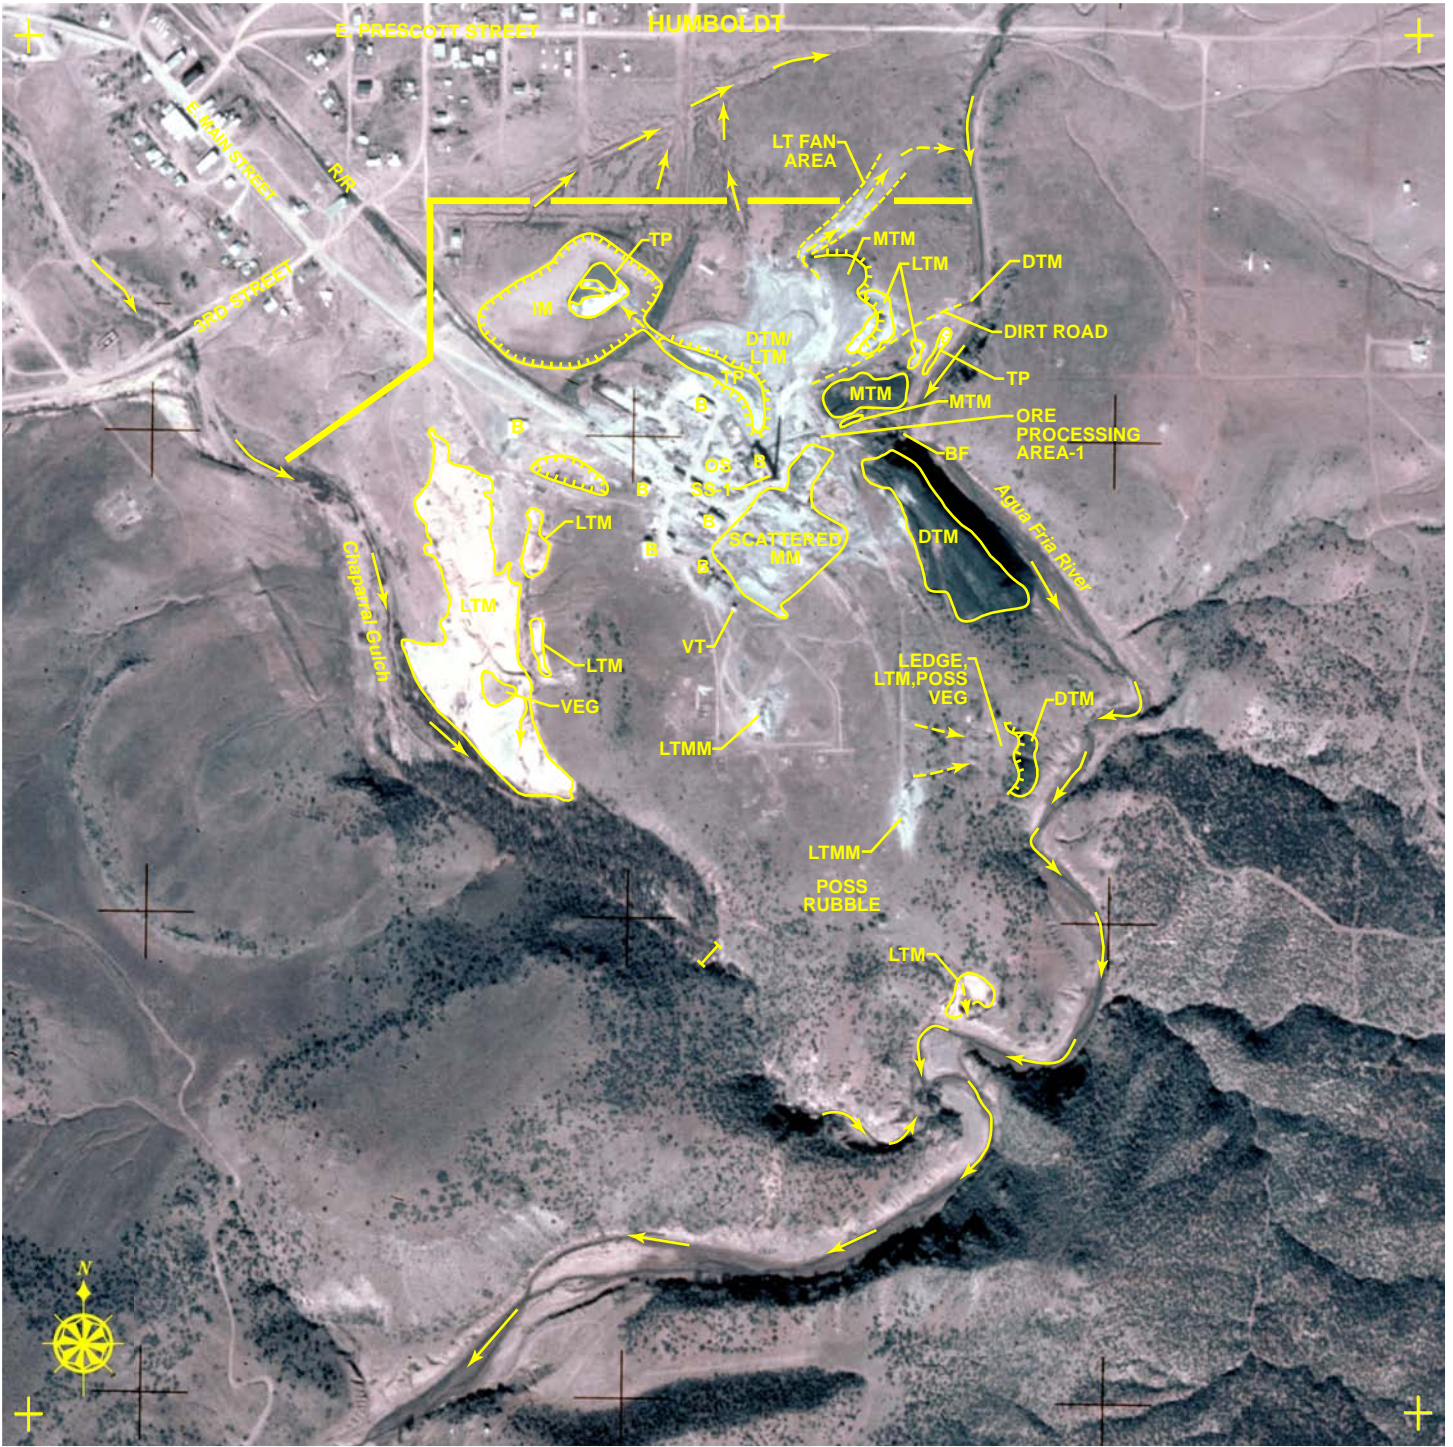
FIGURE 14. HUMBOLDT SMELTER, FEBRUARY 6, 1970. APPROX. SCALE 1:4,500.

Since 1964 ore processing in northern section of the smelter has continued. A linear-shaped tailings pond has been constructed and is in use northwest of smokestack SS-1. The pond appears to be designed to direct the flow of liquid into another tailings pond located in the large impoundment first noted in 1964 in the northwest section of the smelter. The drainage channel connecting the two tailings ponds appears to be blocked at this time. Dark- and light-toned liquid/sludge (not annotated) is in each of the tailings ponds. Light-toned material and dark-toned material has been deposited across the surface of the area east of the two ponds and also on the large mound of medium-toned material located nearby. The area near the northeast corner of the smelter slopes to the northeast and it appears that material has flowed northward toward the Agua Fria River. A dirt road extends down the hill from the area around smokestack SS-1 to the Agua Fria River. The road ends near a tailings pond that has been constructed along the banks of the river. Light-toned material is visible in the pond (not annotated) and on the hillside above the pond. Since 1964 scattered mounds of light-toned and dark-toned material have been deposited in the area south of smokestack SS-1. The probable horizontal tank and two probable impoundments located near smokestack SS-1 are no longer visible.

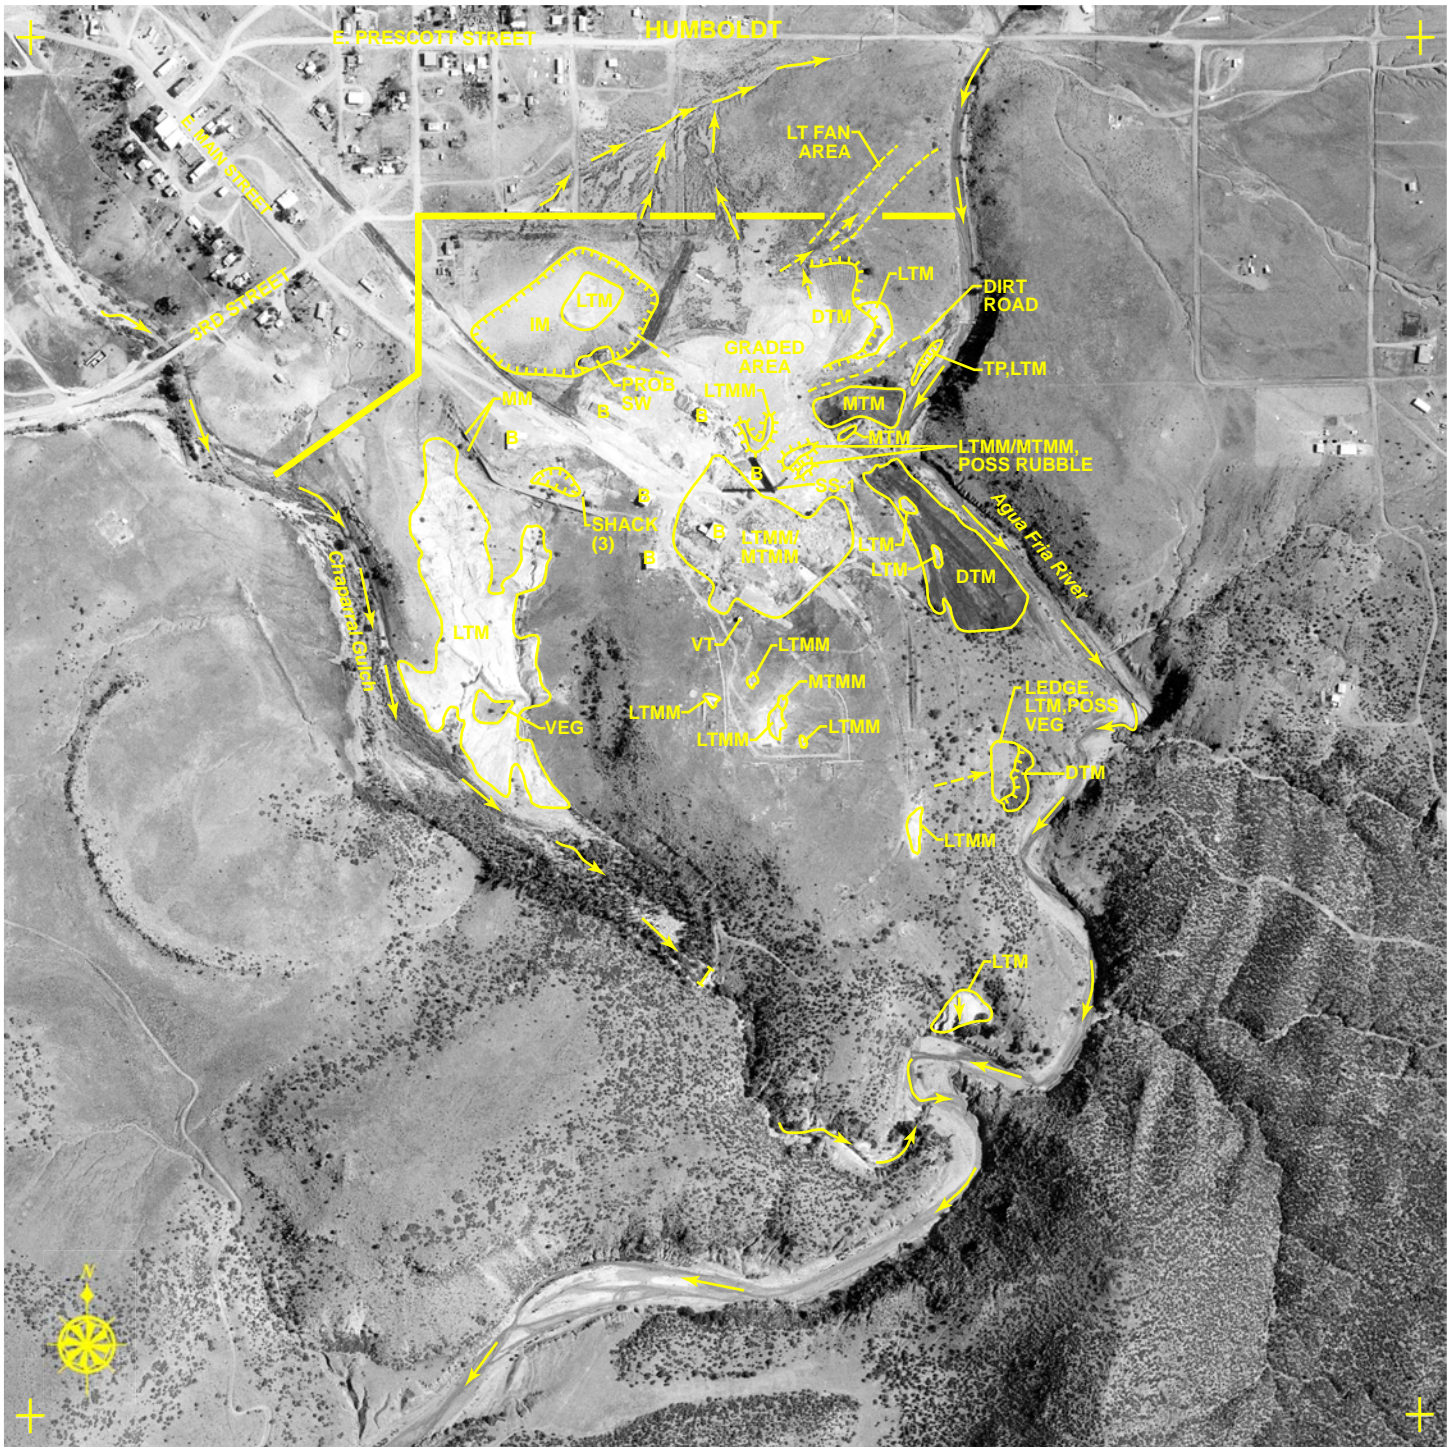
**FIGURE 15. HUMBOLDT SMELTER, JUNE 27, 1973. APPROX. SCALE 1:4,500.**

Ore Processing Area-1 no longer appears to be in operation. The two tailings ponds located in the north section of the smelter in 1970 are no longer in use. The large impoundment, that contained a tailings pond in 1970, is dry and light-toned material covers part of the bottom of the impoundment. Probable solid waste has been deposited along the southern edge of the large impoundment. The linear tailings pond, situated north of smokestack SS-1 in 1970, has been demolished. The ground surface at the location of the former tailings pond and around the area north of smokestack SS-1 has been graded and light-toned fine-grained material appears to have been spread across the surface. Scattered mounds of light-toned and dark-toned material remain in place in the area south of smokestack SS-1 and mounds of light-toned material have been deposited just north of the smokestack. The tailings pond, located along the banks of the Agua Fria River, does not appear to contain liquid and light-toned material lines the bottom of the pond.

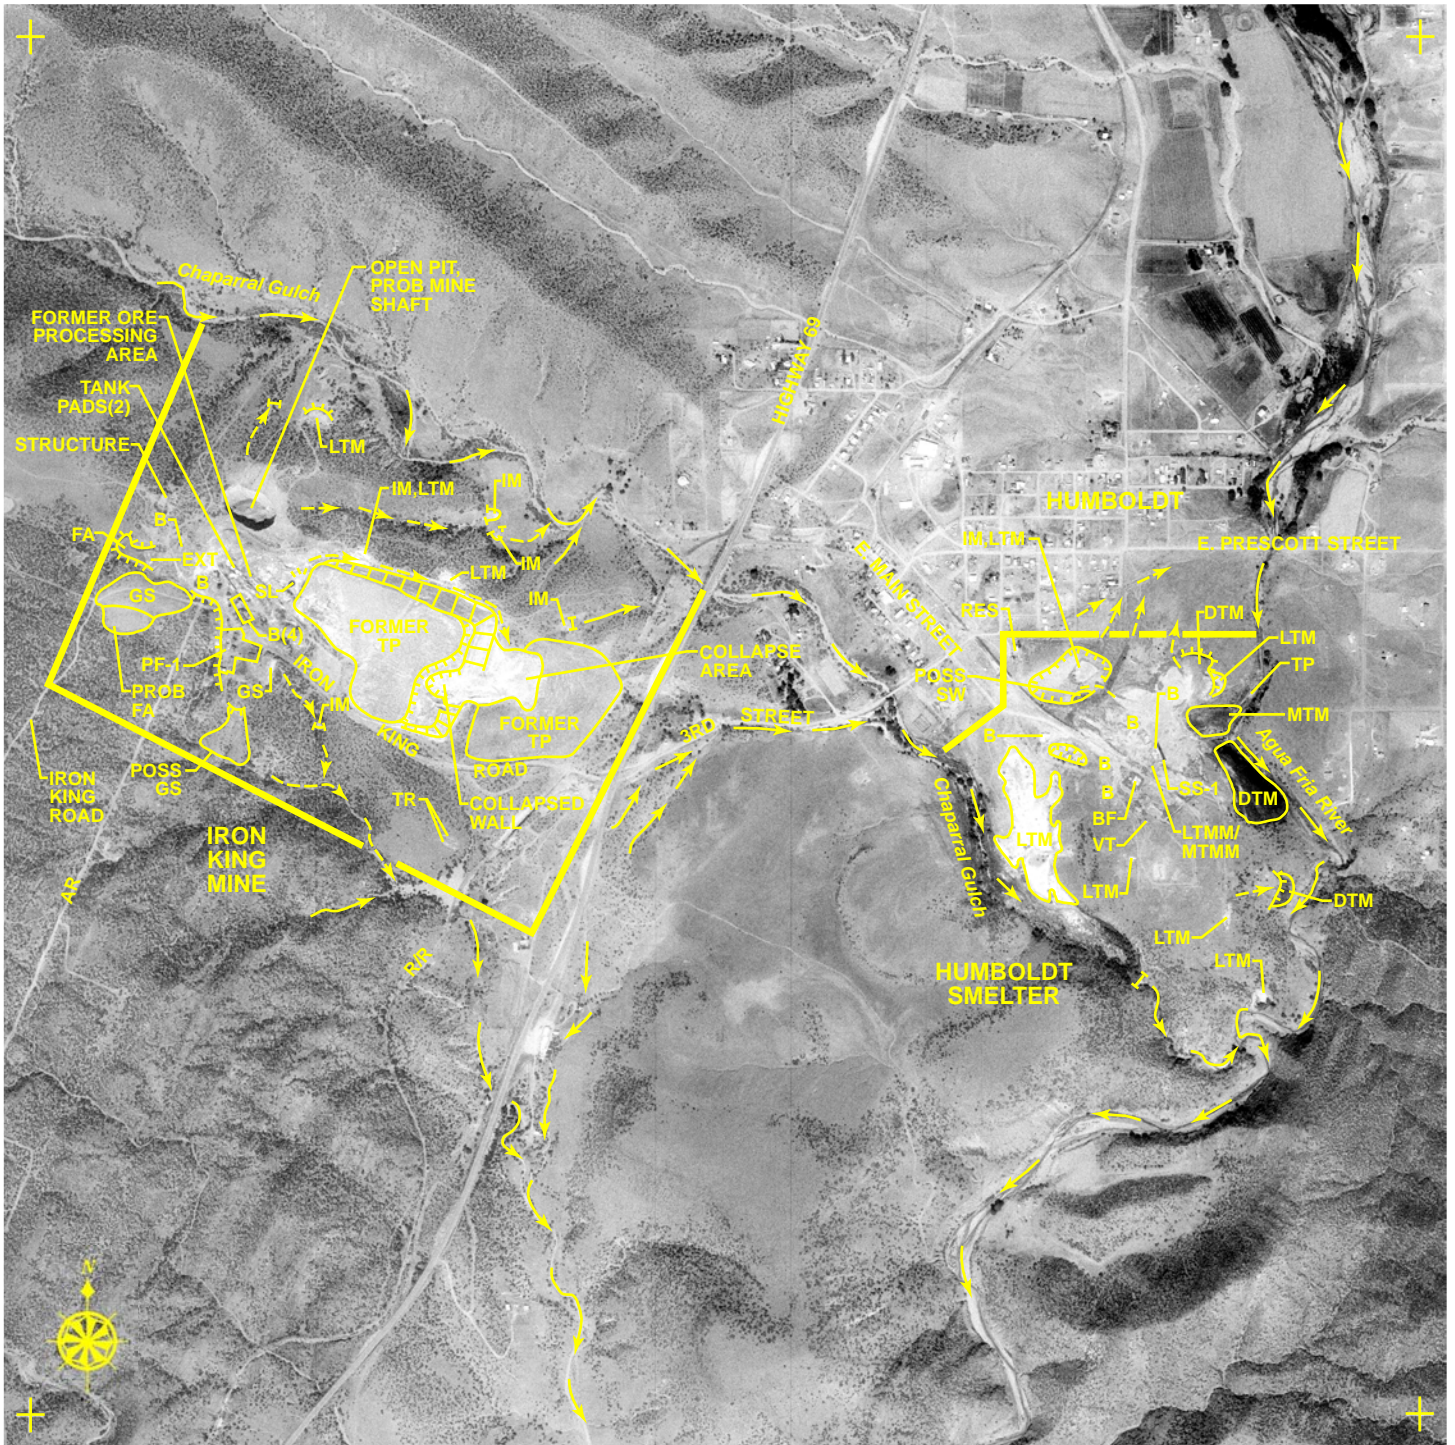
**FIGURE 16. IRON KING MINE/HUMBOLDT SMELTER SITE, SEPTEMBER 25, 1980. APPROX. SCALE 1:9,800.**

Little observable environmentally significant change has occurred on the smelter since 1973. A building in the center of the smelter, southwest of smokestack SS-1, has been removed and a building foundation is visible at the location. The tailings pond, located along the banks of the Agua Fria River, is no longer in use. The large impoundment in the north section of the smelter is empty. A dirt road crosses the southern berm and provides access to the bottom of the impoundment. The probable solid waste, located on the southern berm of the impoundment, does not appear to have changed.

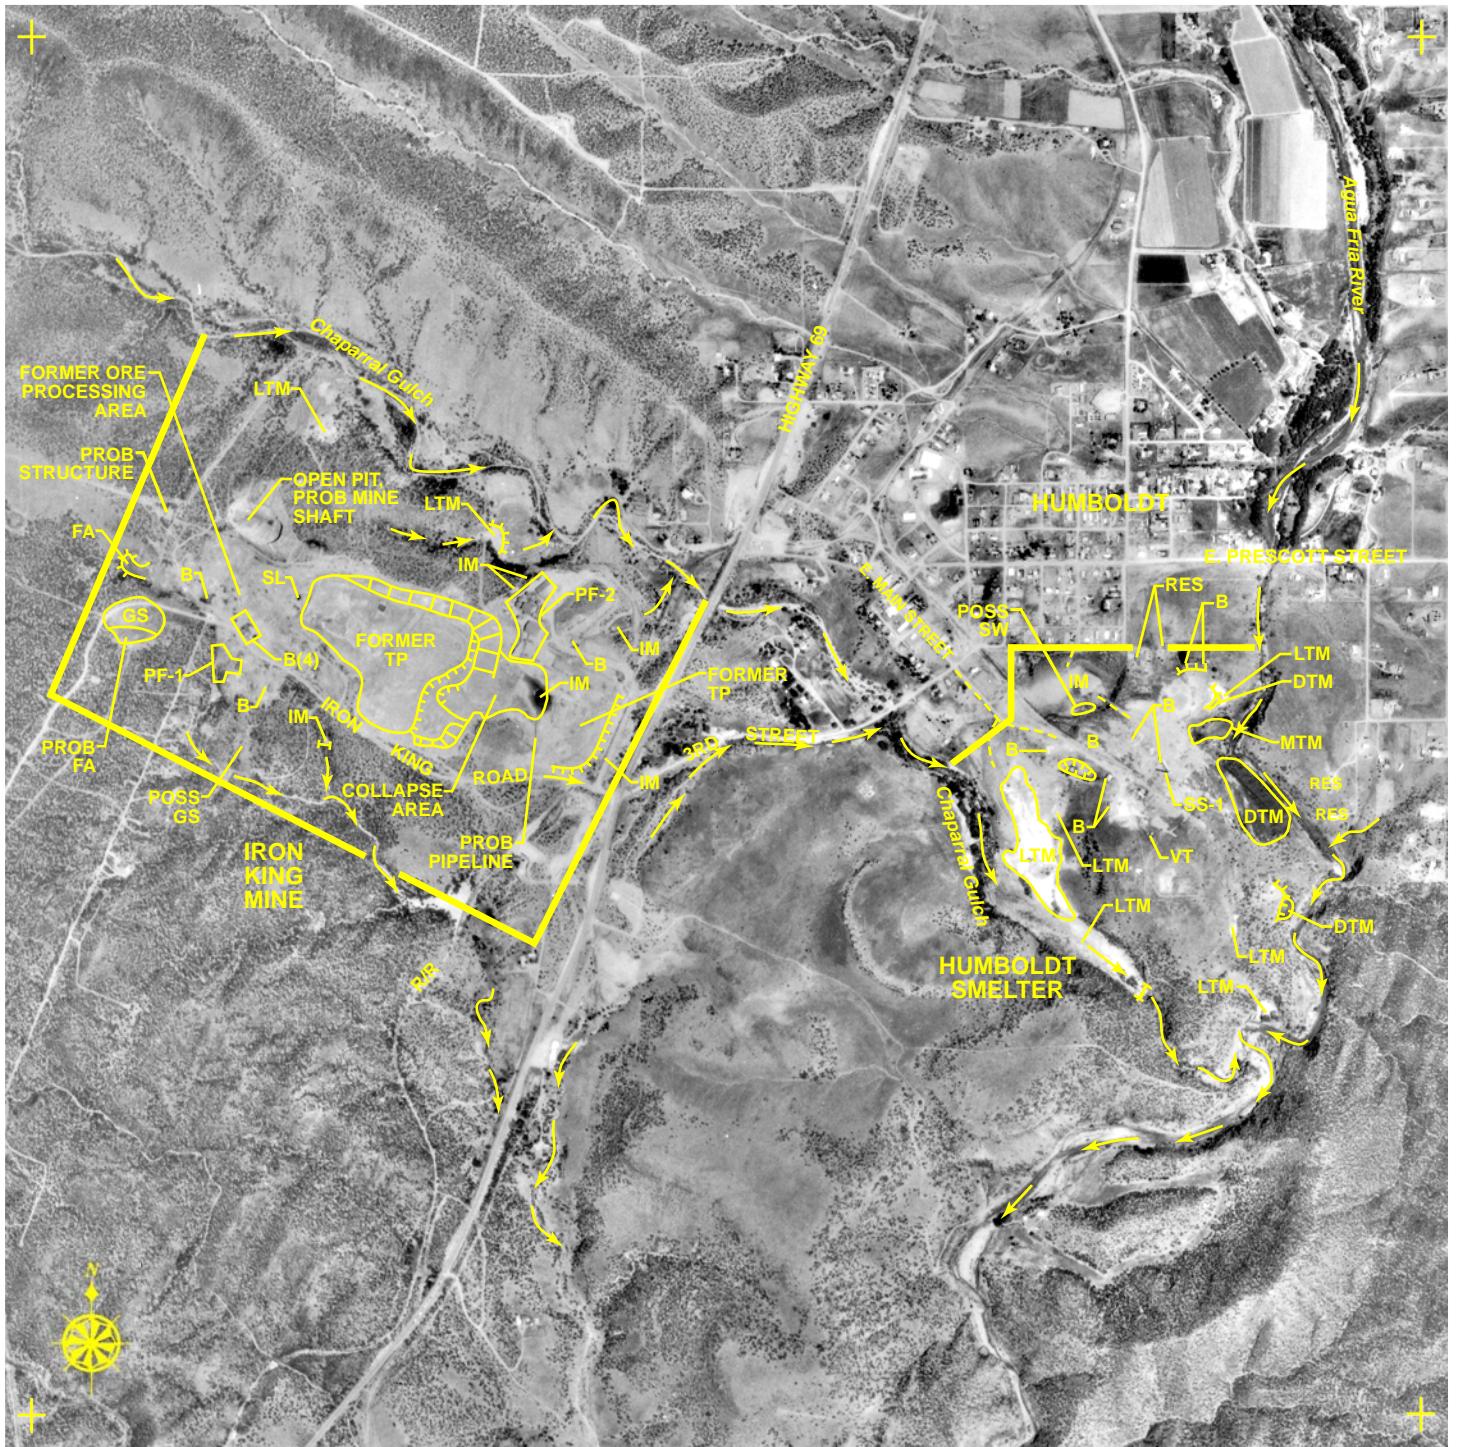
FIGURE 17. IRON KING MINE/HUMBOLDT SMELTER SITE, JUNE 5, 1992. APPROX. SCALE 1:9,800.

Little observable environmentally significant change has occurred on the smelter since 1980. Most of the scattered mounds of light-toned and dark-toned material, in place south of smokestack SS-1 in 1973 and 1980, are no longer visible. Three mounds of medium-toned material (not annotated) have been deposited on the probable solid waste located on the southern berm of the large impoundment. A new dirt road crosses the northern berm of the large impoundment.

Third Street now extends across the northern boundary of the smelter and provides access to the large impoundment. New residences and two out buildings have been built off the site, east of East 3rd Street, along the northern edge of the smelter.

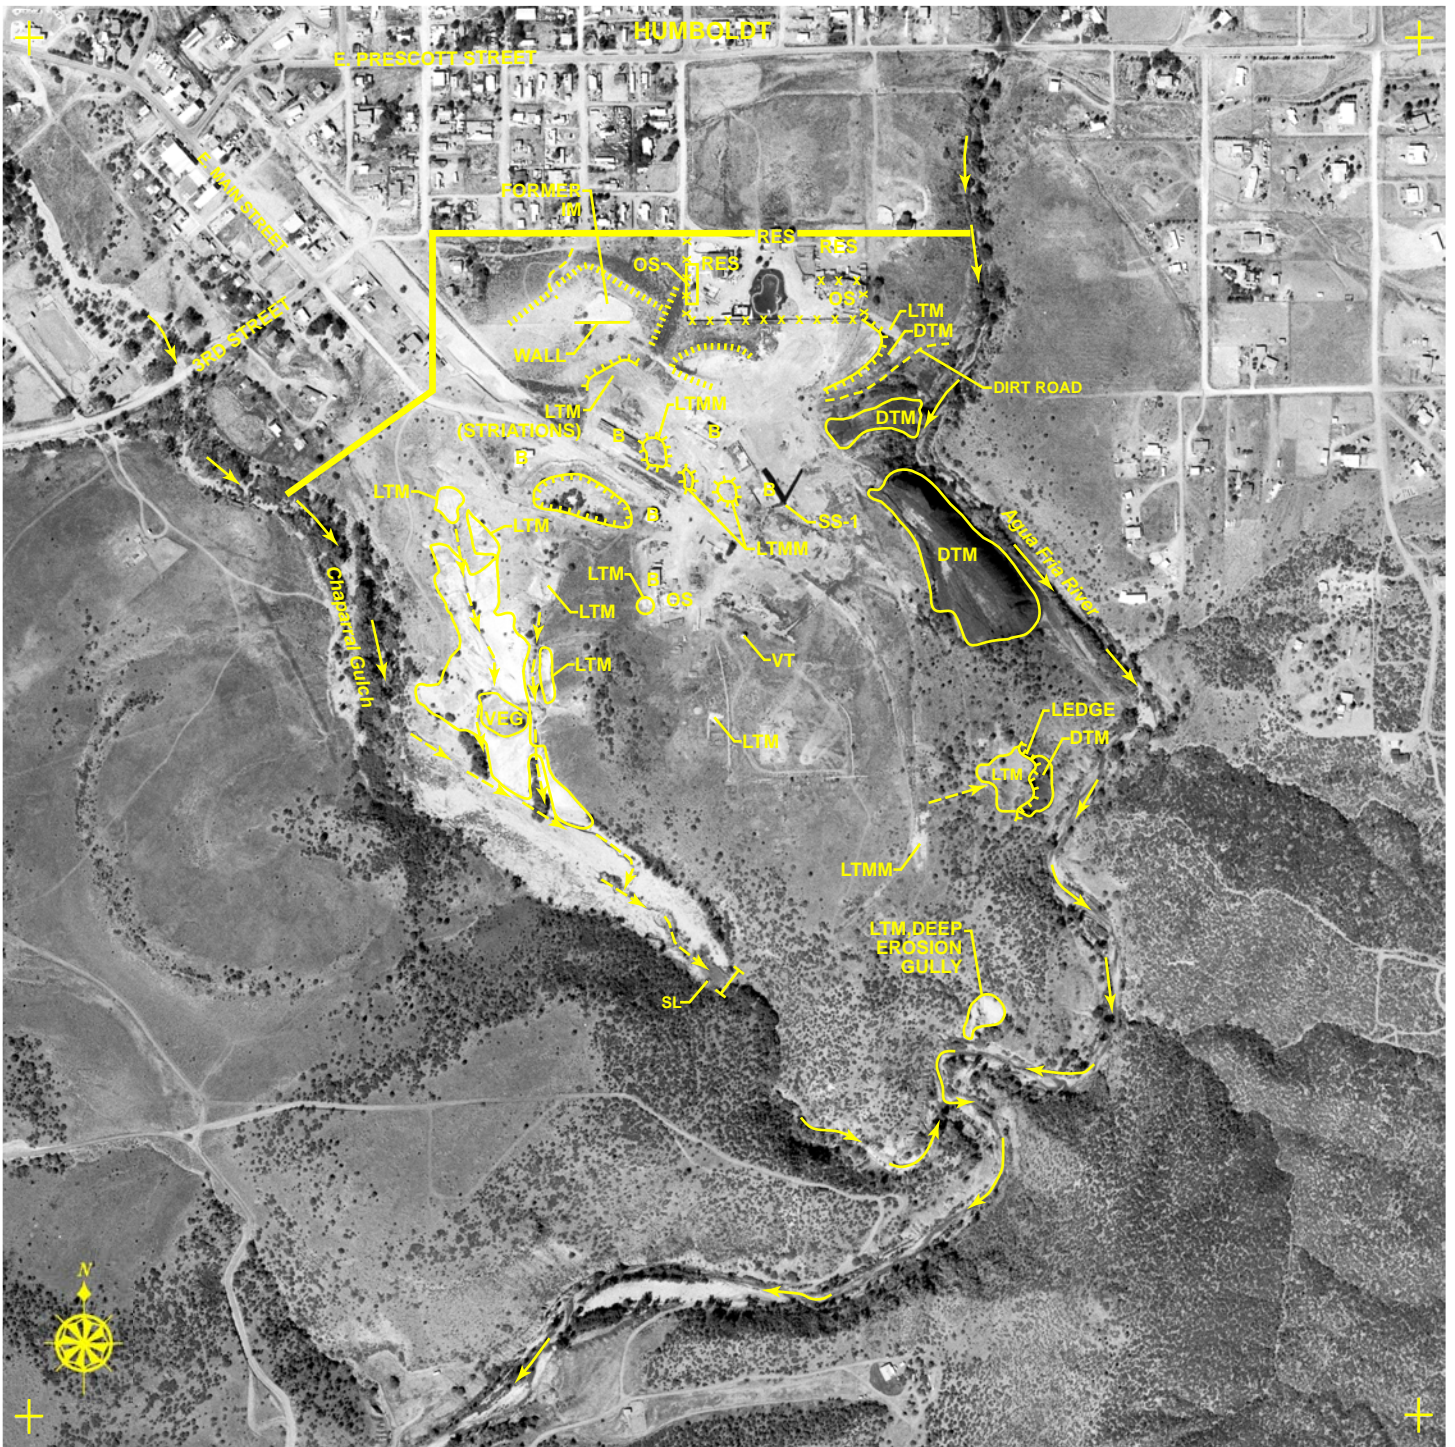
FIGURE 18. HUMBOLDT SMELTER, SEPTEMBER 20, 2003. APPROX. SCALE 1:4,500.

Little observable environmentally significant change has occurred on the smelter since 1992. The tailings pond, located along the banks of the Agua Fria River, is no longer visible. Vegetation obscures the area. An open storage area housing crates and containers is located in the center of the smelter. Light-toned material has been spread across both the southern berm of the large impoundment and across the area where probable solid was visible in the past on the southern berm of the large impoundment. A wall has been built across the bottom of the impoundment and a dirt access road crosses the northern berm of the impoundment.

There are now three residences along the northeast border of the smelter. A fence separates the residences from the smelter. Nearby an open storage area (crates and containers) has been placed on the dark-toned mounded material that had been in place at the location since at least 1940.
