**Field Report and Preliminary Results**  
**X-Ray Fluorescence (XRF) Soil Sampling April 17-19, 2012**  
**Iron King – Humboldt Smelter Superfund Site, Humboldt, Arizona**

By Jeff Dhont, Remedial Project Manager

April 25, 2012

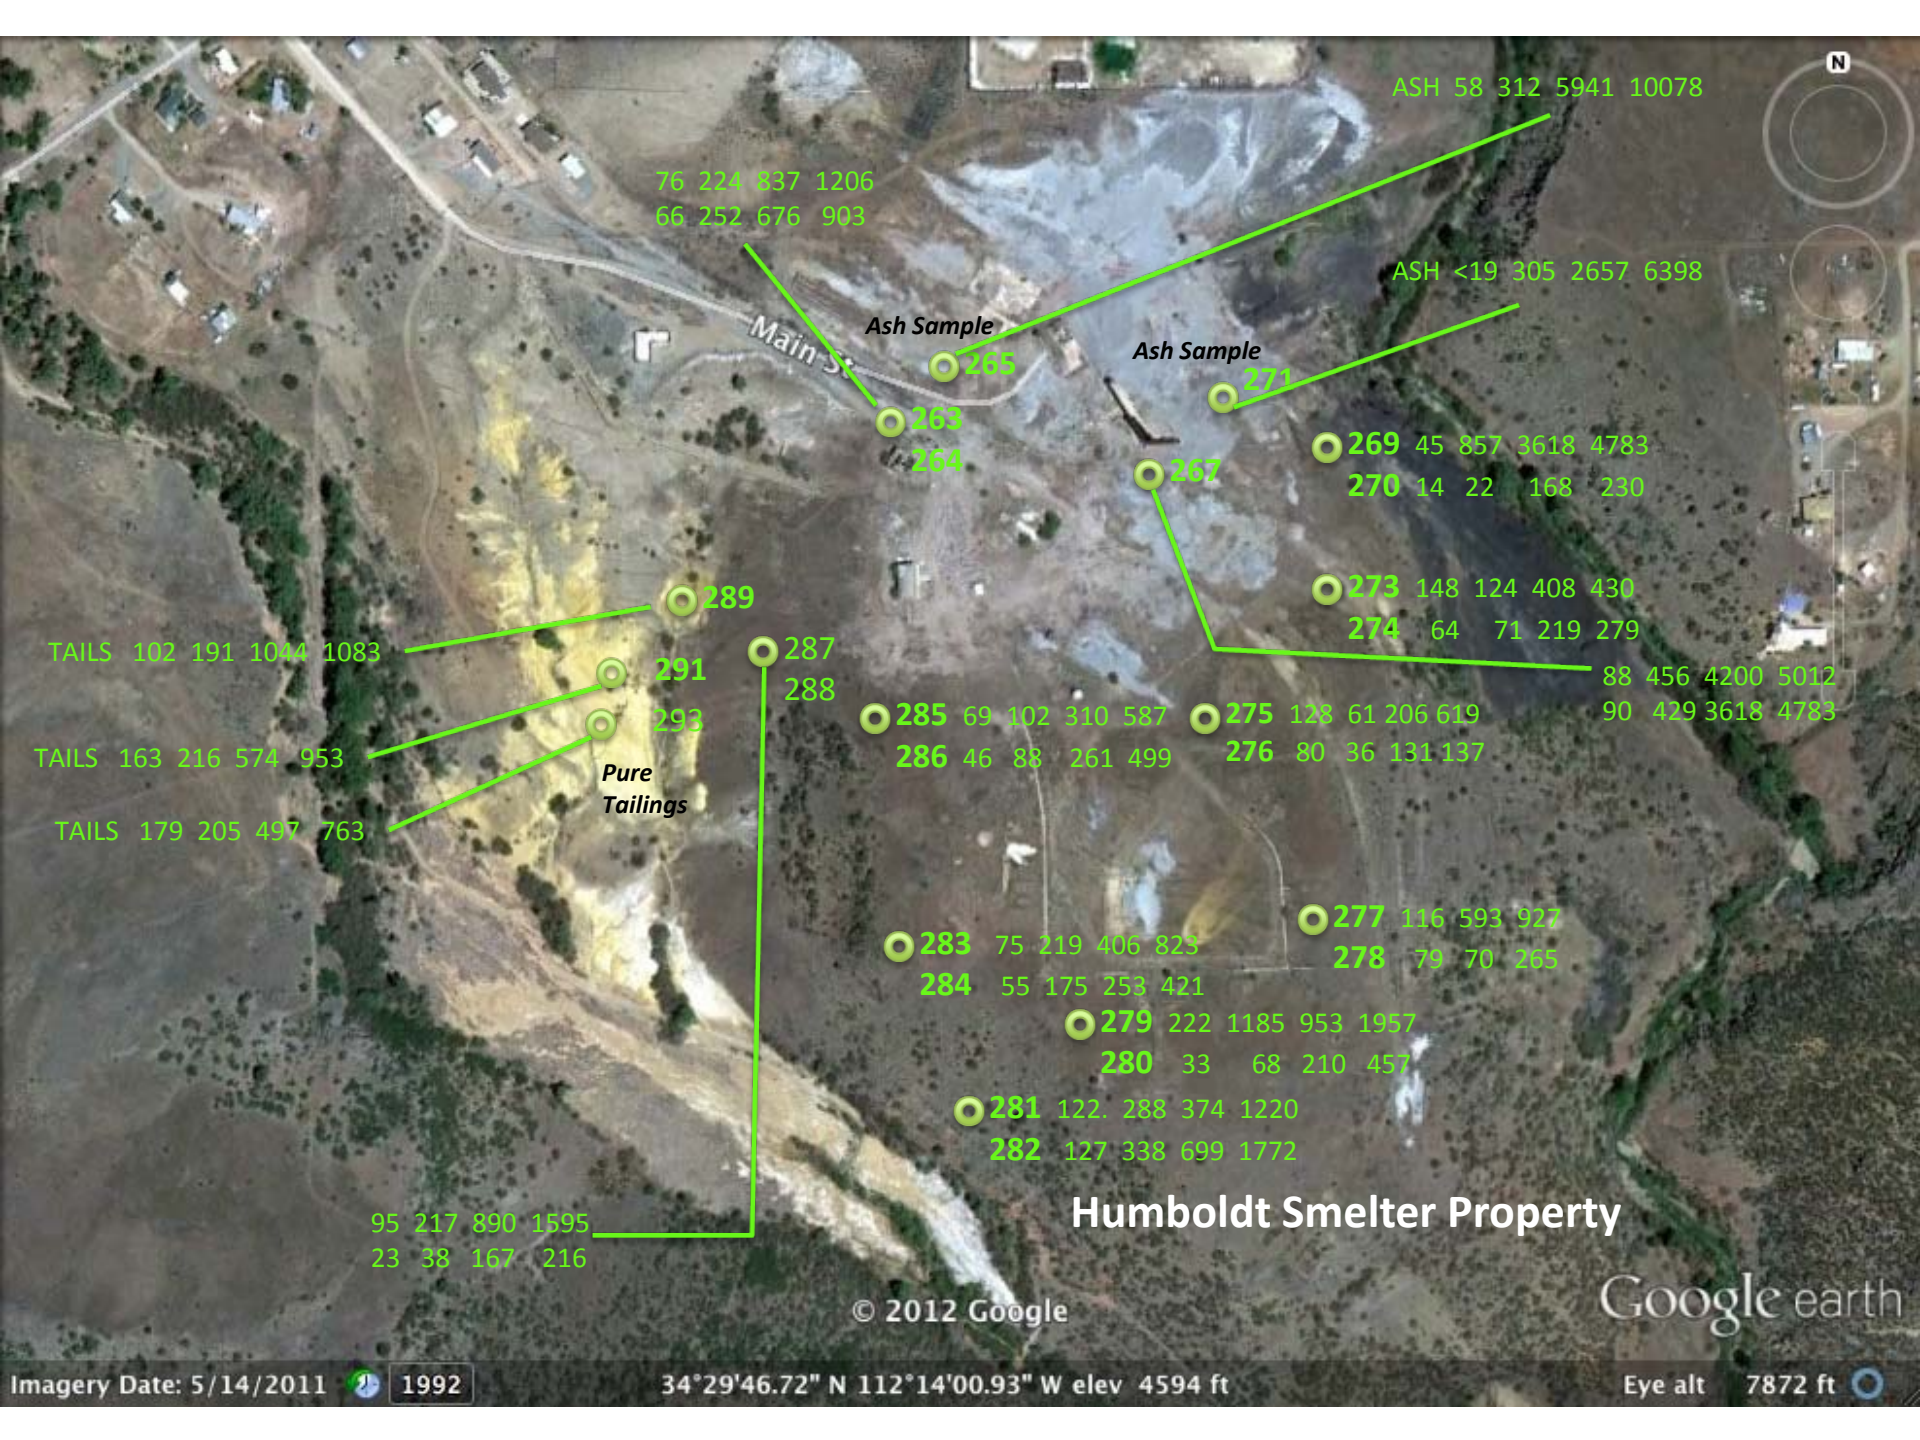
### Humboldt Smelter Property

ASH 58 312 5941 10078

ASH <19 305 2657 6398

Ash Sample  
265

Ash Sample  
271

TAILS 102 191 1044 1083

Pure  
Tailings

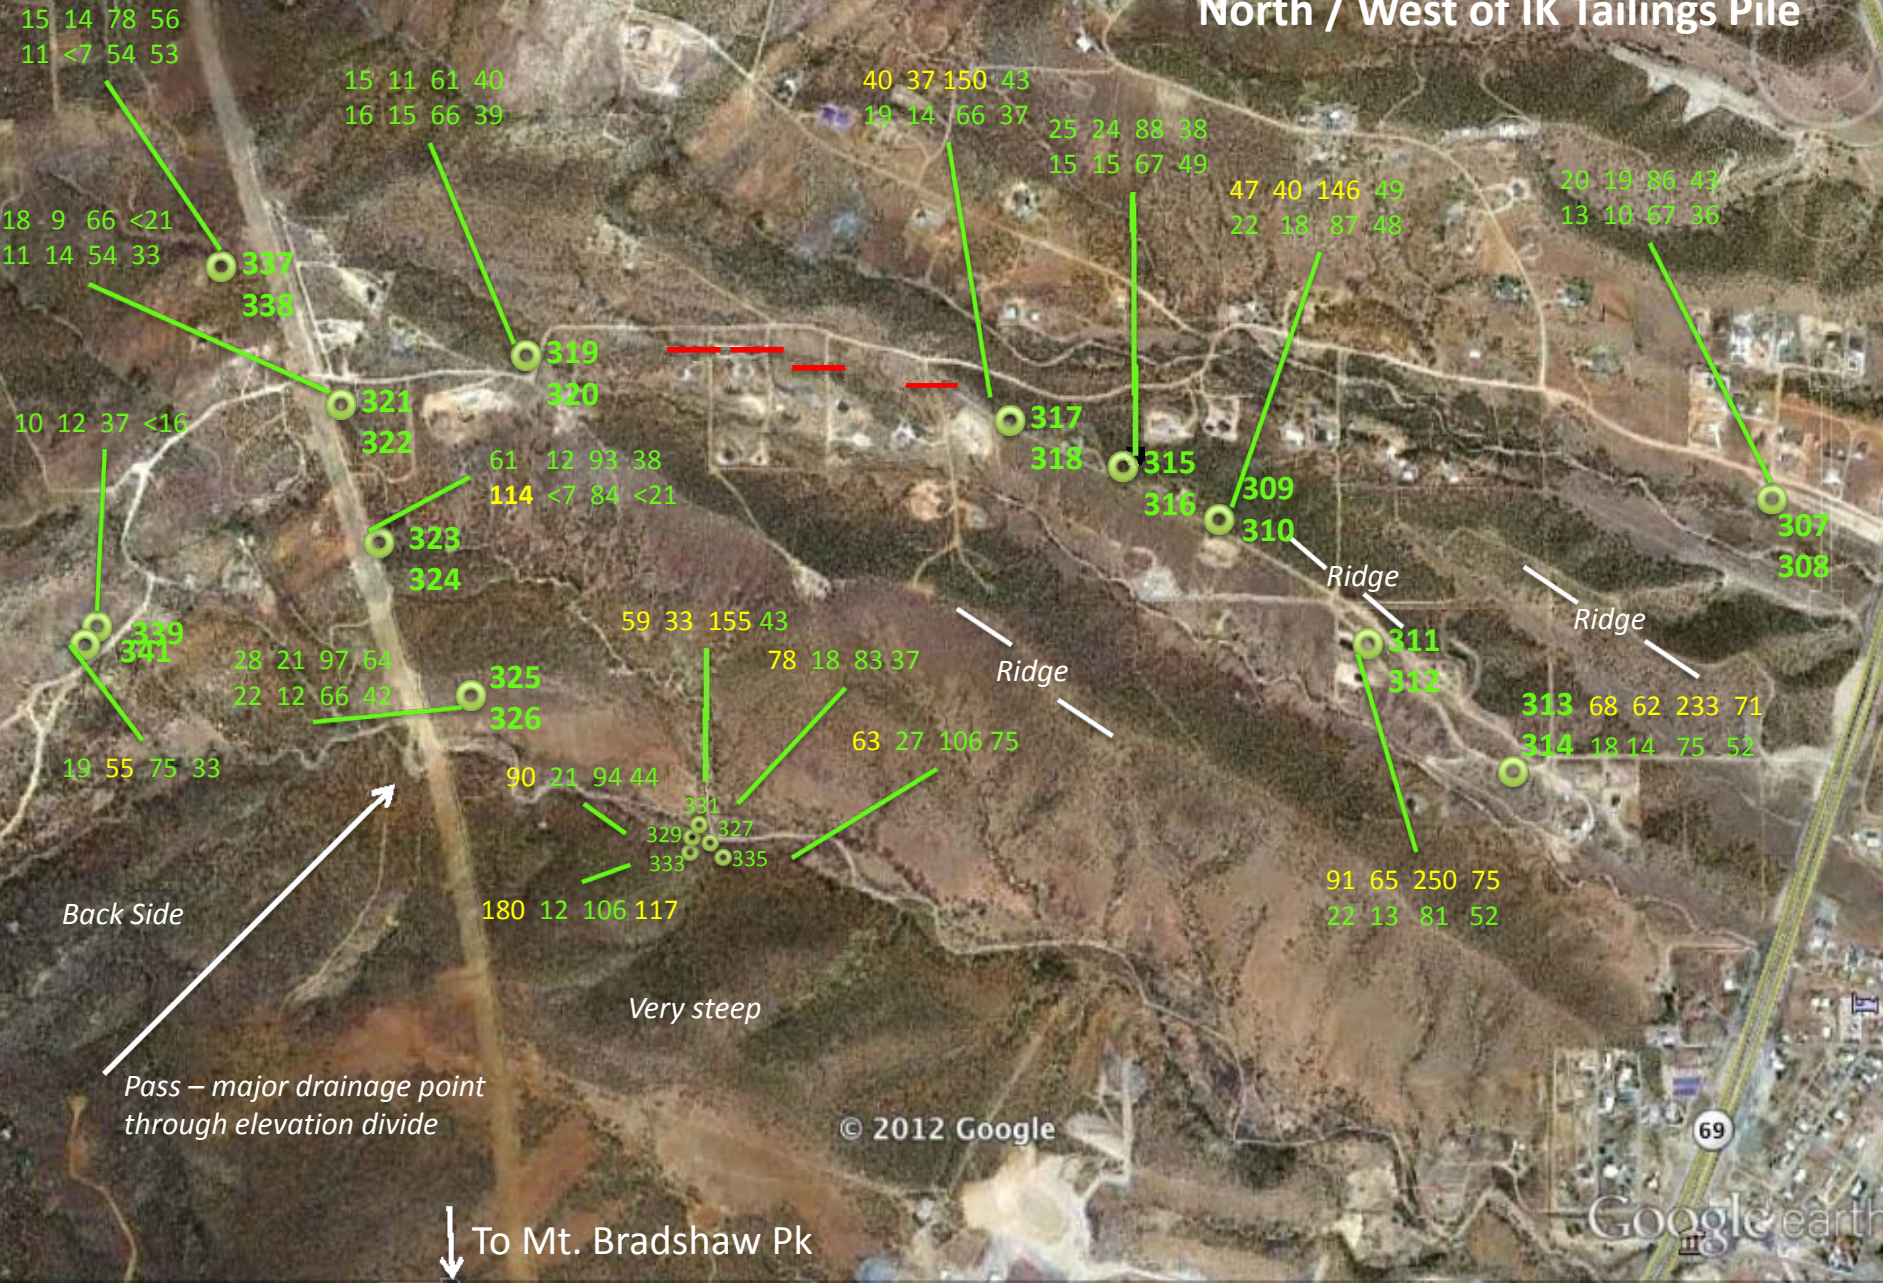
# North / West of IK Tailings Pile

313 68 62 233 71  
314 18 14 75 52
