Subject: Iron King Mine-Humboldt Smelter Site

Interim Removal Action Report

Dewey-Humboldt, Yavapai County, Arizona

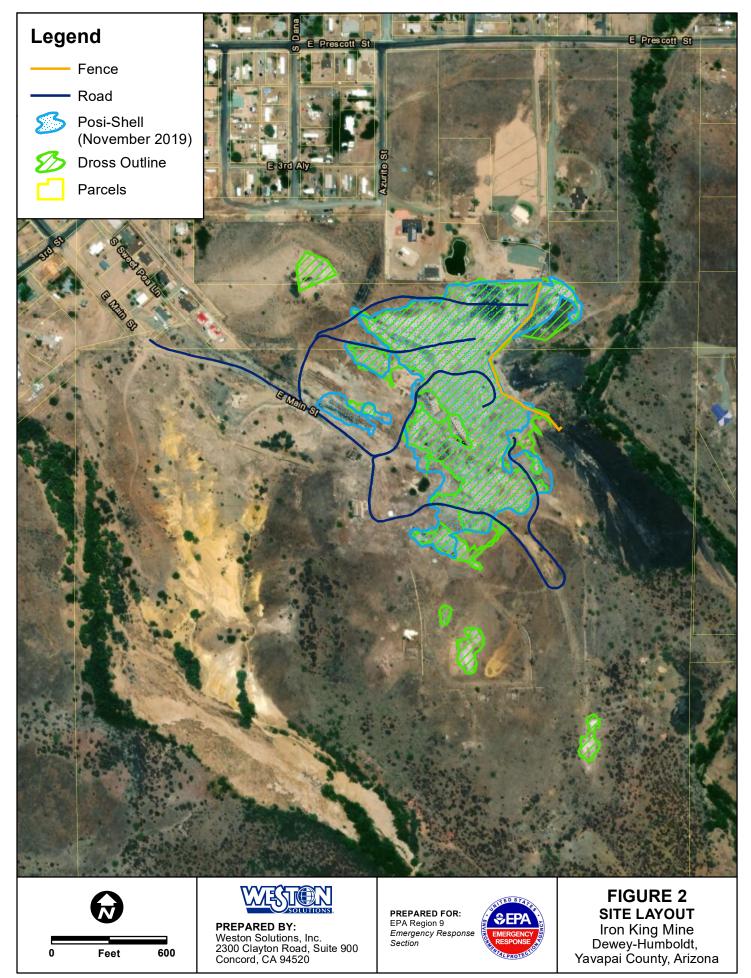
On November 3, 2019, the EPA and Emergency and Rapid Response Services contractor (ERRS) mobilized to the Site to begin preparation work for the application of the dust and erosion control agent (Posi-Shell®) and for the construction of fencing. ERRS refurbished and installed several roads throughout the Smelter area to provide better access for the Posi-Shell[®] application throughout the dross-covered areas of the site. Fencing was installed along the northeast portion of the site on top of the slag pile. The fencing was installed to limit access to the site, to prevent exposure to and migration of site contaminants. START mobilized on November 11, 2019 to document site conditions, the area of the Site covered by dross, the location of the road and fence installation, and to oversee Site activities. On November 13, 2019, Posi-Shell® application covering dross material began in the northeastern portion of the site. The Posi-Shell® material is a mixture of clay binders, reinforcing fibers, polymers, cement, and water, which is applied in a spray-like manner and forms a thin layer of stucco that adheres to the surface and prevents erosion. An approximate 10,000-square foot area of dross material was covered by the Posi-Shell[®] during this application. On November 15, 2019, after completion of fence installation and road refurbishing and construction in preparation for future Posi-Shell® application, EPA, START, and ERRS demobilized from the Site. A Site Layout of these initial actions are presented in Figure 2.

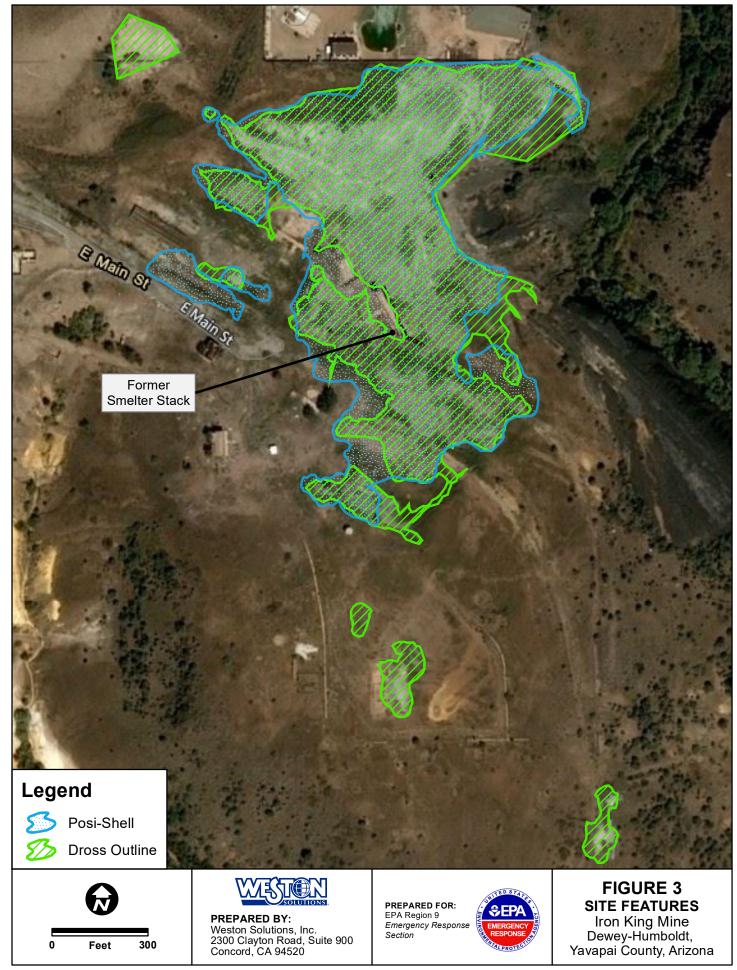
from the Site, having completed all activities for this interim removal action. The areas of the Site covered by dross material and the Posi-Shell® application areas are presented in Figure 3.

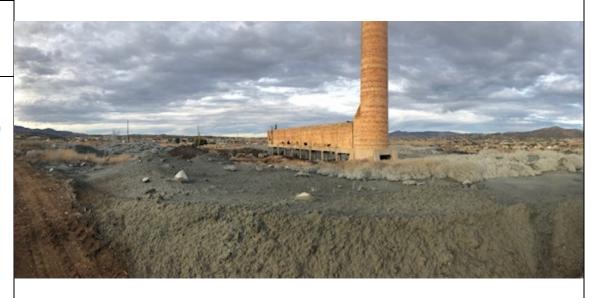
Photo No.1 12/6/19

Overview of southeastern portion of the Site with Posi-Shell®-covered dross.

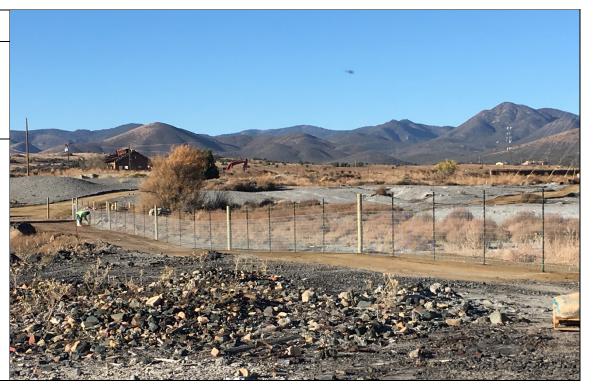
Photo No. 2

View of newly constructed roads and fencing.

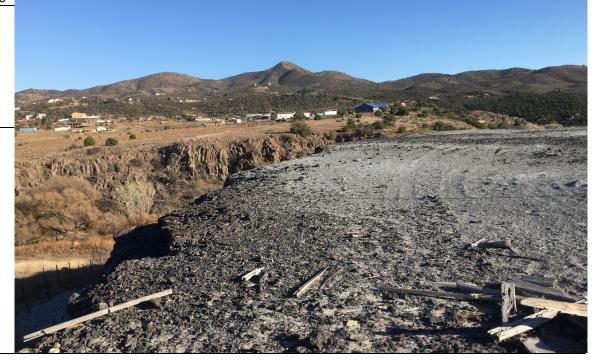
Photo No. 3 **Date:** 11/12/2019

Overview of slag pile and dross prior to Posi-Shell® application in northeast portion of the Site.

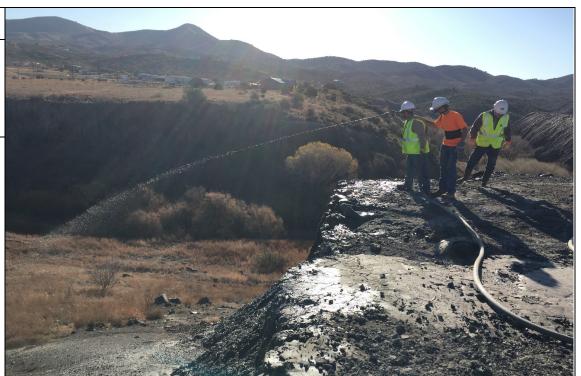
Photo Date: 11/13/19
Direction Photo
Taken:

View of Posi-Shell® application in the northeast portion of the Site.

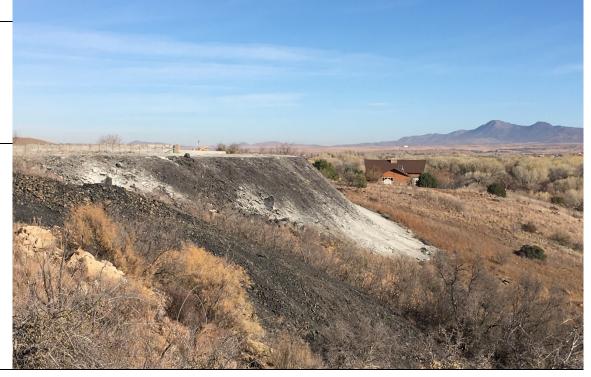
Photo 11/14/19 No. 5

View of slag pile and dross areas the northeast portion of the Site after Posi-Shell® application.

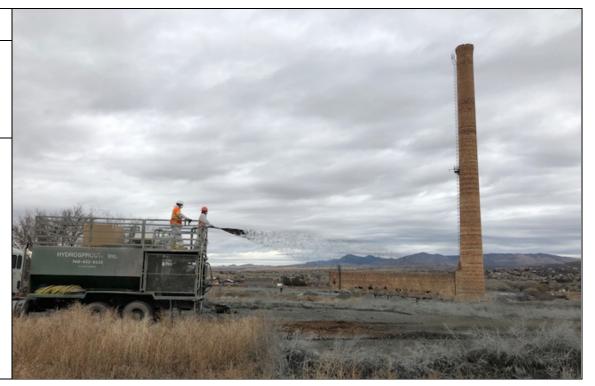
Photo Date: No. 6 12/7/19 **Direction Photo** Taken:

View of former smelter stack and Posi-Shell® application over dross-covered areas.

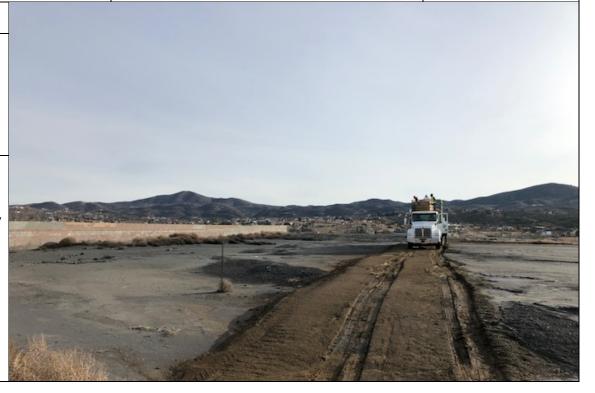
Photo Date: 12/3/19

Posi-Shell® application in the northeast portion of the Site, utilizing the newly constructed road.

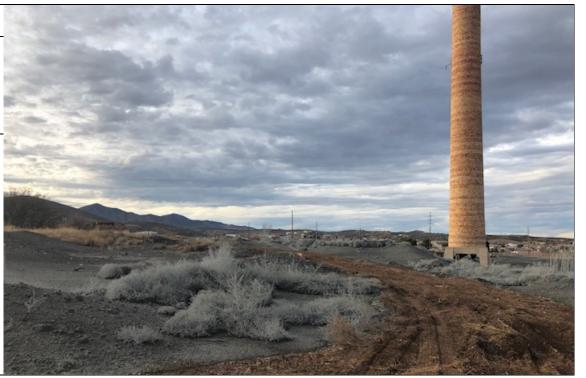
Photo No. 8 **Date:** 12/6/19

View of dross covered with Posi-Shell® in the southeastern portion of the Site.

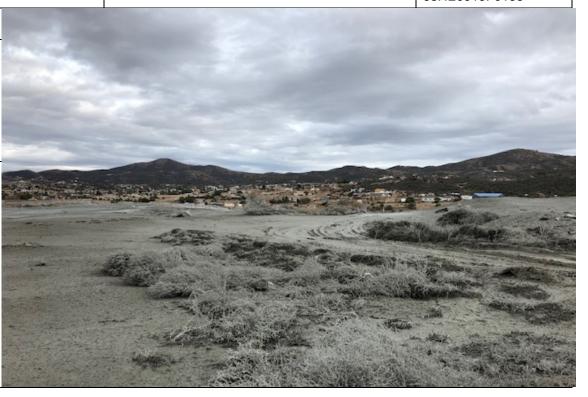
Photo No. 9 **Date:** 12/7/19

Posi-Shell® covering dross and associated vegetation.

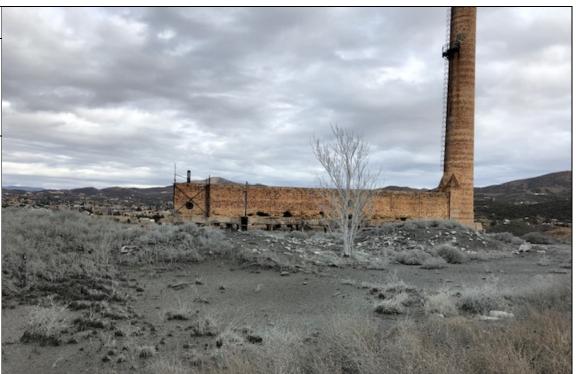
Photo No. 10 **Date:** 12/7/19

View of Posi-Shell® covered area south of the former smelter stack.
