# Appendix D

## Interim Removal Action Reports

D1. Removal Action Completion  
Report (Brown and Caldwell, 2007)

REMOVAL ACTION  
COMPLETION REPORT

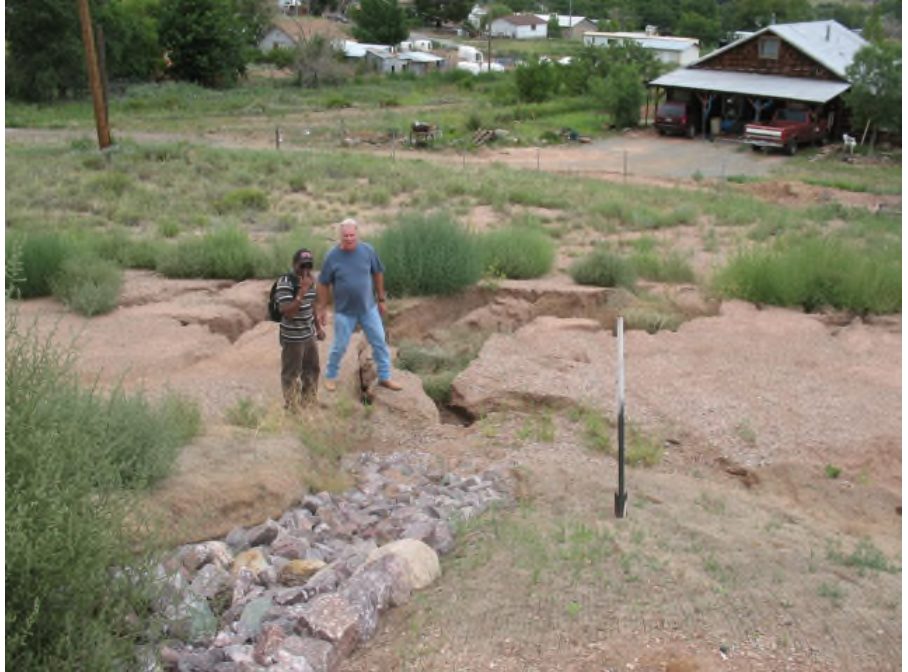
**Description:** ERRS and ERT personnel survey erosion damage leading across OFS-260. OFS-306 is visible in the background.

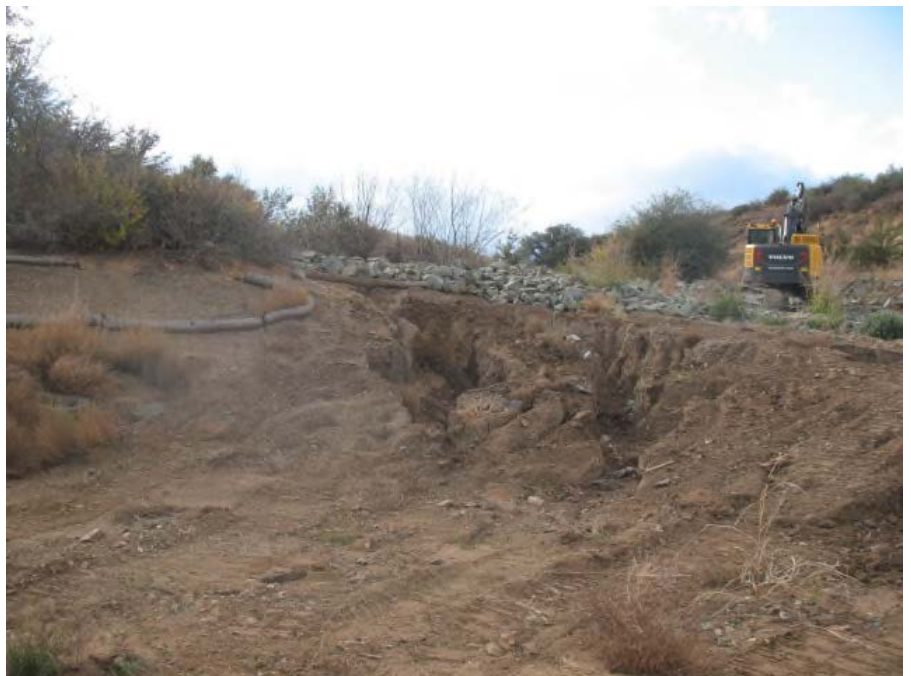
**Description:** Erosion damage leading from Iron King Mine property at spillway in area of former STP.

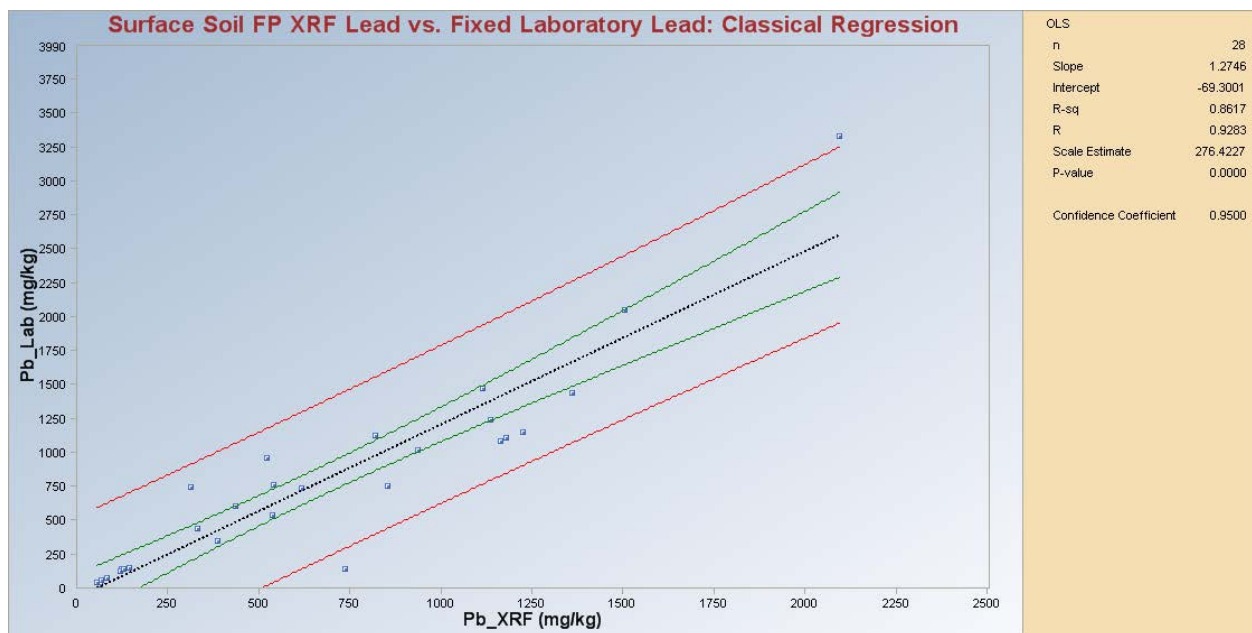
**Lead.** FP XRF readings for lead which were included in the statistical analyses ranged from 54 mg/kg to 2,095 mg/kg. Corresponding laboratory results ranged from 39.2 mg/kg to 3,330 mg/kg. A classical OLS regression analysis was conducted on these measurements with the XRF readings as the independent variable and the laboratory results as the dependent variable. The resulting coefficient of determination ( $R^2$ ) was 0.8617 which met the criteria,  $R^2 > 0.70$  for XRF confirmation analysis, identified in SERAS Standard Operating Procedure (SOP) #1720, *Operation of the NITON XLt792YW Field Portable X-ray Fluorescence Unit*. The figure below depicts the regression analysis with associated statistics listed to the right of the graph.
