Current Site Photographs, Iron King Mine – Humboldt Smelter Superfund Site

*Iron King Mine – Humboldt Smelter Superfund Site
Dewey-Humboldt, Yavapai County, Arizona*

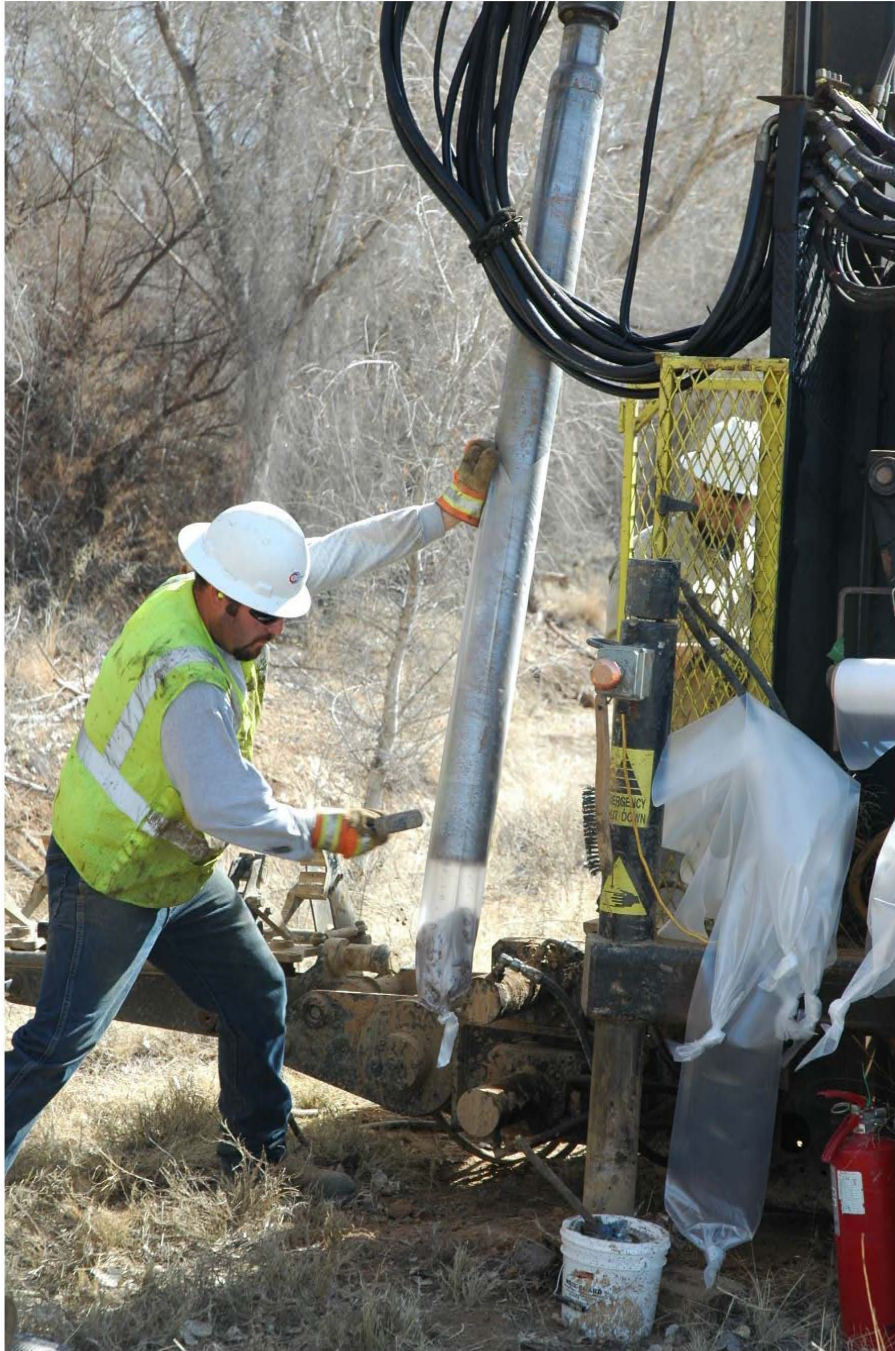
Photo DSC_0615: Photos during investigation: depicting percussion drill rig used to obtain cores from the ground in area of the Humboldt Smelter

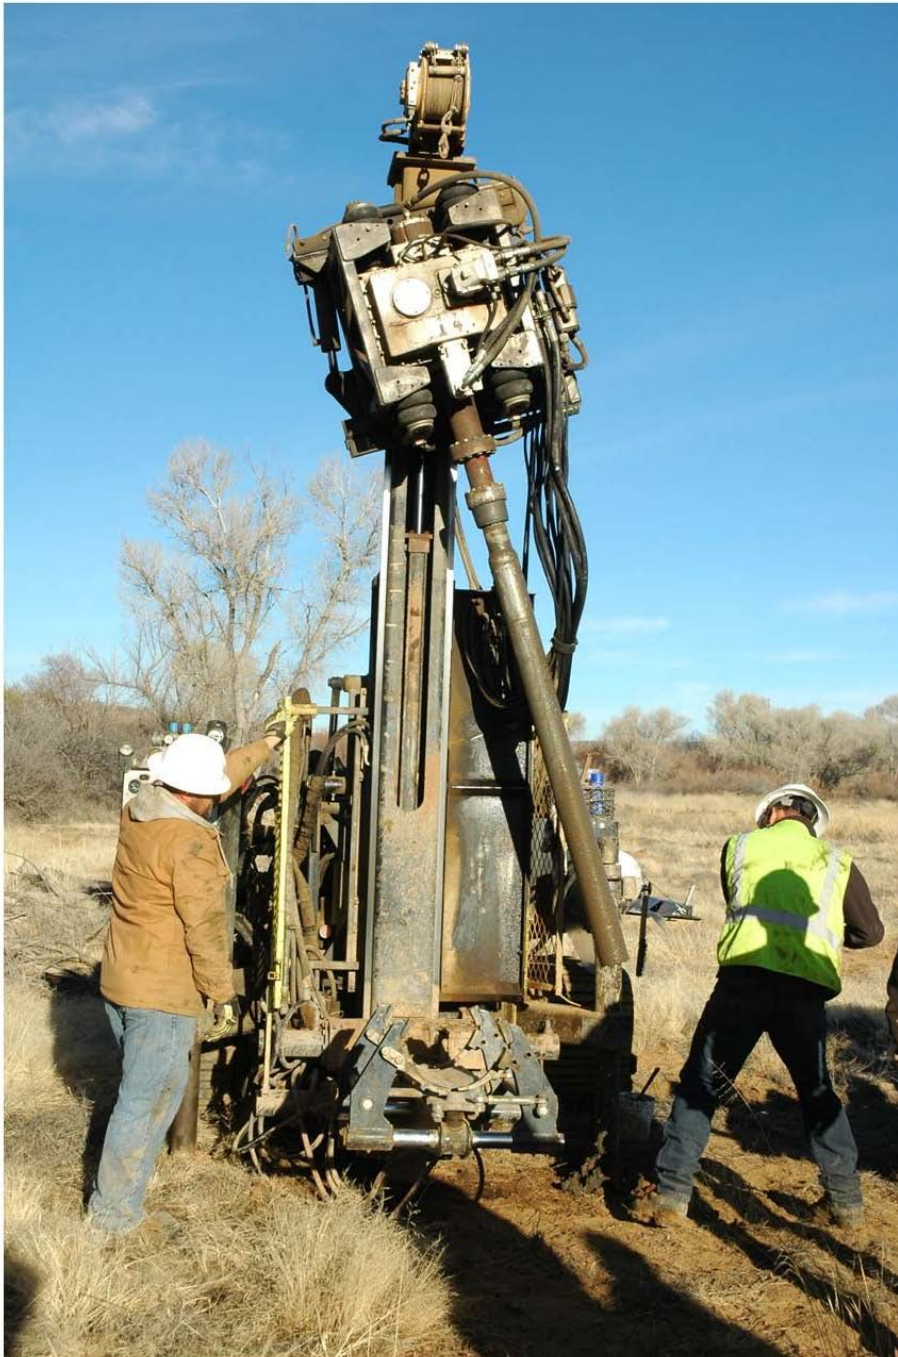
Photo DSC_0643: Photos during investigation: depicting percussive drill rig used to obtain cores from the ground in the Iron King Mine Blow Out Path

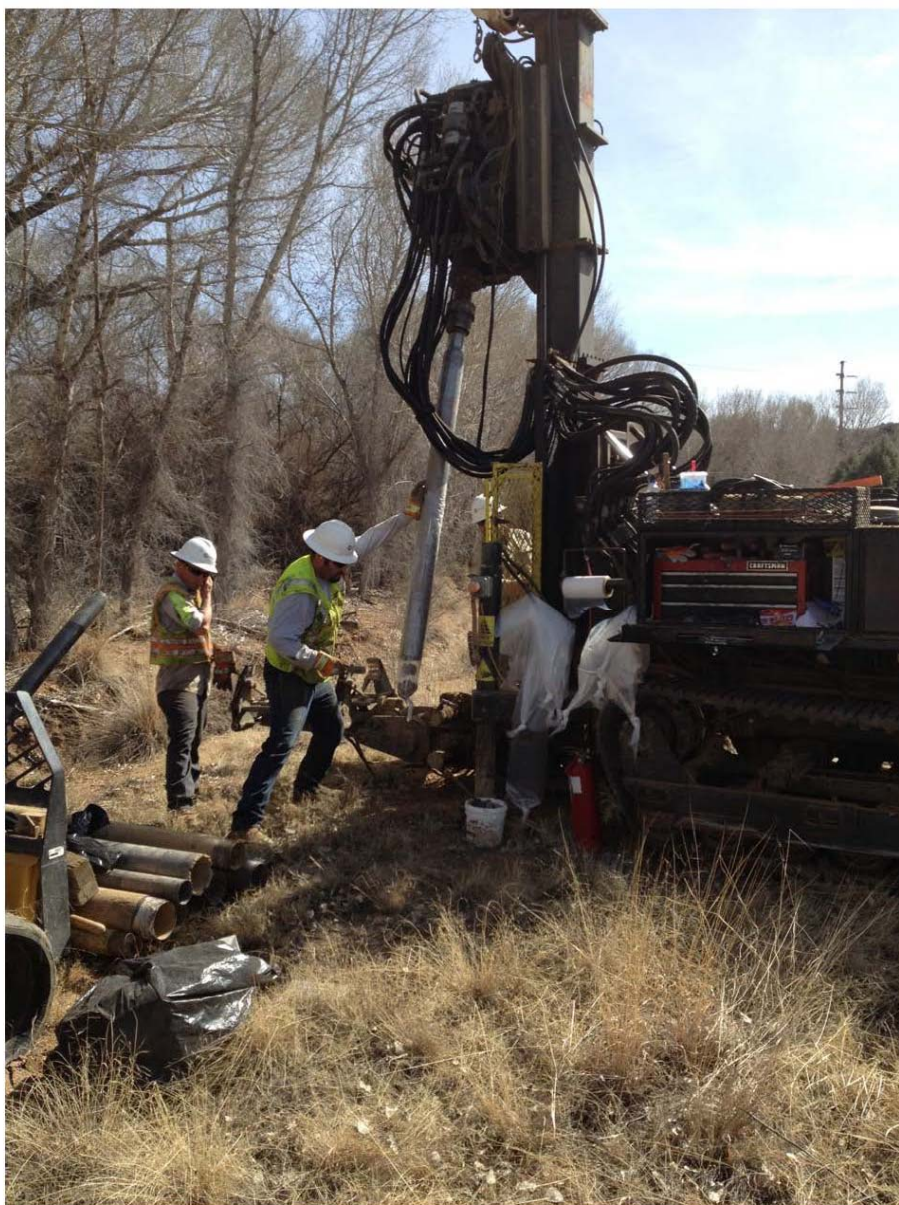
Photo IMG_0814: Photos during investigation: depicting percussive drill rig used to obtain cores from the ground in the Upper Gulch

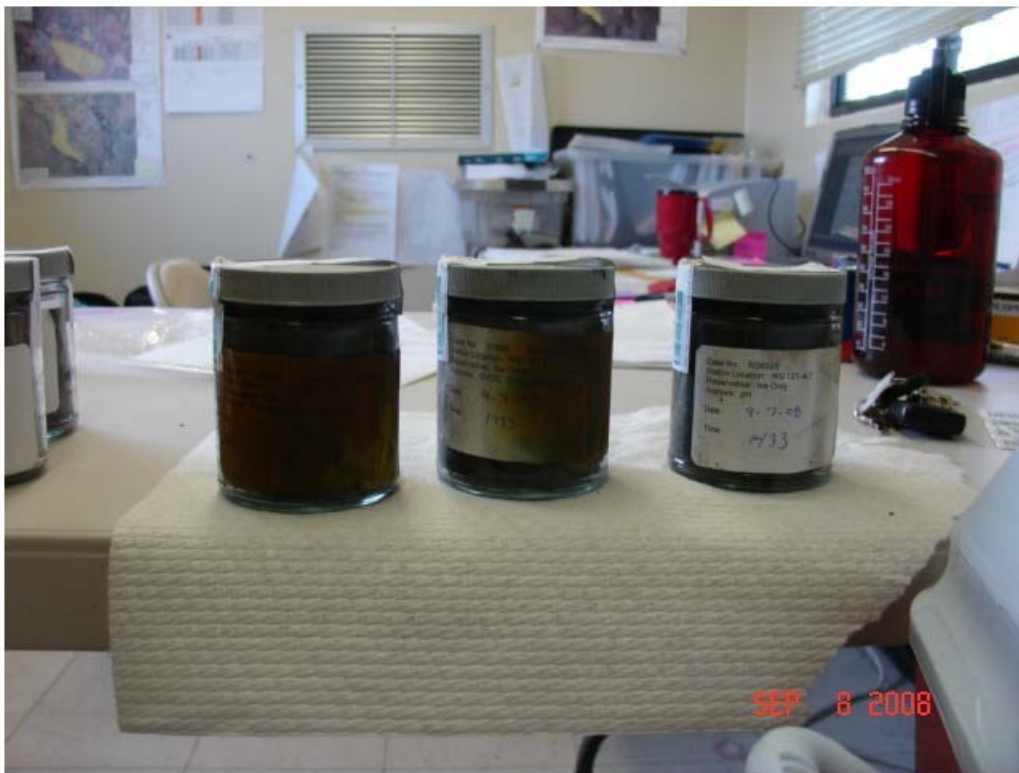
Photo DSC00116: Core samples prior to shipment to laboratory
