Figure 4-1A
Phase 1 Surface Soil Sample Locations, 2008 to 2009 Initial Remedial Investigation
 Iron King Mine – Humboldt Smelter Superfund Site
 Dewey-Humboldt, Yavapai County, Arizona

Figure 4-2A
Subsurface Soil Sample Locations,
EPA Remedial Investigations – Overview
Iron King Mine – Humboldt Smelter Superfund Site
Dewey-Humboldt, Yavapai County, Arizona

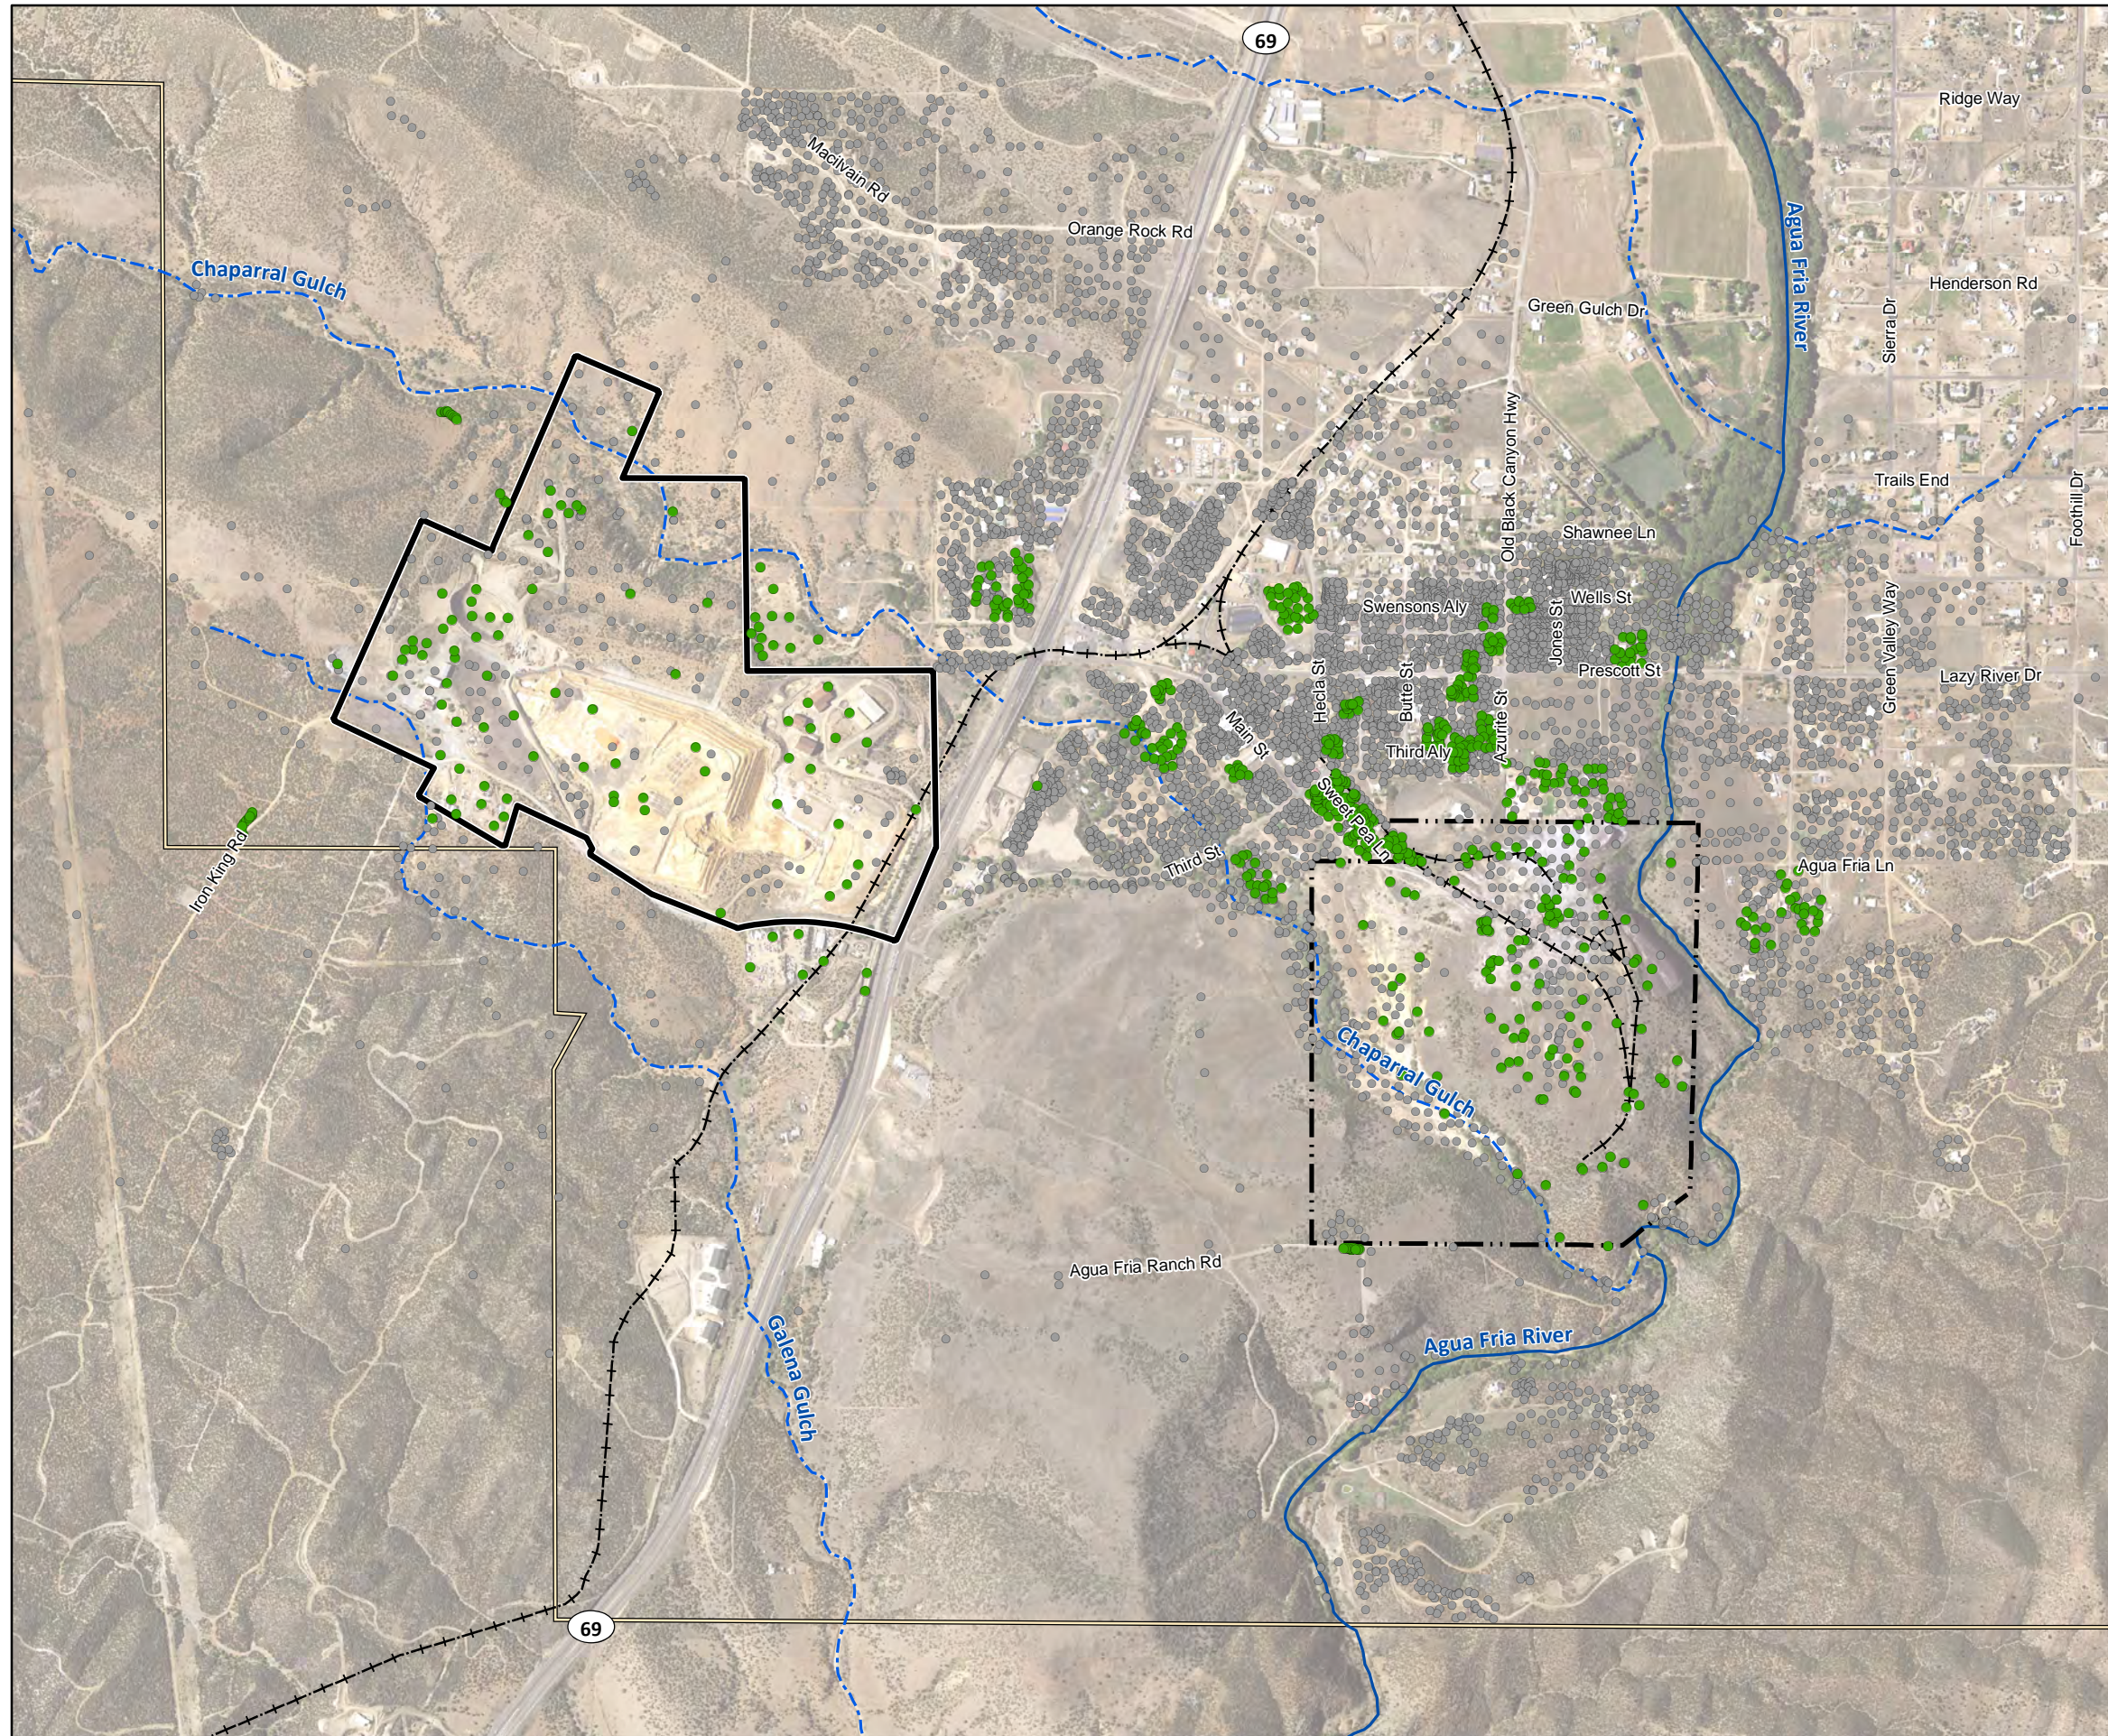
^aSurface soil samples are defined as having a sample start depth less than or equal to 2 feet below ground surface.
